Fukushima Daiichi Nuclear Power Station Unit 2
Results of RPV internal investigation using the existing reactor
water level instrument pipe

April 23, 2026

Tokyo Electric Power Company Holdings, Inc.

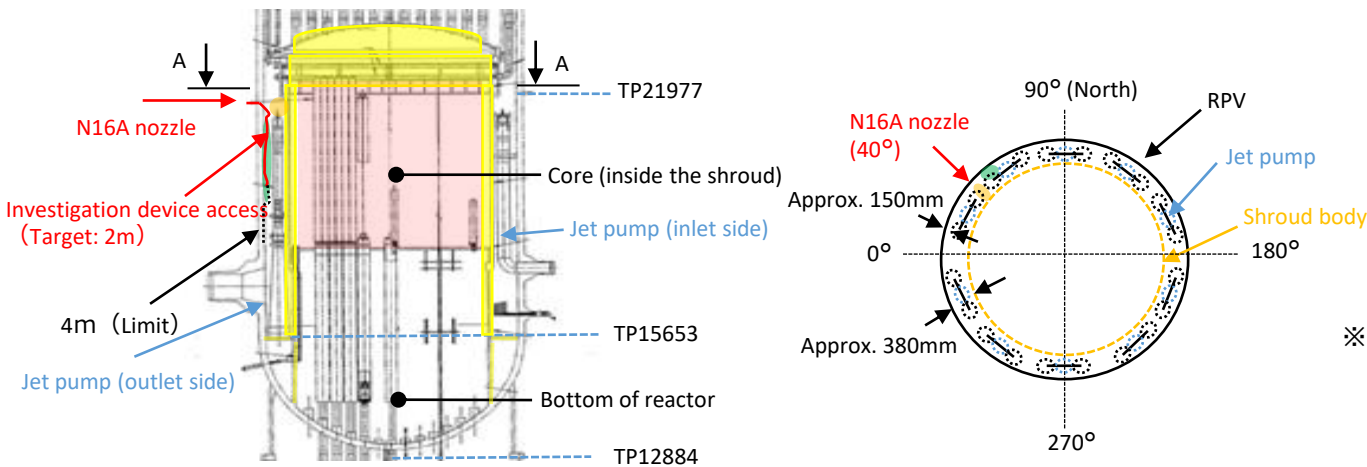
- : Scope of visual confirmation (if the tip of the investigation device reaches the vicinity of the N16A nozzle)
- : Scope of visual confirmation (if the tip of the investigation device reaches a point 2 meters below the N16A nozzle)
- : Shroud body (including supports)
- : Core

Investigation device access route and scope of visual confirmation (estimated)

- ※ Footage confirming the visibility of the investigation device: After the tip of the investigation device reaches the inside of the RPV it will be vertical around the vicinity of the N16A nozzle, but because bends will develop in the fiberscope as it maneuvers around obstructions inside the pipe, at the point two meters below the N16A nozzle, it may bend to face north of the nozzle.

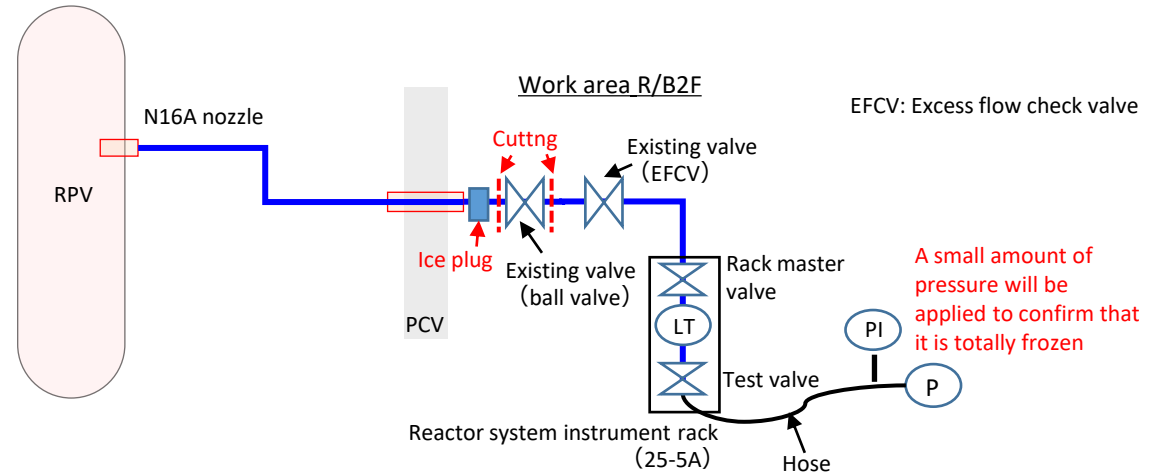
- The pipe will be flooded with filtered water. A freezing jig will be used to completely freeze the pipe after which the existing valve will be cut out with a pipe cutter.
- The inside surface of the pipe shall be examined to ensure that there are no adhesions that may impact the investigation.

Concept diagram of pipe freezing/cutting (X-28-c)
