Fukushima Daiichi Nuclear Power Station Completion of the Dismantling for the flanged tanks in E Area

Tokyo Electric Power Company Holdings, Inc.

Completion of the Dismantling of the D1 tank E Area

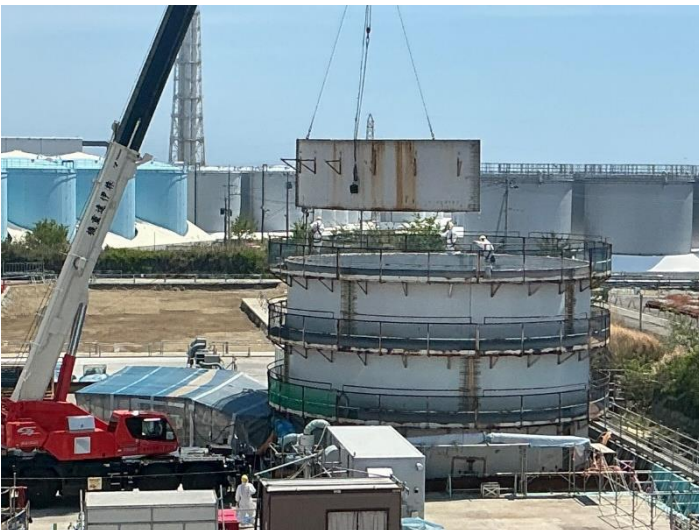
Dismantling of D1 tank in E area (May 12, 2026)

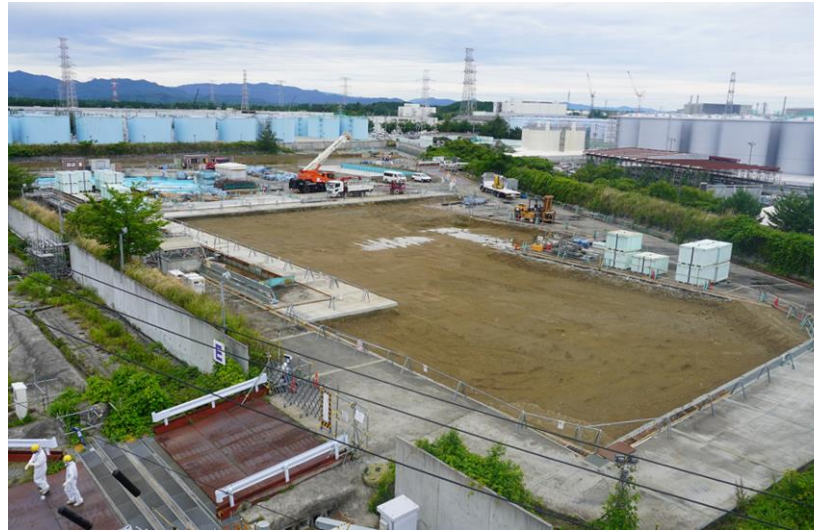
After dismantling D1 tank in E area (June 15, 2026)

- Dismantling of the D1 tank in E area was completed on June 15.
- This marks the completion of the dismantling of all 334 flanged tanks used to store contaminated water for approximately 11 years since the accident which began in May 2015.
- We will continue to prioritize safety as we move carefully forward with the decommissioning work of the Fukushima Daiichi Nuclear Power Station in order to reduce risk.

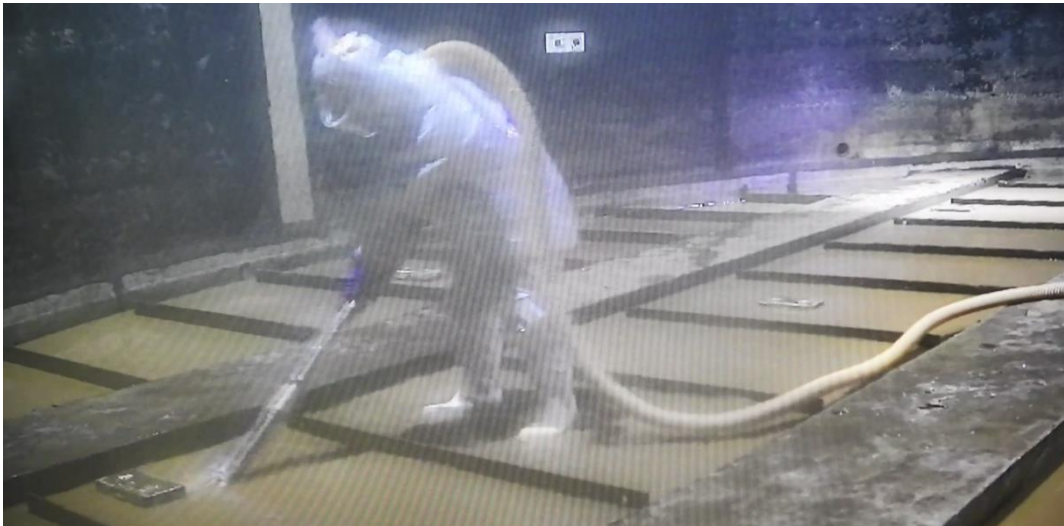
Cleaning the inside of tank D1 in E area (December 24, 2025)

- The inside of the tank was cleaned and decontaminated after which dismantling began on May 12, 2026, and was completed on June 15, 2026.
- Standardization[※] of the dismantling process, which took place over the course of flanged tank dismantling, and the introduction of technology, such as laser decontamination, enabled the highly contaminated tanks to be dismantled safely.

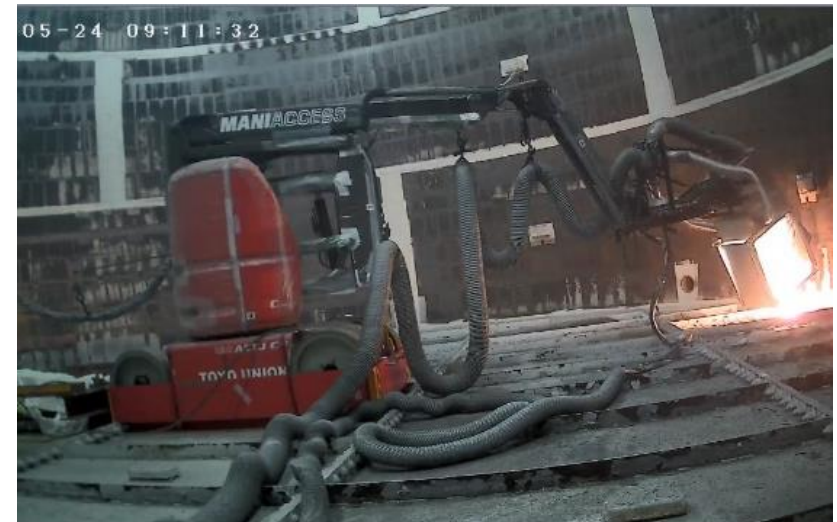
Using lasers to decontaminate a tank in E area (May 24, 2022)
