# Fukushima Daiichi Nuclear Power Station Progress of Fuel Removal from Spent Fuel Pools

July 30, 2026

Tokyo Electric Power Company Holdings, Inc.

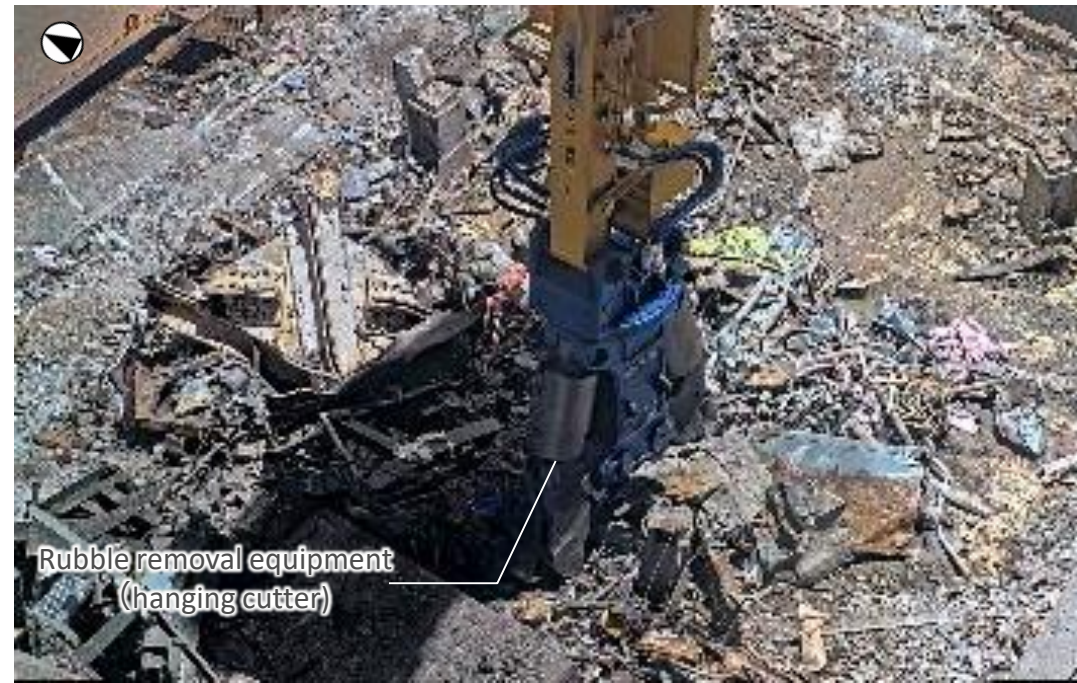
Crushing rubble on the operating floor  
(photographed on July 16, 2026)

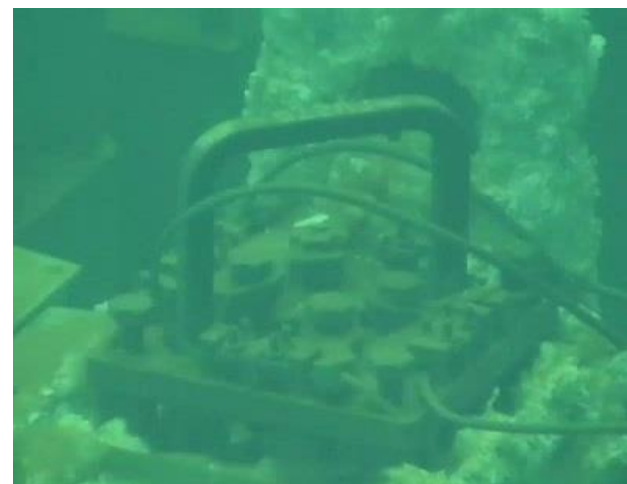
- In the Unit 2 spent fuel pool there is a fuel assembly that has been repaired with a wire that has been in storage since the 1980s. ※<sup>1</sup>
- No abnormalities were observed during the underwater camera inspection of the upper part of the fuel. Corrosion testing using wire of the same specification, conducted in consideration of the seawater injection during the accident, confirmed sufficient wire strength. However, because special measures would be required if wire slackening or other issues were to occur during lifting, a lifting test will be carried out in August to confirm that the fuel can be lifted safely and without problems.

Photograph of the top of the fuel assembly that has been repaired with a wire (Photographed on July 8, 2026)

- During this investigation, the upper portion of the aforementioned fuel assembly was examined and a submersible ROV was used to search for any breaks in the wire used to make the repair or loose securing jigs. None of the above was found.

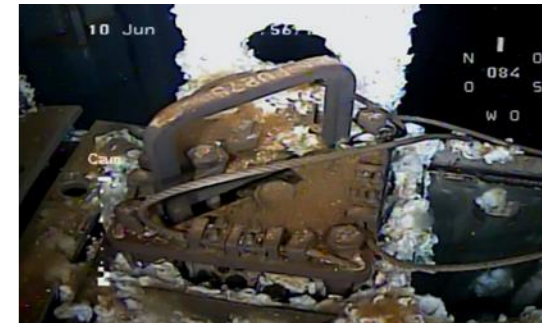
Photo of the top of the fuel repaired with a wire
