# **Fukushima Daiichi Nuclear Power Station Unit 2 PCV Internal Investigation/ Status of Fuel Debris Trial Retrieval**

July 30, 2026

International Research Institute for Nuclear Decommissioning  
Tokyo Electric Power Company Holdings, Inc.

# 1. PCV internal investigation and trial retrieval plan overview

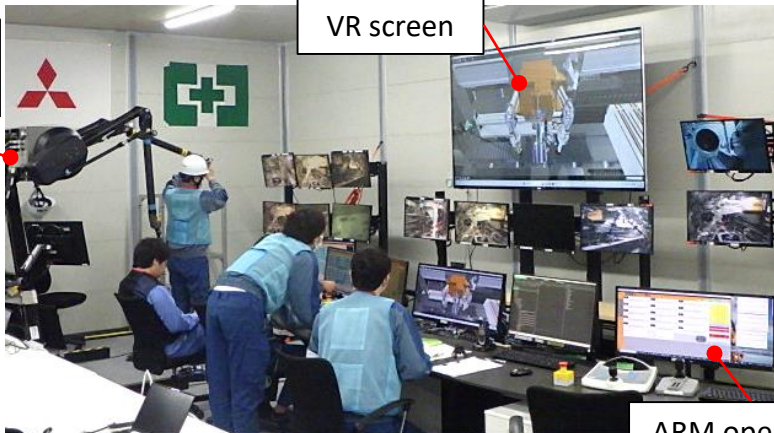
Manipulator  
(operations side)

Remote operations center

The manipulator is remotely  
operated inside the enclosure  
while watching a camera

- Function checks are underway to confirm the integrity of the robotic arm.
- TEPCO operators will operate the robotic arm and manipulator from the remote operations center.
- Arm and manipulator operation will be checked with the isolation valve of the X-6 penetration connection structure, which is the PCV boundary, closed.

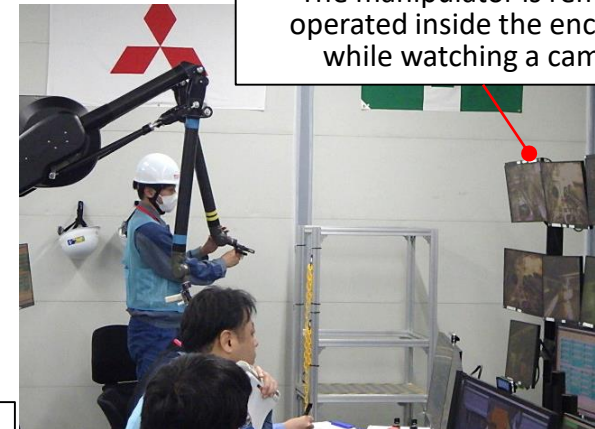
Manipulator function check

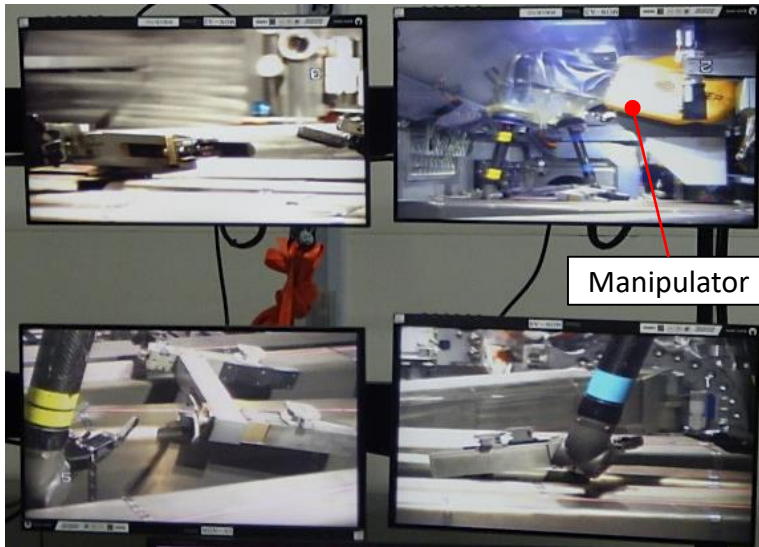
- The following investigations were implemented on the electrical and mechanical systems.
- Each investigation showed that there are no problems with the electrical system, so we assume the cause is the mechanical system.
- It was determined that the shaft motor needs replacing, so we are deliberating replacement of the aforementioned motor.

Performing an investigation with the manipulator  
(Monitors showing the camera feed from inside the enclosure)

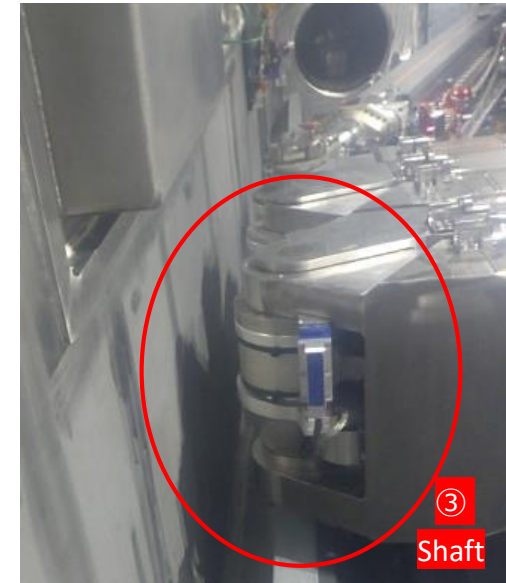
Performing checks inside the enclosure

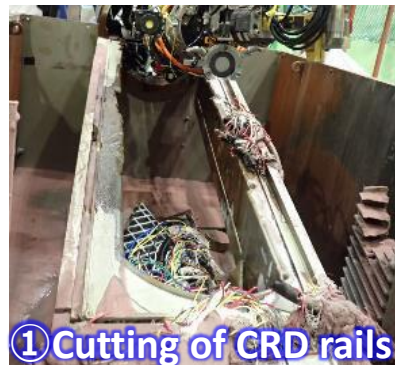
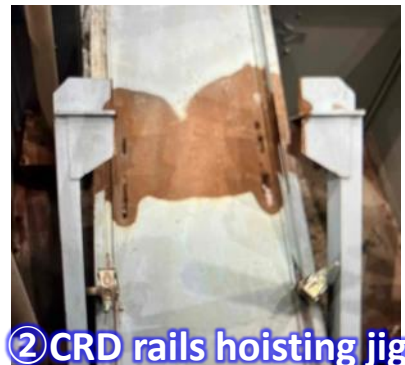
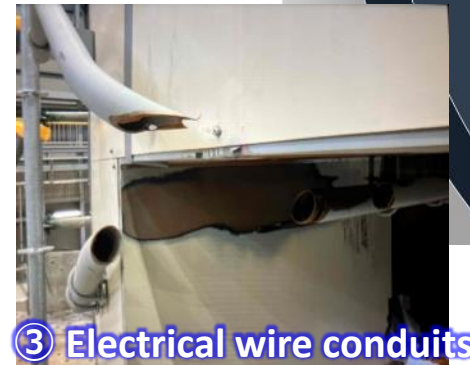
■ Access route construction  
(locations from which obstructions will be removed)

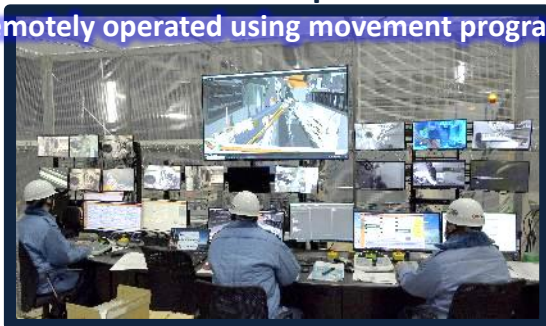
## Robotic arm operations

Remotely operated using movement programs

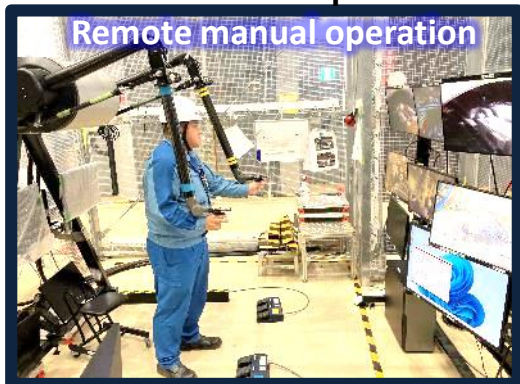
- There are multiple tip tools that can be attached to the wand of the robotic arm in accordance with the task to be performed. The **dual manipulator inside the enclosure is operated remotely to switch out these tip tools.**

Remote manual operation

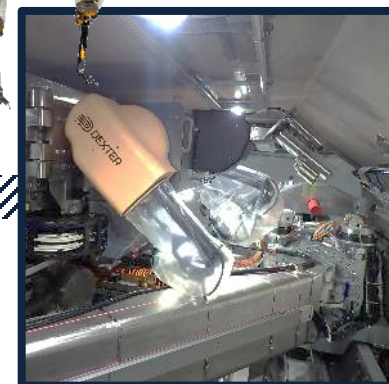
## Trial retrieval

Inside the enclosure
