Sampling Results Regarding the Water Leak at a Tank in the H4 area in Fukushima Daiichi Nuclear Power Station (South Water Outlet, Drainage Channel)

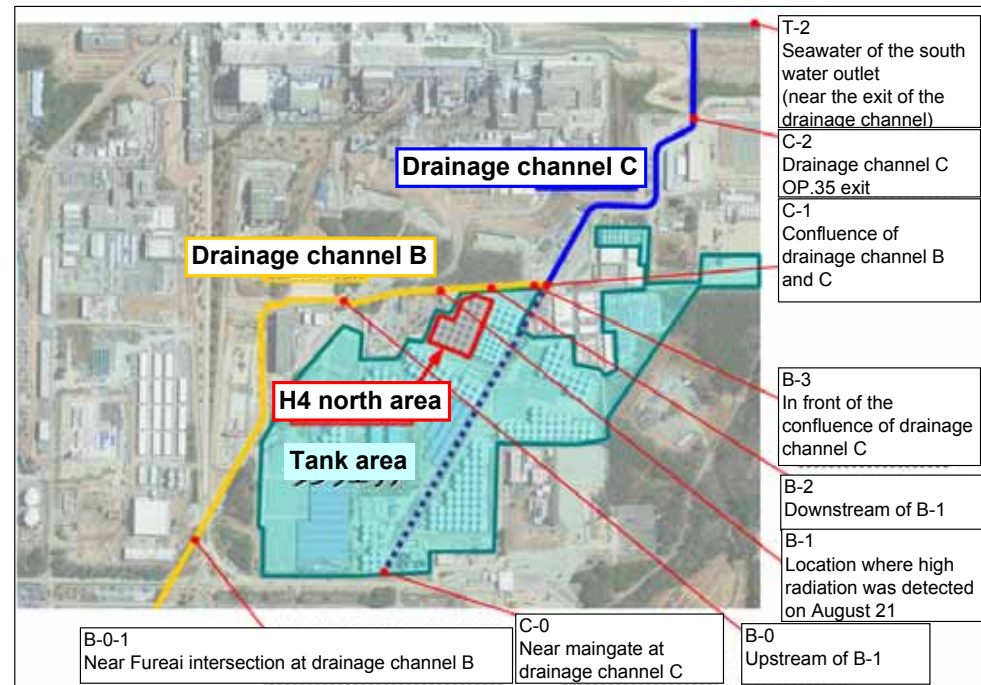
Note 1: Approx. 330m south from Unit 1-4 water outlet (T-2)

Note 3: Water inflow location of drainage channel to the tank area
