Sampling Results Regarding the Water Leak at the Tanks in the H4 area and the B area in Fukushima Daiichi Nuclear Power Station (South Water Outlet, Drainage Channel)

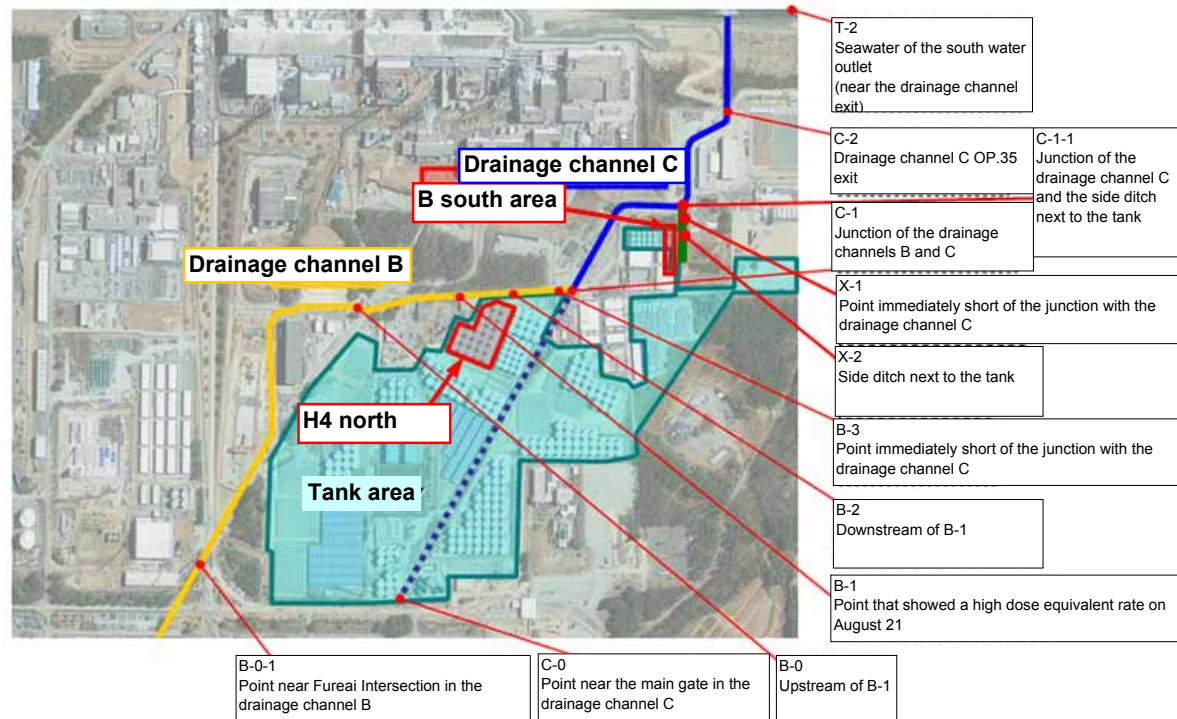
Seawater of the south water outlet <small>Note 1</small> (near the drainage channel exit) ¹ (T-2)	Junction of the drainage channels B and C <small>Note 2</small> (C-1)	Side ditch next to the tank (X-2)	Side ditch next to the tank (point immediately short of the junction with the drainage channel C) (X-1)	Junction of the drainage channel C and the side ditch next to the tank (C-1-1)	Sampling points of the inside of drainage channel B			Point near Fureai Intersection in the drainage channel B <small>Note 3</small> (B-0-1)	Point near the main gate in the drainage channel C <small>Note 3</small> (C-0)	Drainage channel C OP.35 exit (C-2)
						Point that showed a high dose equivalent rate on August 21 (B-1)	Downstream of B-1 (B-2)	Point immediately short of the junction with the drainage channel C (B-3)			
Date of Sampling	Oct 4, 2013	Oct 4, 2013	Oct 4, 2013	Oct 4, 2013	Oct 4, 2013	*	*	Oct 4, 2013	Oct 4, 2013	Oct 4, 2013	Oct 4, 2013

Note 1: Approx. 330m south from Unit 1-4 water outlet (T-2)

Note 2: Same sampling point as side ditch in front of the core warehouse sampled on August 19 (announced on August 20) and August 20 (announced on August 21)

Note 3: Water inflow location of drainage channel to the tank area
