Sampling Results Regarding the Water Leak at the Tanks in the H4 area in Fukushima Daiichi Nuclear Power Station (South Water Outlet, Drainage Channel)

<Reference>  
January 11, 2014  
Tokyo Electric Power Company

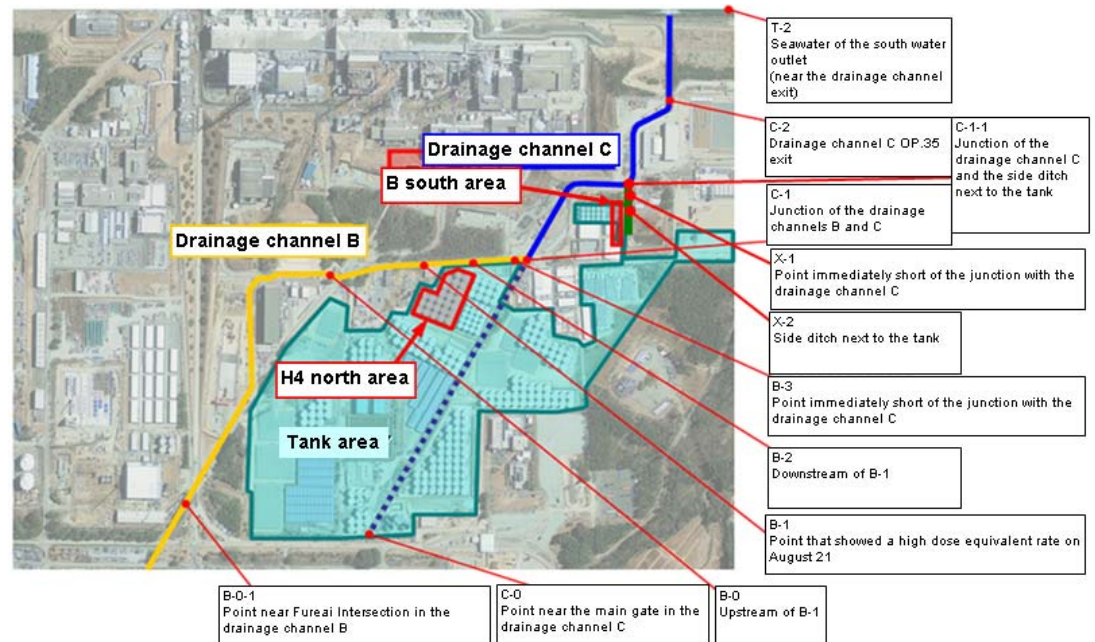
Seawater of the south water outlet <sup>Note 1</sup> (near the drainage channel exit) <sup>†1</sup> (T-2)	Junction of the drainage channels B and C <sup>Note 2</sup> (C-1)	Side ditch next to the tank (X-2)	Side ditch next to the tank (point immediately short of the junction with the drainage channel C) (X-1)	Junction of the drainage channel C and the side ditch next to the tank (C-1-1)	Sampling points of the inside of drainage channel B			Point near Fureai Intersection in the drainage channel B <sup>Note 3</sup> (B-0-1)	Point near the main gate in the drainage channel C <sup>Note 3</sup> (C-0)	Drainage channel C OP.35 exit (C-2)
						Point that showed a high dose equivalent rate on August 21 (B-1)	Downstream of B-1 (B-2)	Point immediately short of the junction with the drainage channel C (B-3)			
Date of Sampling	Jan 10, 2014	Jan 10, 2014	Jan 10, 2014	Jan 10, 2014	Jan 10, 2014	Jan 10, 2014	*	Jan 10, 2014	Jan 10, 2014	Jan 10, 2014	Jan 10, 2014

Note 1: Approx. 330m south from Unit 1-4 water outlet (T-2)

Note 2: Same sampling point as side ditch in front of the core warehouse sampled on August 19 (announced on August 20) and August 20 (announced on August 21)

Note 3: Water inflow location of drainage channel to the tank area
