# Debris Removal from the Upper Part of Unit 3 Reactor Building at Fukushima Daiichi Nuclear Power Station Renewal of the Protection Installed on the Spent Fuel Pool and the Skimmer Surge Tank Hatch

<Reference>  
May 27, 2013  
Tokyo Electric Power Company

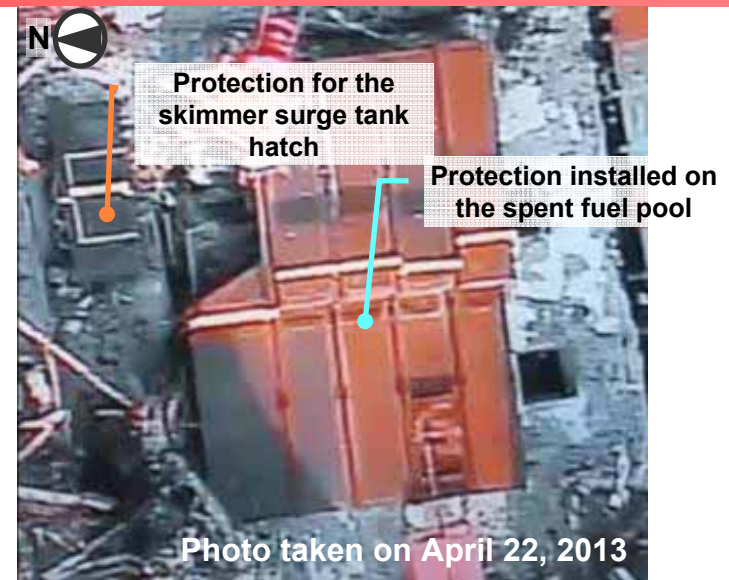
Before the protection on the spent fuel pool was renewed
