Steam-like Gas Found Near the Central Part of the Fifth Floor (Equipment Storage Pool Side) of Unit 3 Reactor Building at Fukushima Daiichi Nuclear Power Station

<Reference>
July 18, 2013
Tokyo Electric Power Company

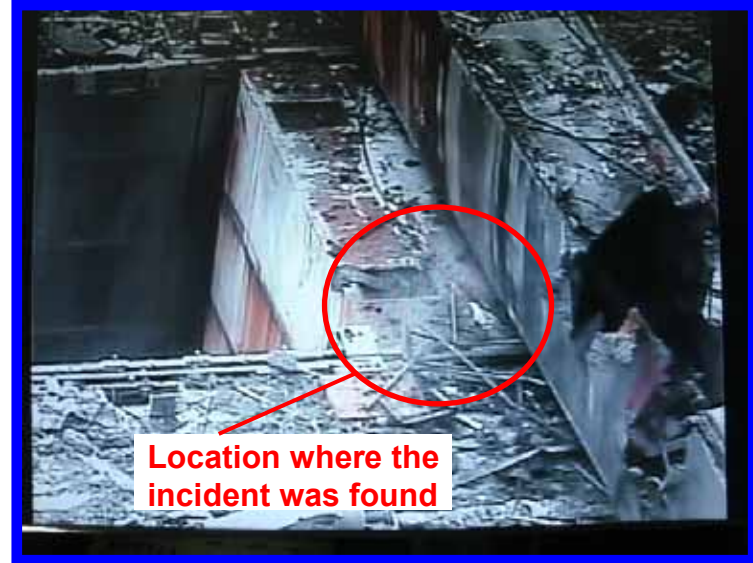
[Photo (2)]

■ At around 8:20 AM on July 18, 2013, an associated company worker, investigating the site using a camera ahead of debris removal work, encountered a steam-like gas wafting through the air near the central part of the fifth floor (equipment storage pool side) of Unit 3.

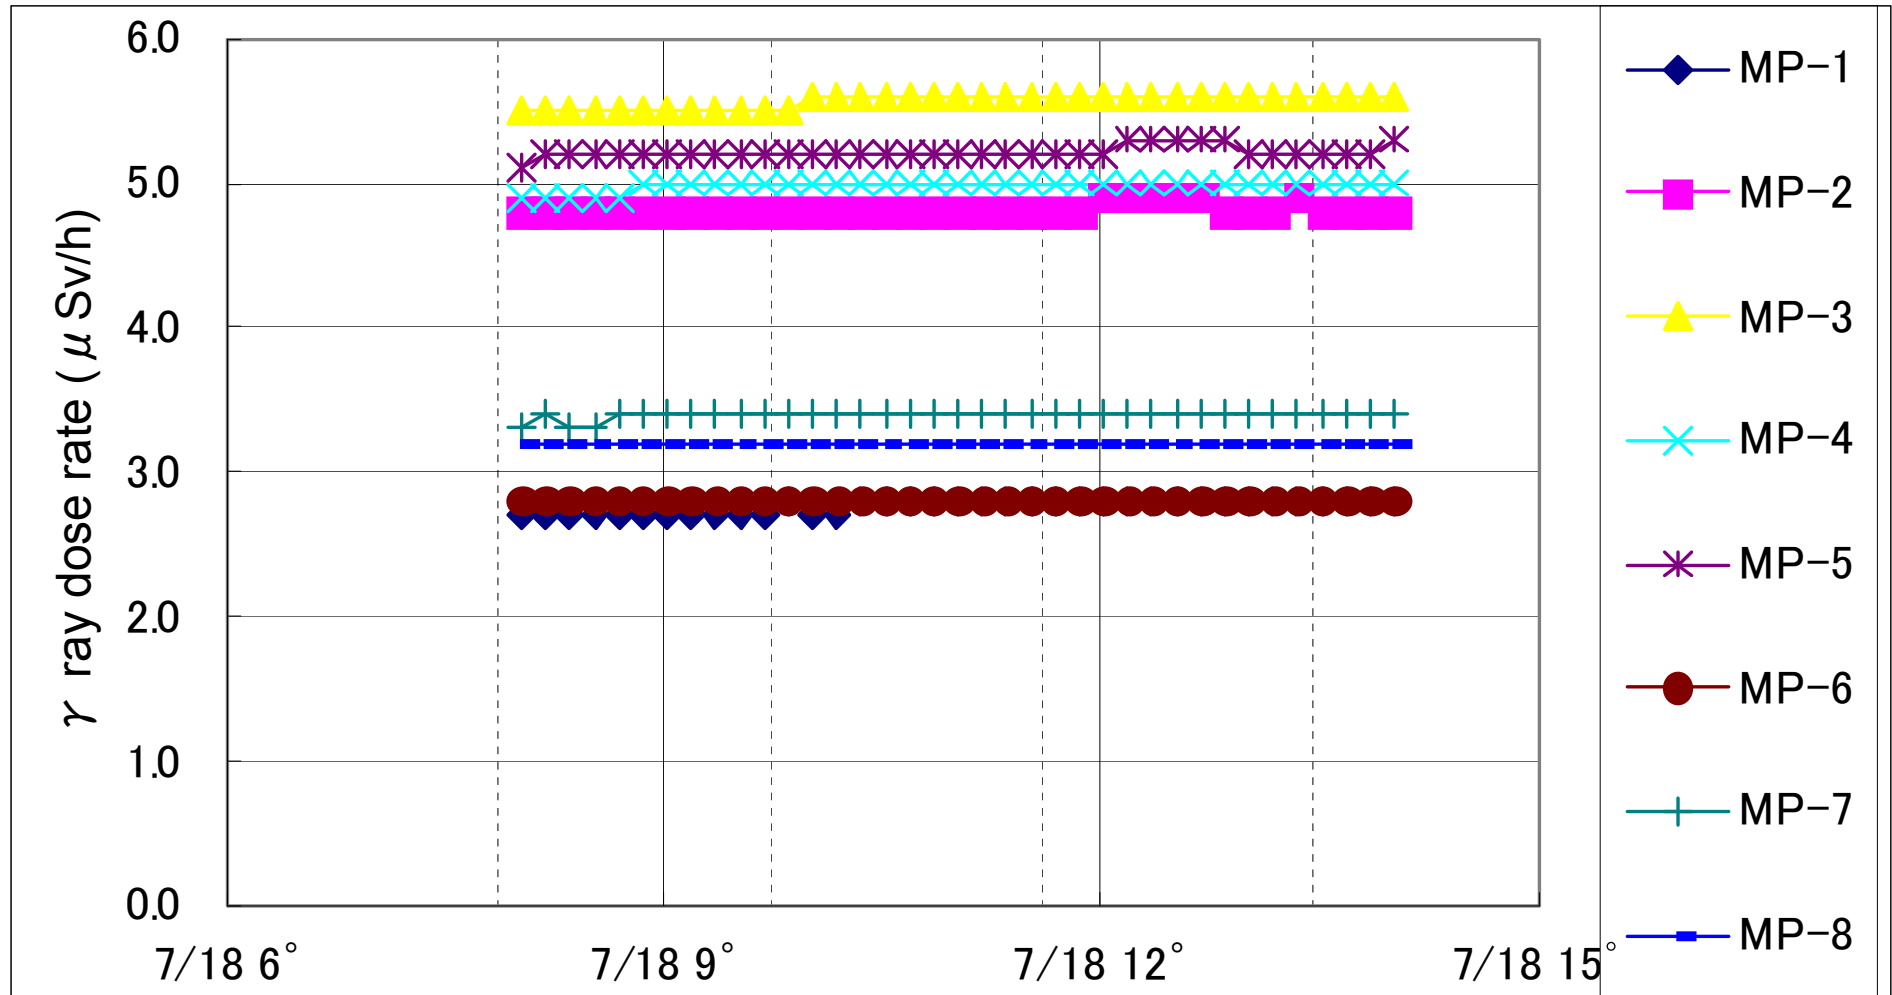
[Reference] Transition of monitoring post readings (8:00 AM – 2:00 PM on July 18)

- Reactor water injection, cooling of the spent fuel pool:
Continuing stably
- Monitoring post readings, continuous dust monitor amounts:
No significant change was found
- Temperature of RPV/PCV:
No significant change was found
- Noble gas monitor:
No significant change was found
- Nitrogen injection of PCV:
No significant change was found
