# Accumulated Water Inside the Dike in Each Tank Area at Fukushima Daiichi Nuclear Power Station (Renewed Version)

<Reference>  
September 20, 2013  
Tokyo Electric Power Company

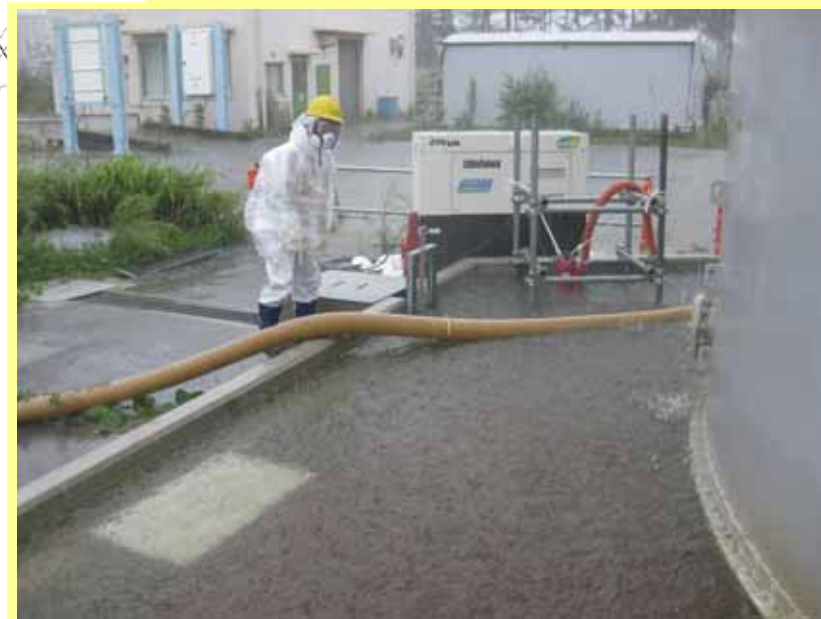
<Condition at the B area (South)>

(Photo taken by TEPCO on September 15, 2013)
