Results of the Local Vacuum Test for the Tank Bottom Plate

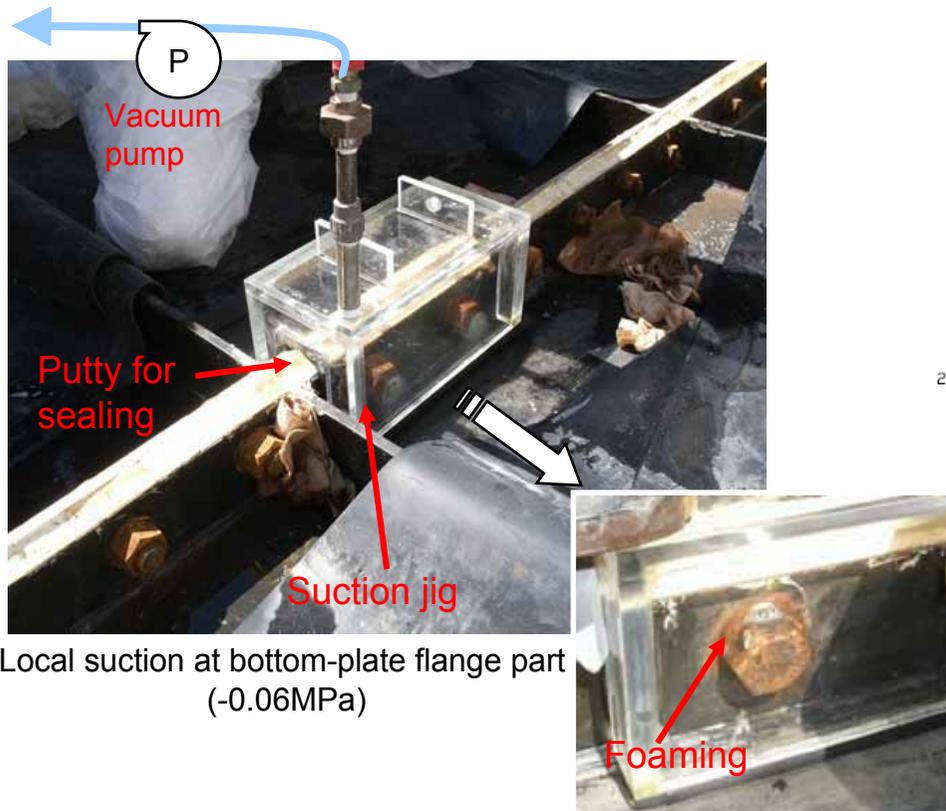
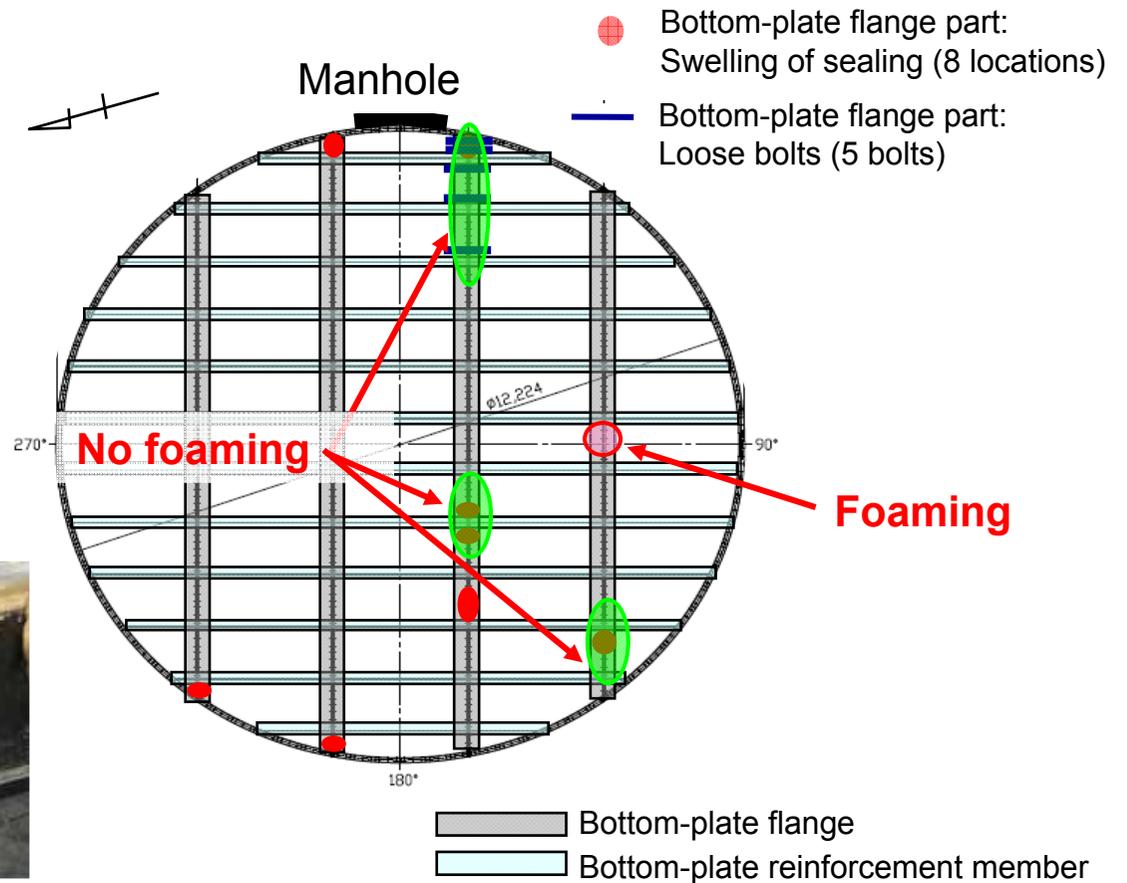
- We conducted the local vacuum test at the point(s) in which 1) bubbles were vacuumed up in the vacuum test for the bottom-plate, 2) bolts were found loose, and 3) swelling of sealing was found. As a result, **we found foaming at the point 1)**, but NO foaming at the points 2) and 3).
