Overflow of Water from the Notch Tank for H6 Area Located on the East of H5 Area at Fukushima Daiichi NPS

October 1, 2013

Tokyo Electric Power Company

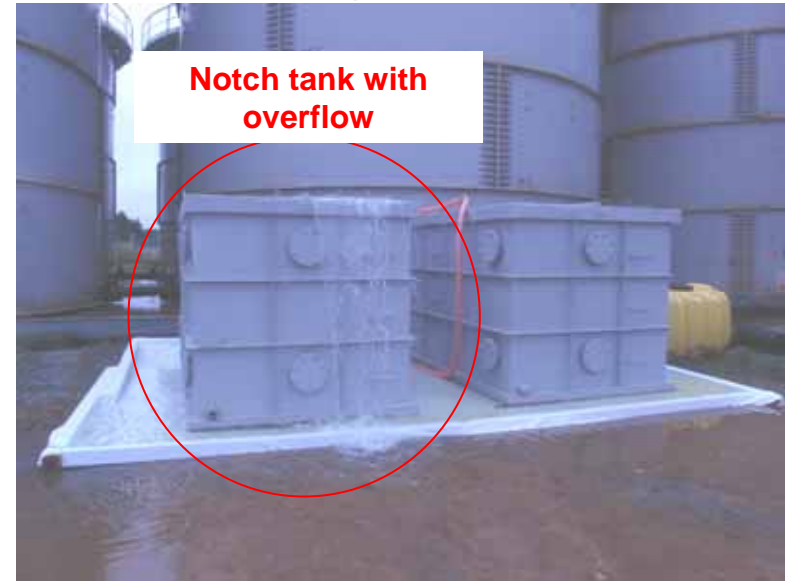
Photo taken by Nuclear Regulatory Commission on October 1, 2013

■ Details : A TEPCO employee started transferring rainwater inside the dike at H6 area into H2 area (south), for the purpose of preparing for a typhoon. The transfer hose should have been connected to H2 area (south), but actually was connected to the notch tank for H6 area. It caused the water overflow from the notch tank after activating the operation of the pump.

<Before suspending the pump >

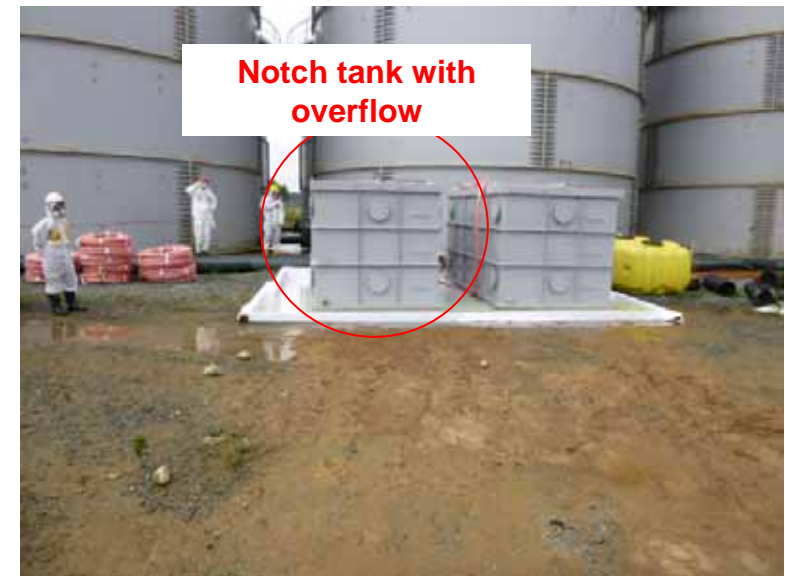
Photo taken by TEPCO on October 1, 2013

At 12:10, we suspended the operation of the transfer pump, and found no more water overflow from the notch tank.

<After suspending the pump >
