**Multi-nuclide Removal Equipment
- Cause and Measure of the outflow
of carbonate slurry-**

May 23, 2014

Tokyo Electric Power Company

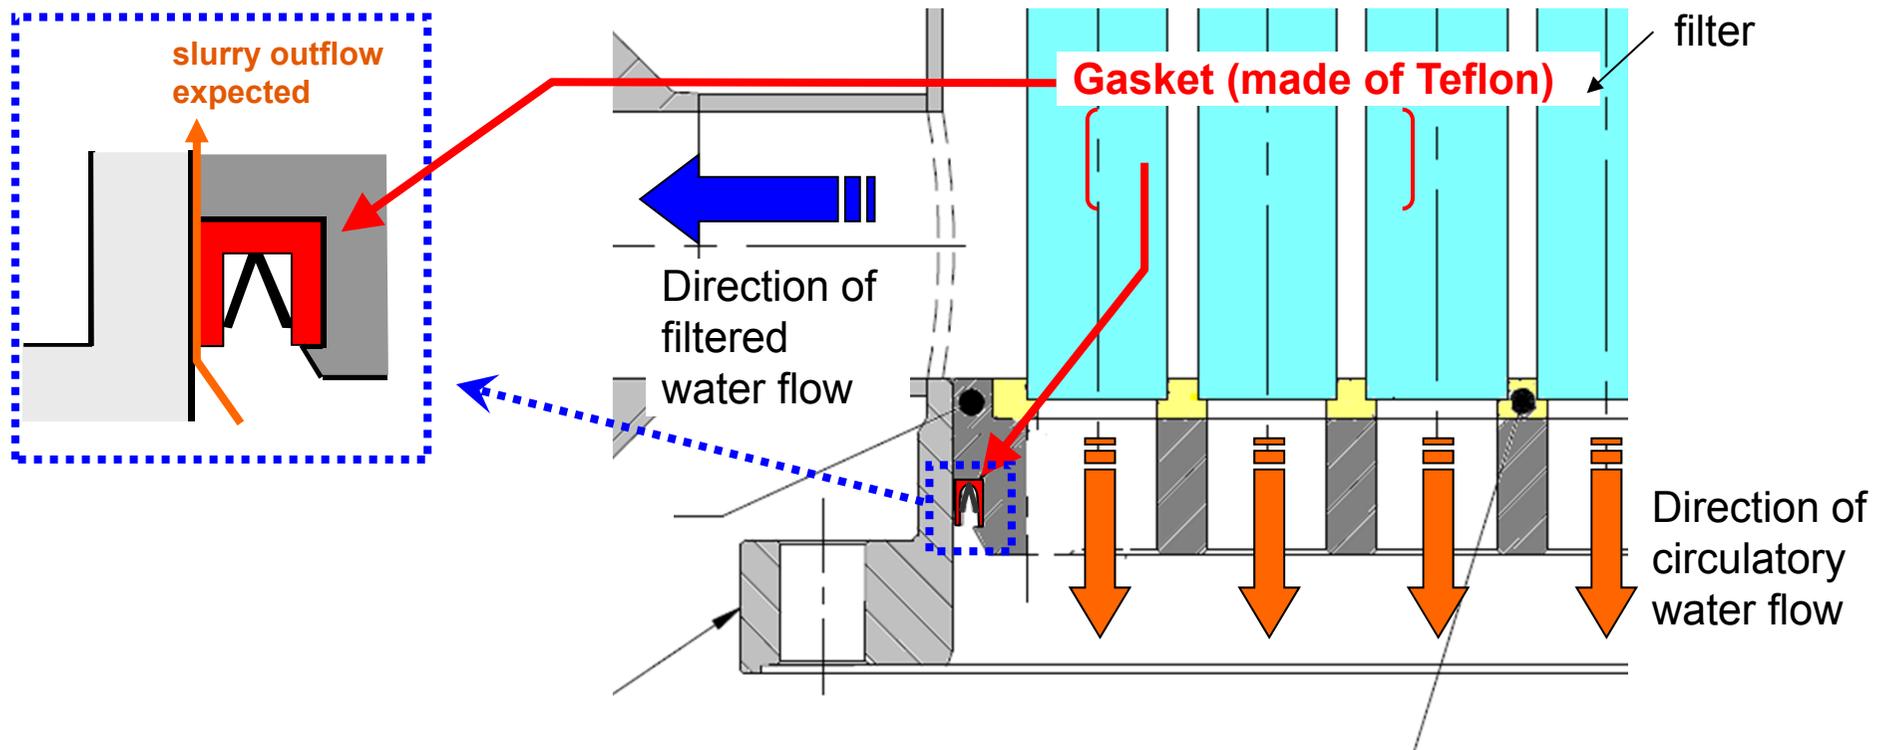
Outlet details

- We overhauled the filters and found there are defects, or micro scratches on the gasket. Slurry of carbonate is assumed to have flown through them to the downstream.

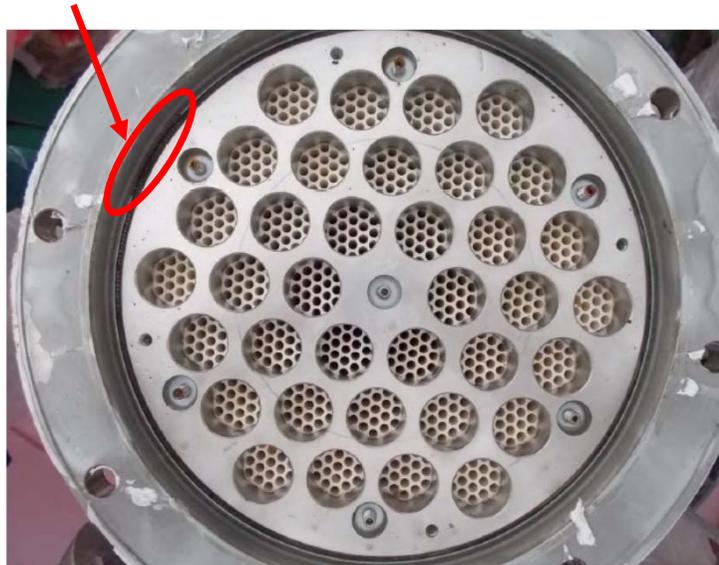
Defect on the gasket

Defects found at the overhauled filter (3B cross flow filter)

- A defect was identified on the gasket of the 3B cross flow filter.

- Below improvement was made for the filter
 - Change the material of the gasket to a more highly-resistant **EPDM (synthetic gum)**

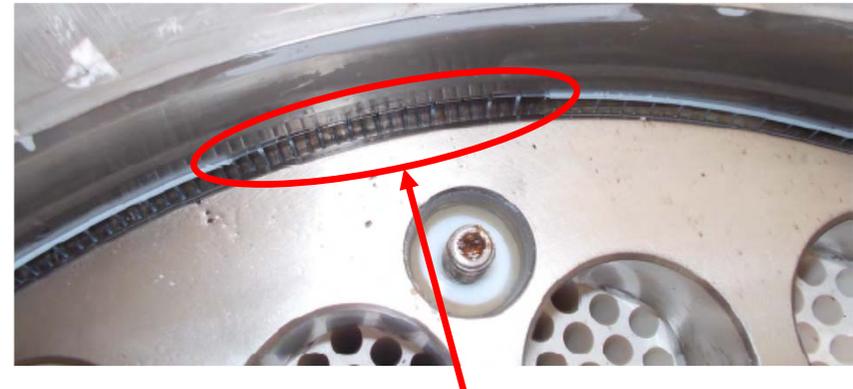
View from above

Defect: 6-cm width, 3-mm depth

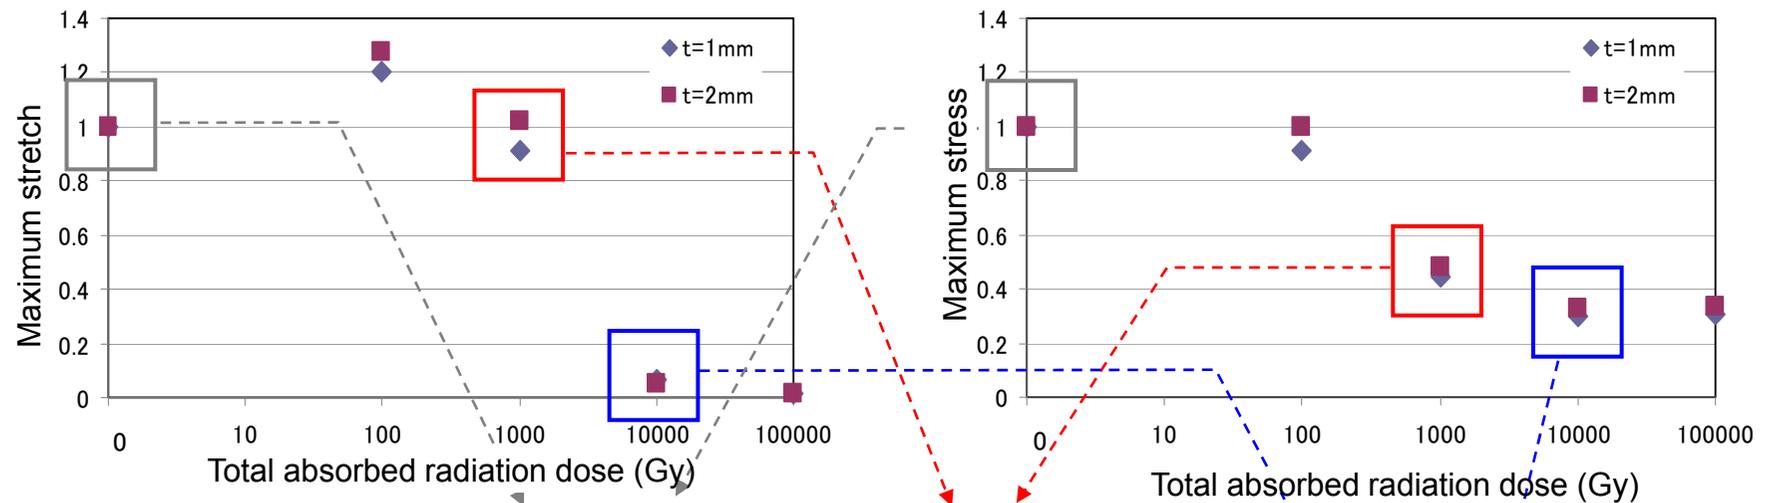
■ Radiated test results (PTFE (Teflon))

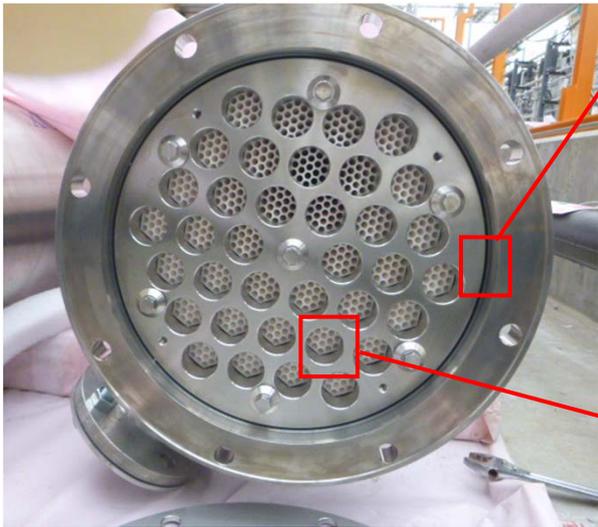
Output side view

<Reference> Improved filter

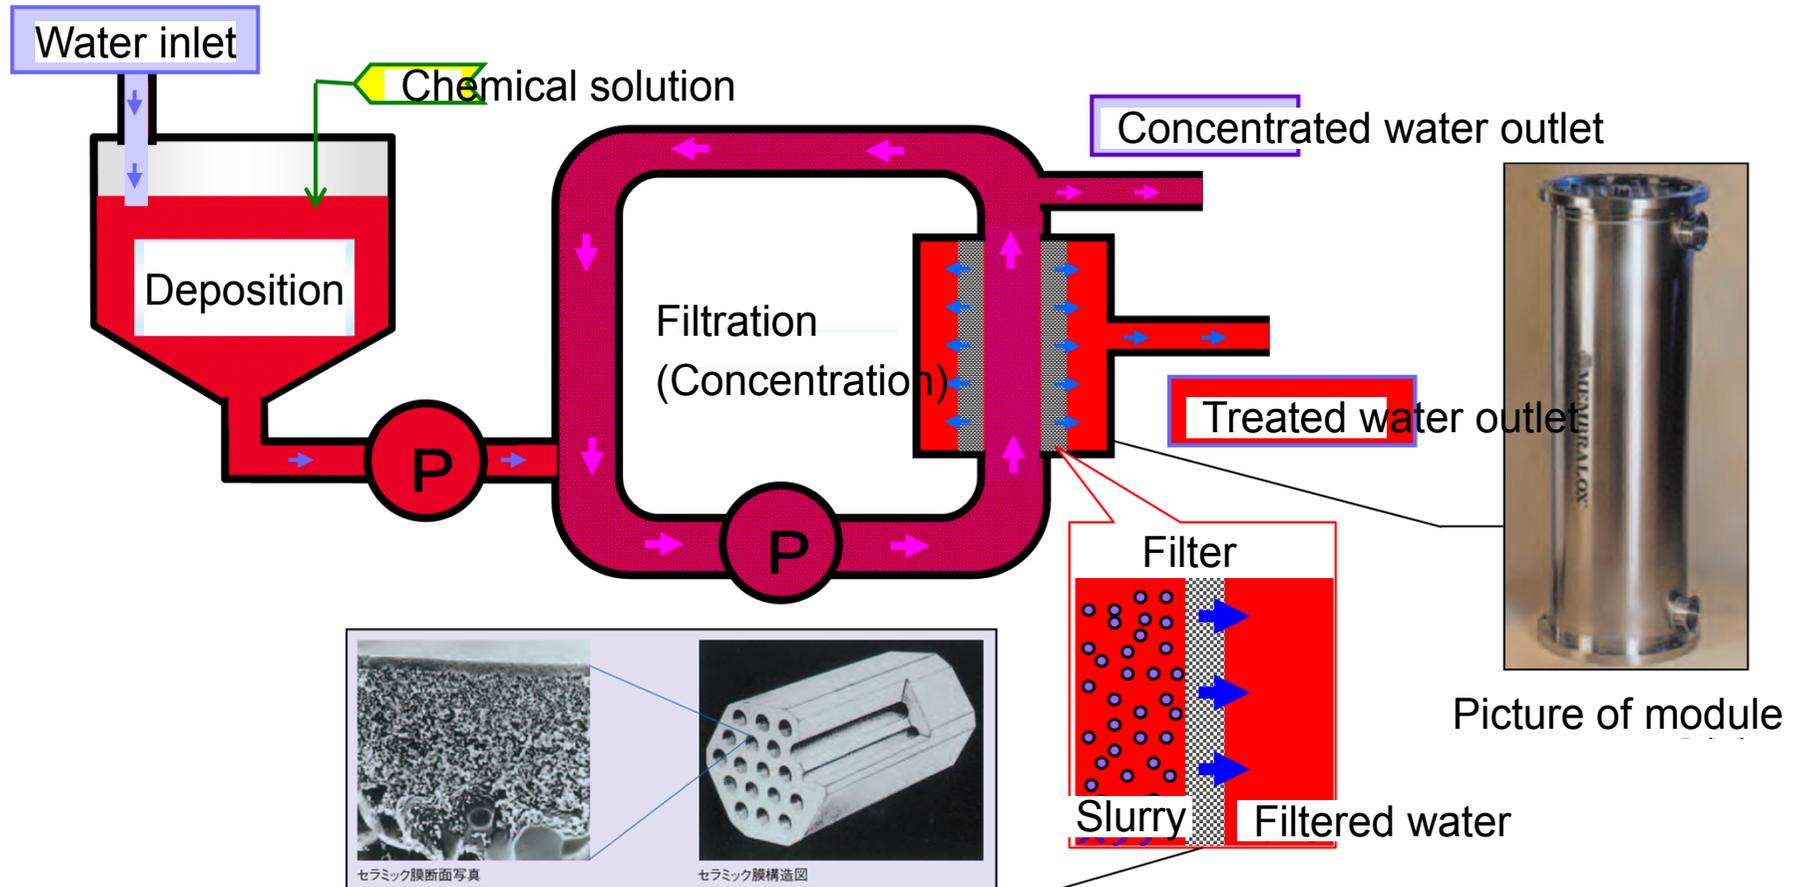
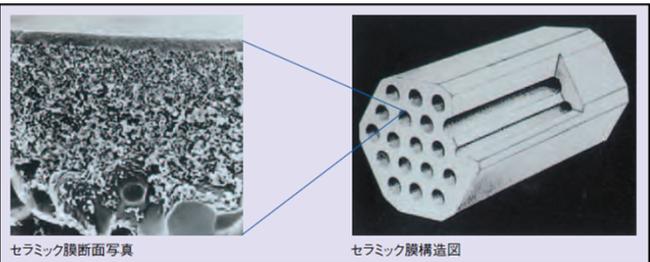
Detail of the filter *

- Sedimentation by infusing the chemical solution and controlling water quality, the solid material would be filtered.

セラミック膜断面写真

セラミック膜構造図
