Completion of Seaside Impermeable Wall Closure at Fukushima Daiichi Nuclear Power Station

For Reference
October 26, 2015
Tokyo Electric Power Company

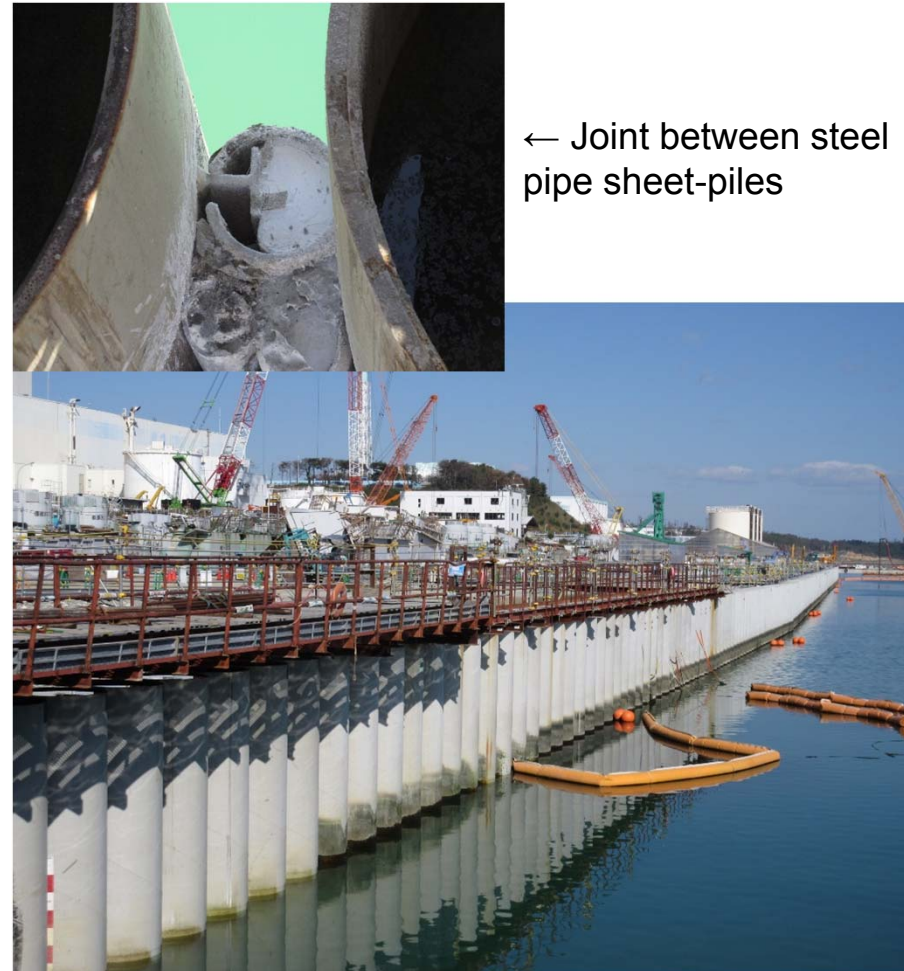
Photo taken on October 26, 2015

Completion of closure

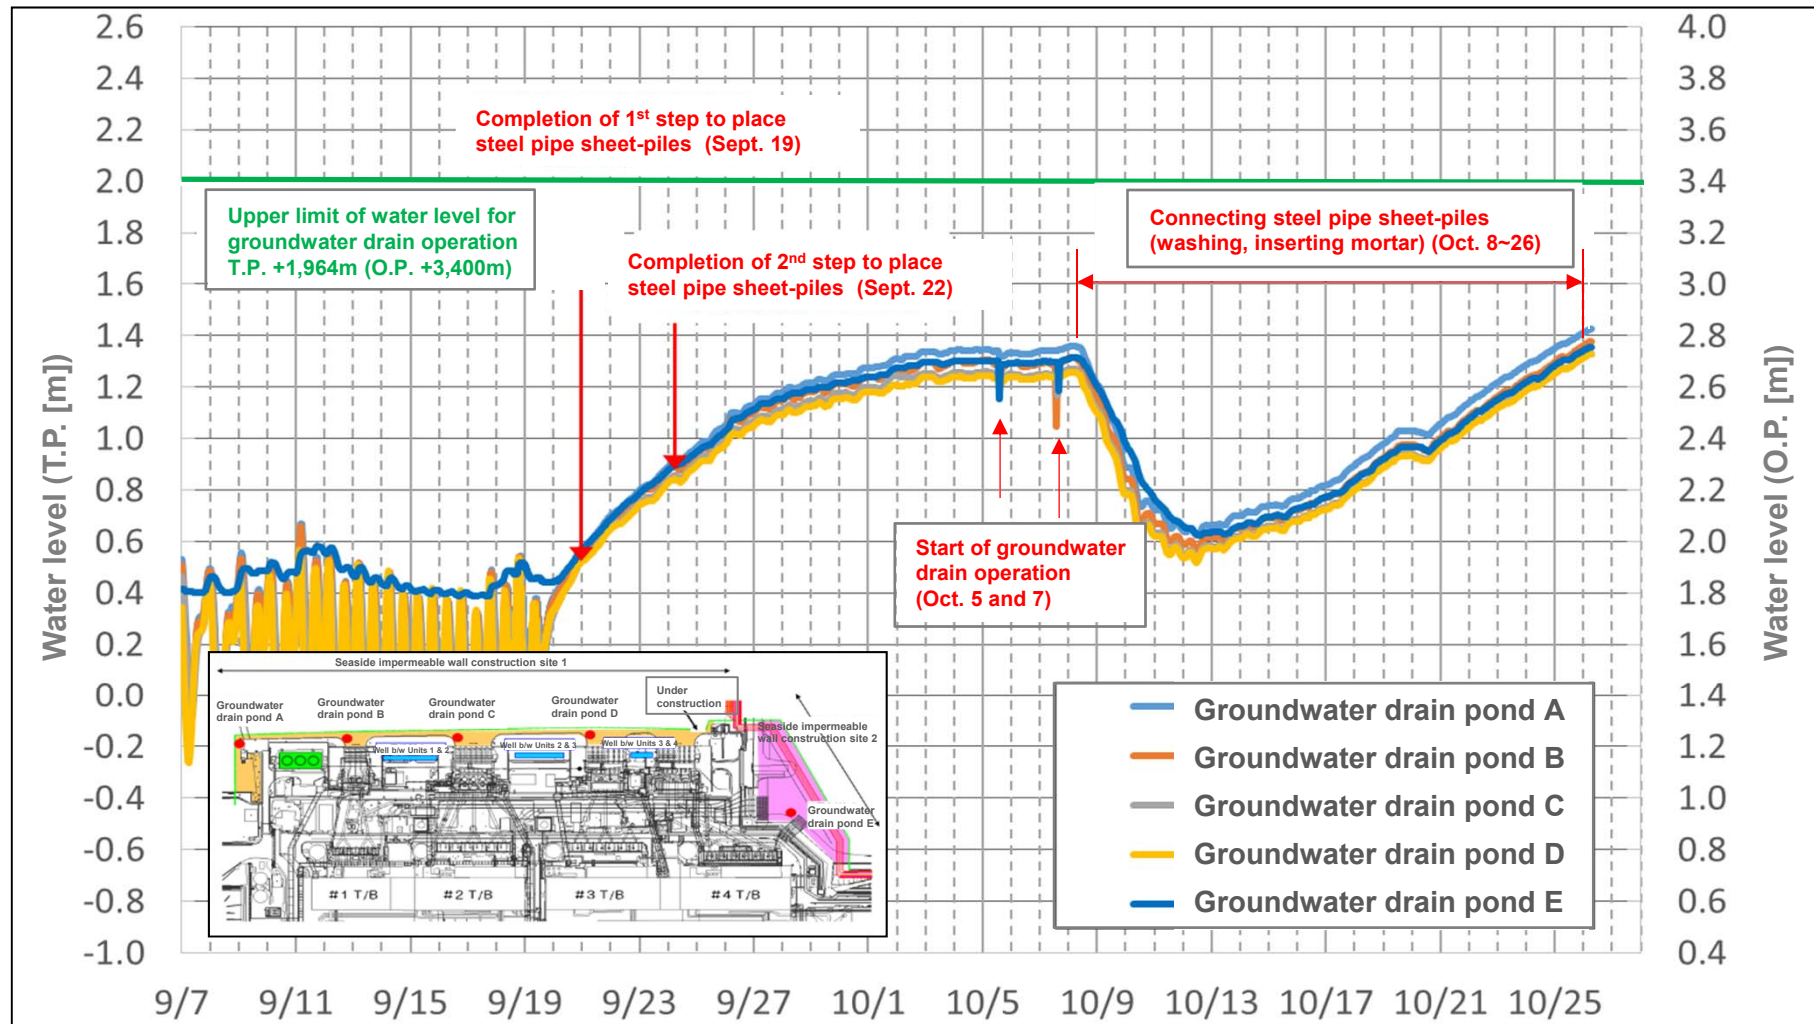
Reference: Closure of seaside impermeable wall and fluctuation in water levels of groundwater drain

- The water levels inside the groundwater drain ponds rose after placing steel pipe sheet-piles into the earth, fell temporarily after washing the joints between the sheet-piles (October 8, 9, and 19), and finally rose again after inserting mortar into the joints.

- The effects of stopping the groundwater flow have started to appear as a rise in groundwater levels on the landside of the seaside impermeable wall. Close monitoring of the port area will be continued.
- The Subdrain systems will continue to be operated by managing the related facilities and keeping the upper limits of radioactive concentrations.
