(Reference) Investigation of the PCV interior of Unit 2

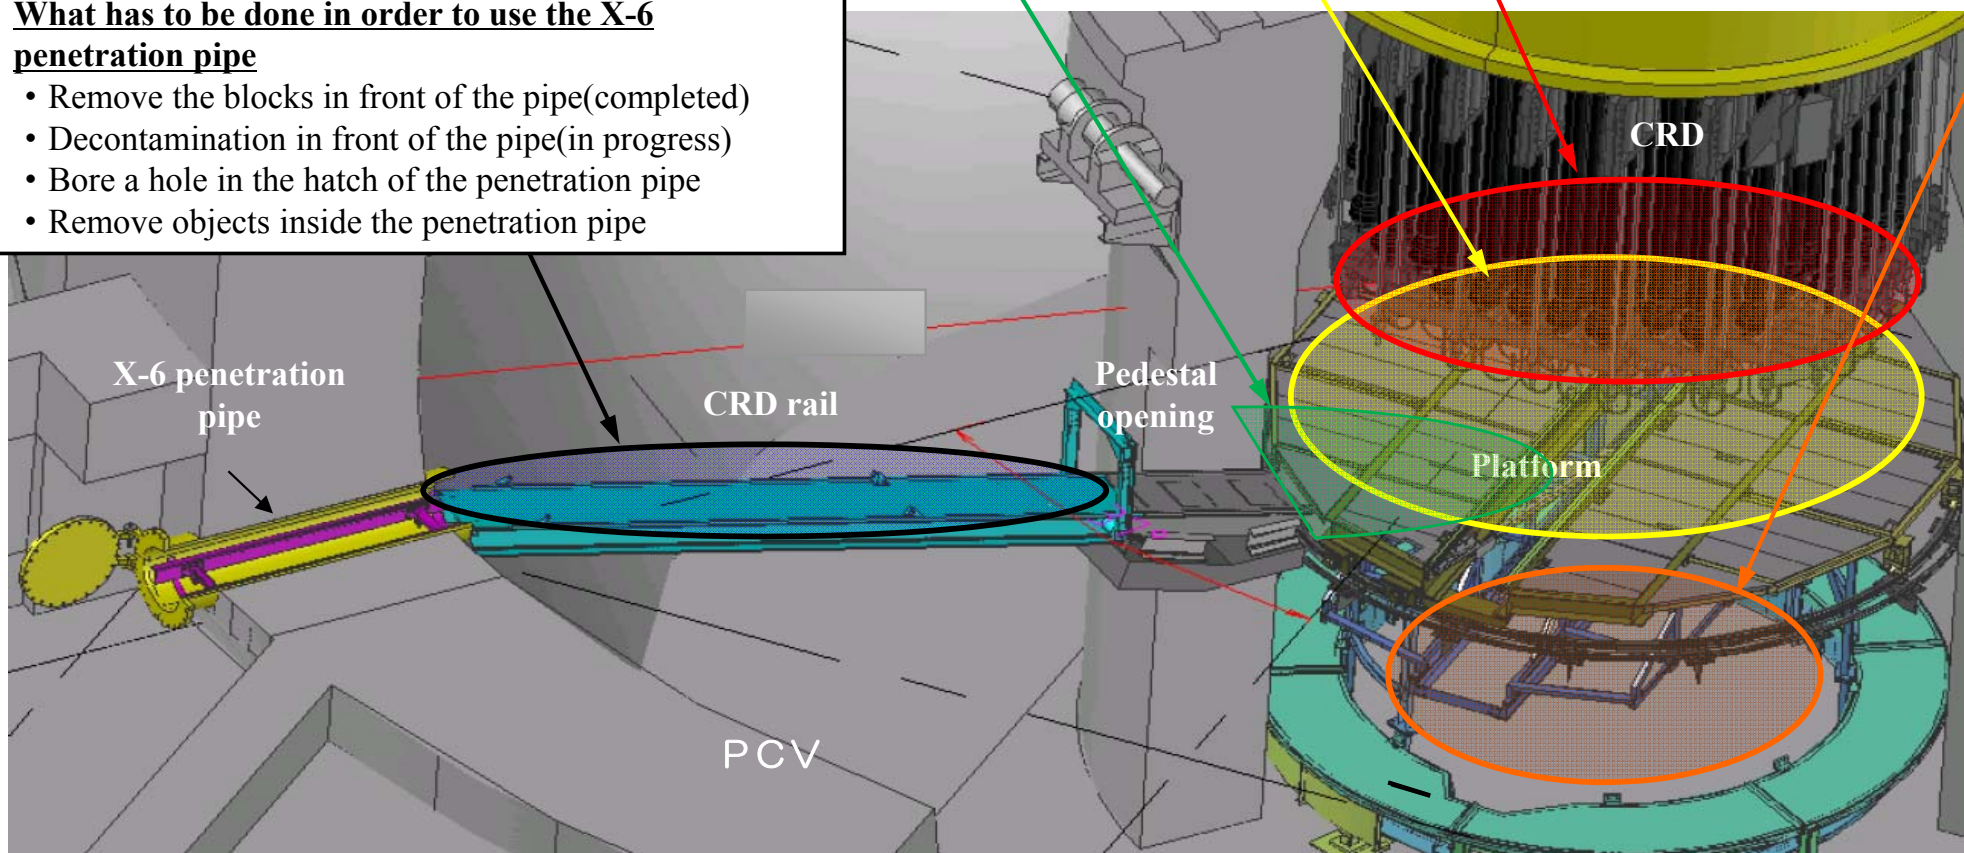
A1. Investigation of the condition of the CRD rail (conducted in August, 2013)

A2. Investigation of the condition of the Platform inside the Pedestal

A3. Investigation of the condition of the lower part of the CRD and the Platform

A4. Investigation of the condition on the underground floor of the Pedestal

What has to be done in order to use the X-6 penetration pipe

- Remove the blocks in front of the pipe (completed)
- Decontamination in front of the pipe (in progress)
- Bore a hole in the hatch of the penetration pipe
- Remove objects inside the penetration pipe
