Unit 2 Primary Containment Vessel Investigation
at Fukushima Daiichi Nuclear Power Station
(Investigation results by the self-propelled investigation device)

1. Work steps for Unit 2 PCV investigation

2. Investigation results by the self-propelled investigation device (digital images)

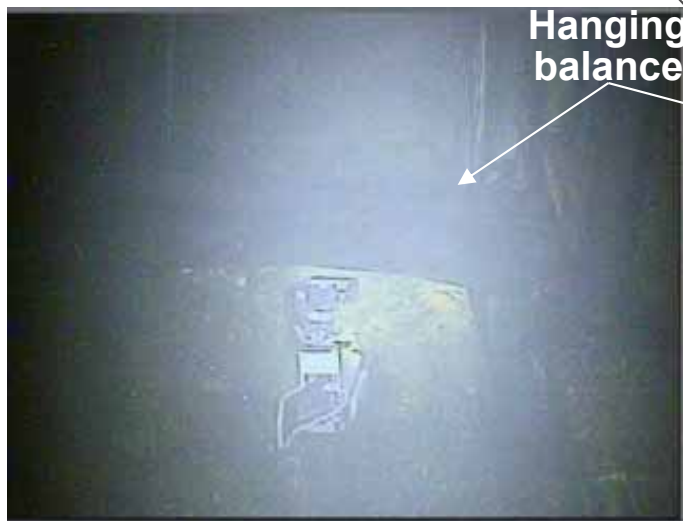
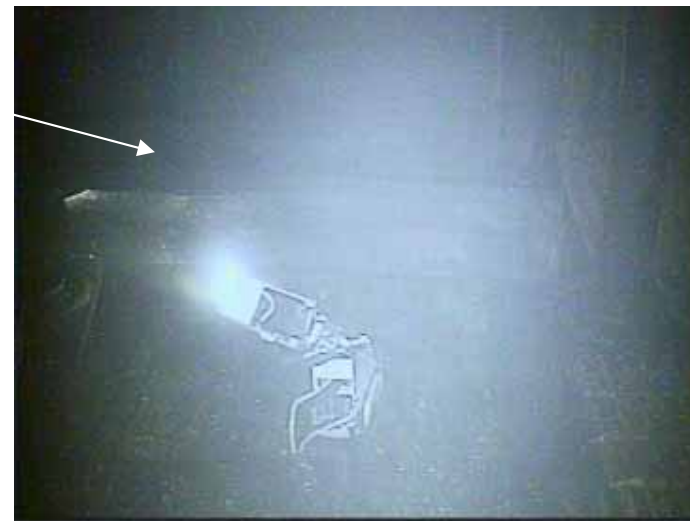
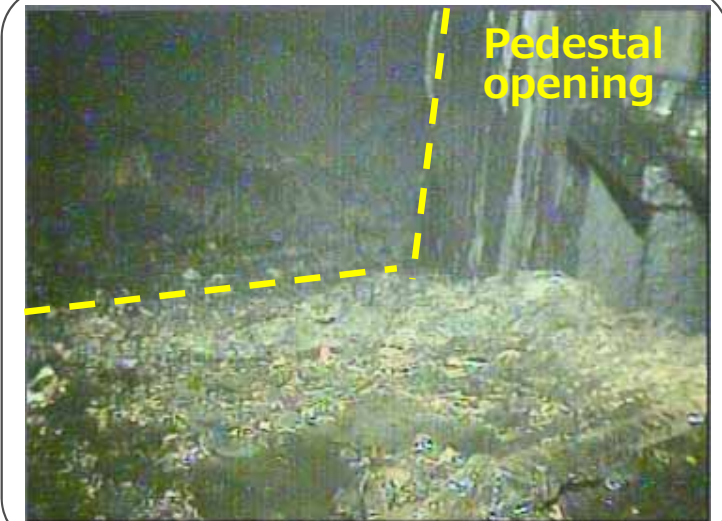
- Today's investigation results
 - The self-propelled investigation device ran on the deposits of the CRD rail and reached the area toward the pedestal (the vicinity of hanging balance), further than the area where the deposit removal device reached.
 - It tried to move further toward the pedestal but could not reach there because the crawler belt on the left side could not move any more.
 - It investigated temperatures and radiation levels on the CRD rail as well as conditions of surrounding structures.
 - The connection cable was cut and the device was left on the side of the CRD rail not to obstruct further investigations.

TEPCO will continue to evaluate the information, such as deposits on the CRD rail and conditions inside the pedestal, obtained from this entire investigation.

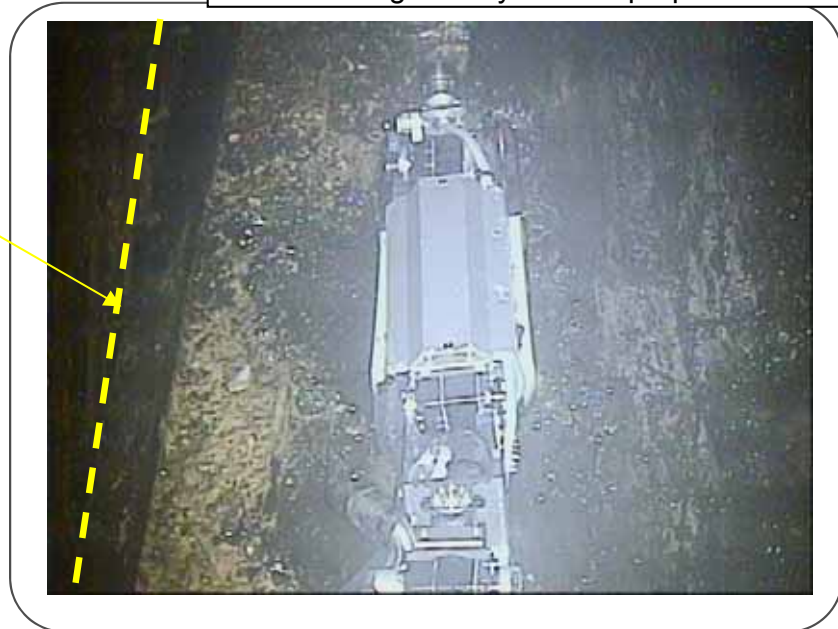
Reference: Location where the device was left

End of CRD rail

Location where the device was left
