Water Leak from the Decontamination Apparatus

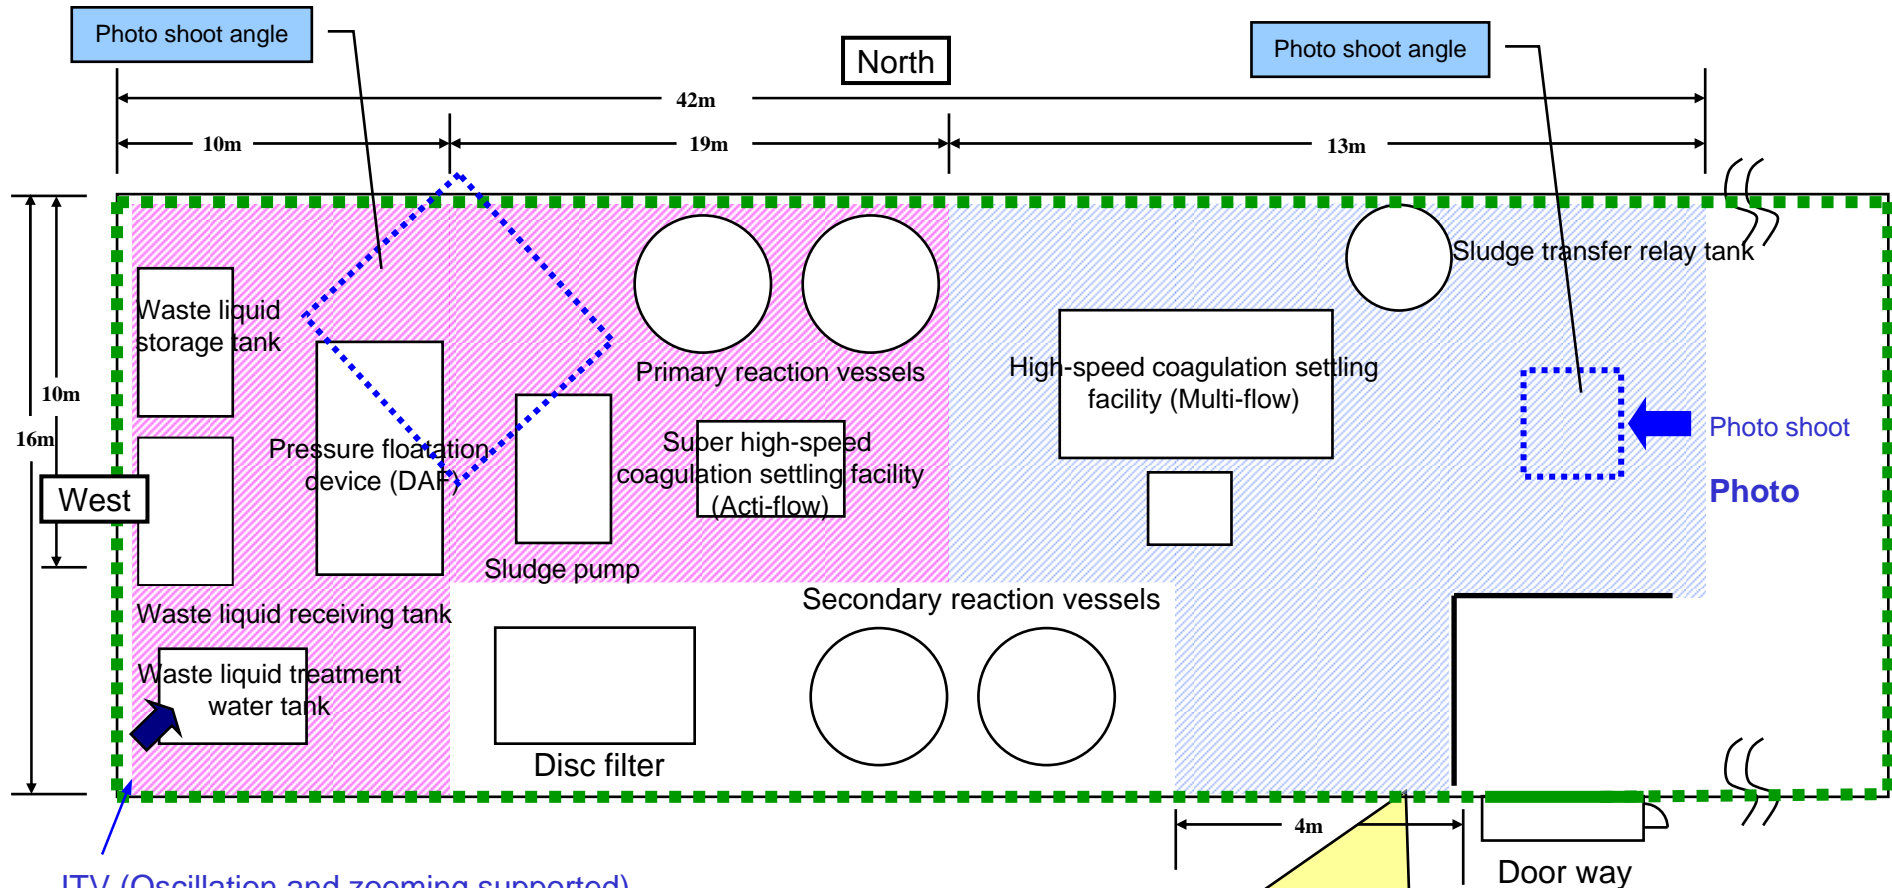
ITV (Oscillation and zooming supported)

Area affected by water leak (Depth: 1cm)

Area affected by water leak (Depth: 0.5cm)

**Dam (The area indicated by a dotted line is a dam)
No leakage detector is installed.**

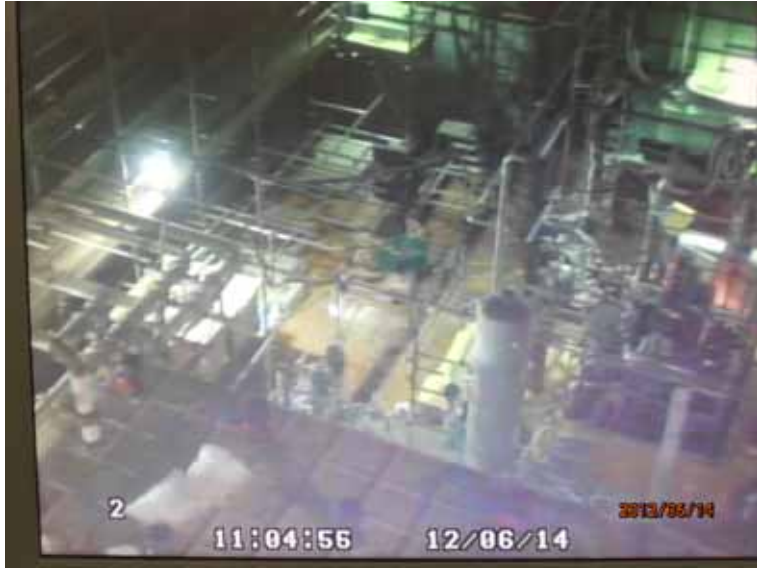
Monitoring camera image

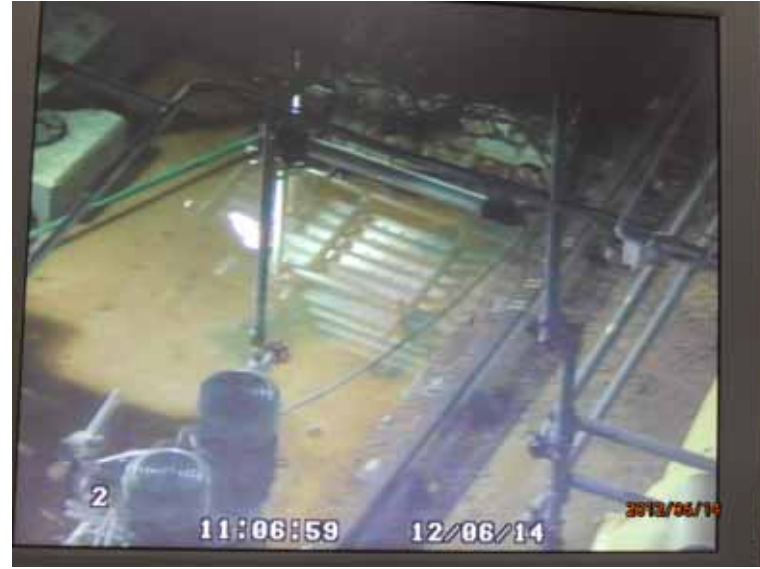
Monitoring camera image (Enlarged)

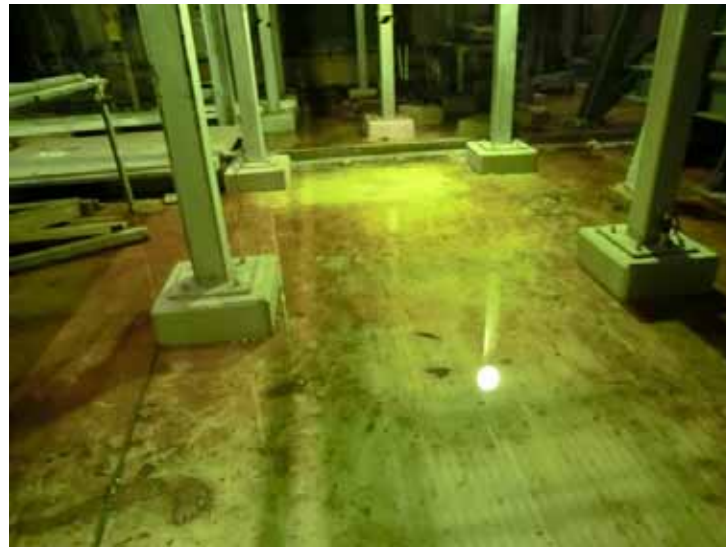
Photo taken at the site

Photo taken by TEPCO on June 14, 2012

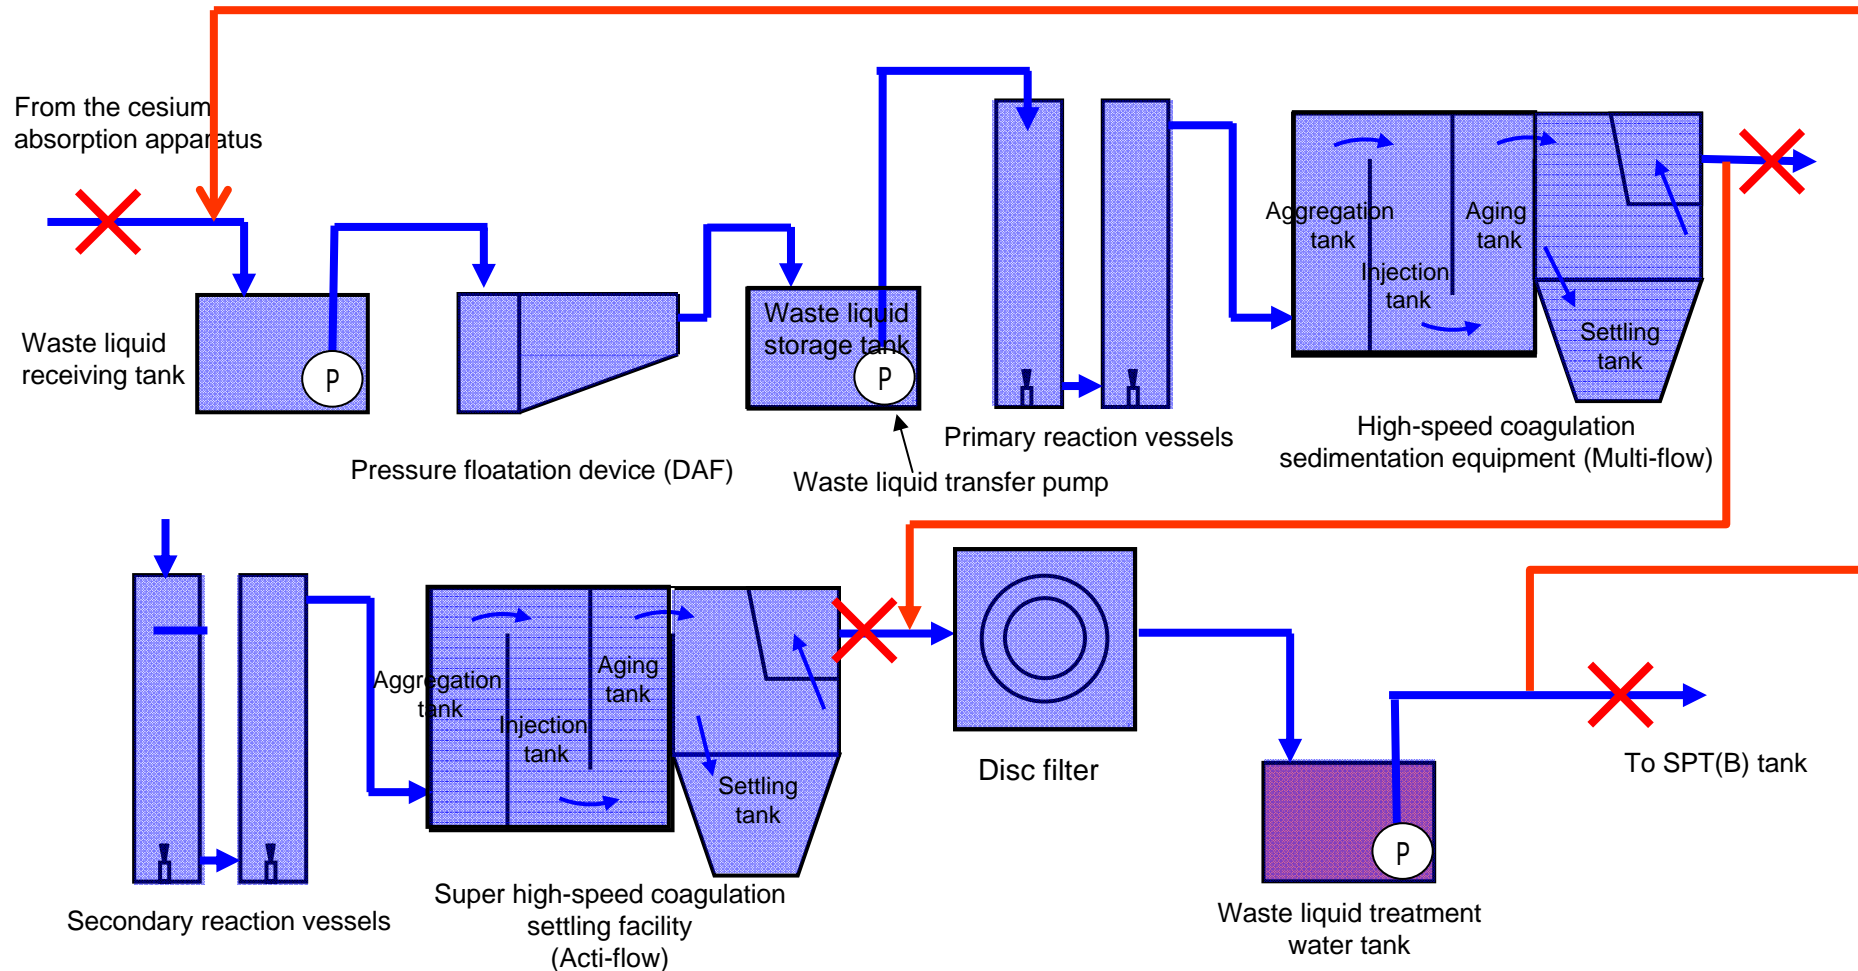
Overview of Circulating Purification Operation

The sludge in the waste liquid treatment water tank is transferred to the waste liquid receiving tank to be purified.

The acti-flow (the pump is currently out-of-order) functions as a bypass.

The apparatus has been on isolated circulating operation since May 21.
