Investigation Result of the Water Leak from the Decontamination Apparatus (Occurred on June 14)

Condition of the Waste Liquid Storage Tank

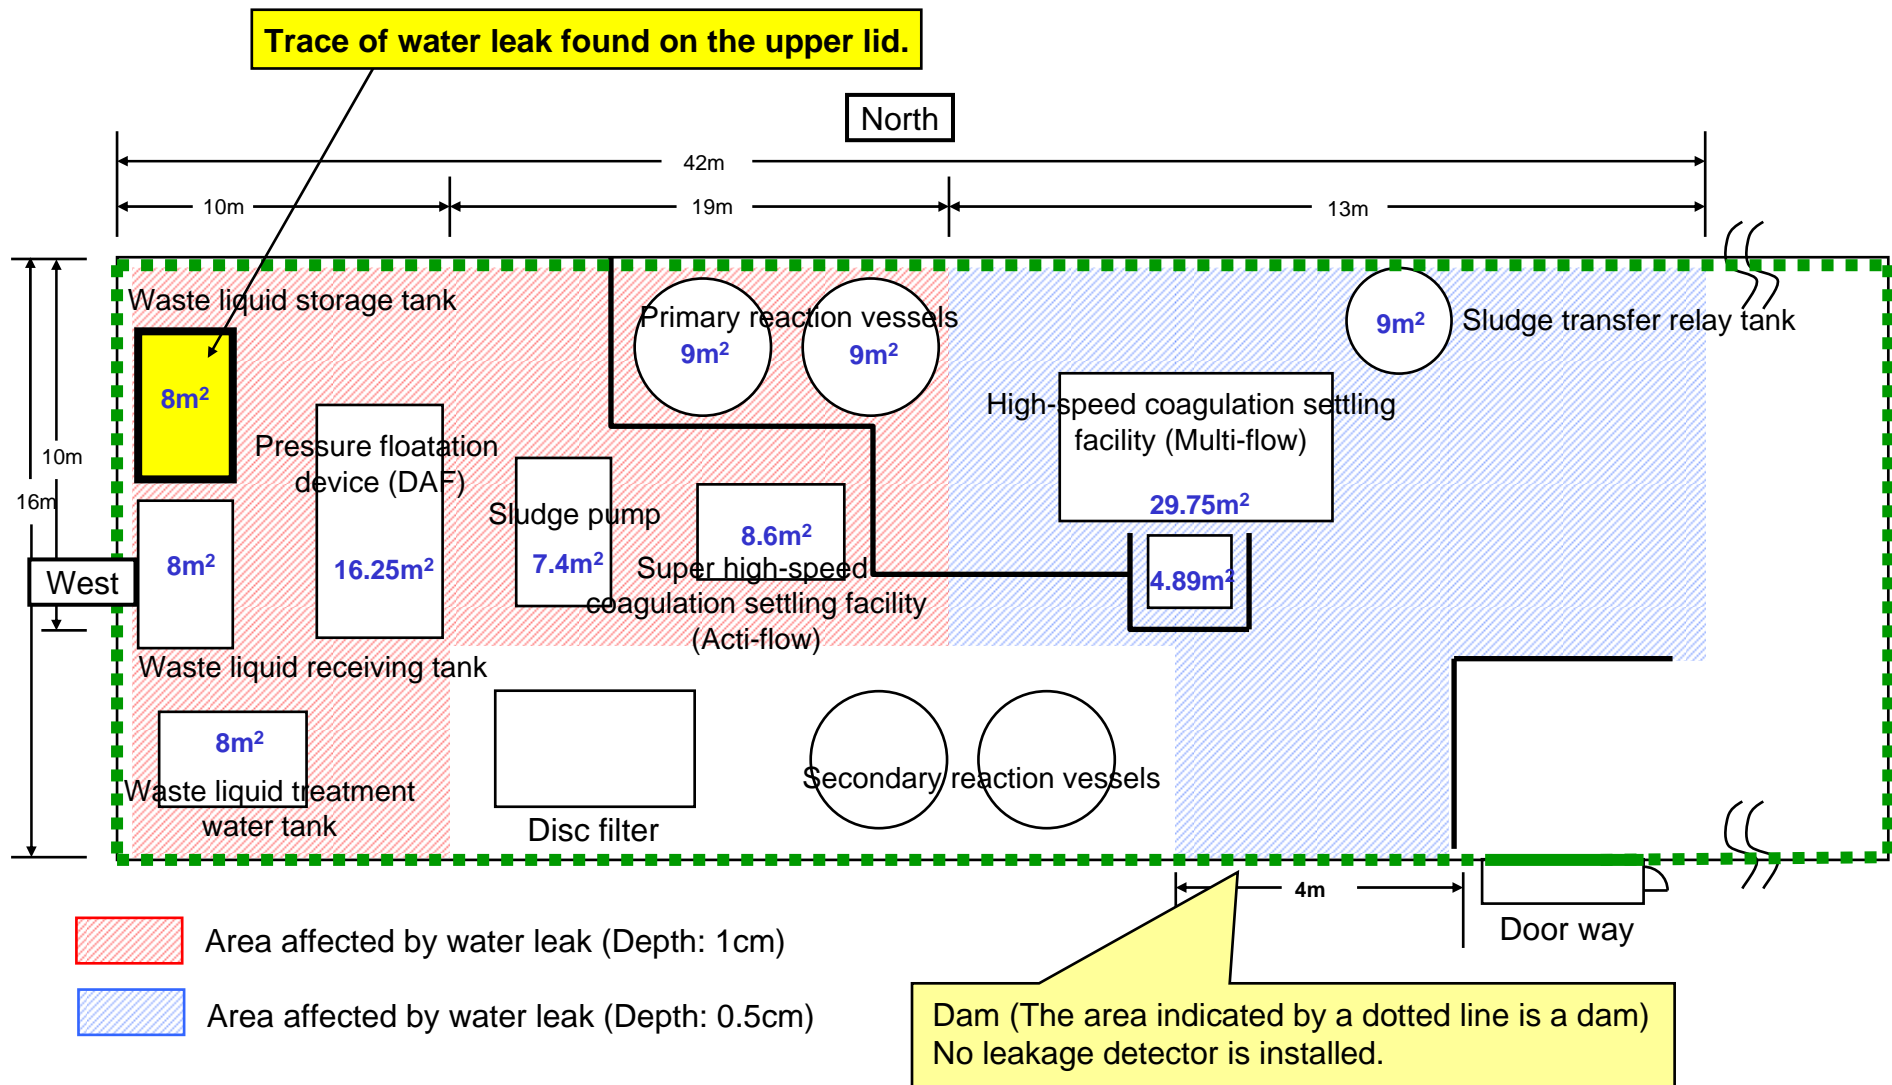
- A trace of water leak was found on the upper lid.
- The discharged water inlet pipe of DAF is inserted into the waste liquid storage tank (Water seems to have overflowed from the gap)
- The water overflowed from the upper lid seems to have flown into DAF (The left area on the photo)

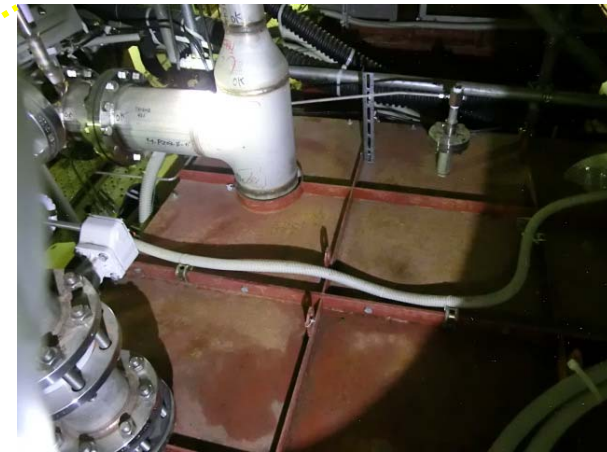
Photo taken by TEPCO on June 15, 2012
