Fuel Oil Leakage from the Diesel Generator for the Spare Nitrogen Supply Equipment at Fukushima Daiichi Nuclear Power Station (Occurred on July 20)

< Reference >
July 23, 2012
Tokyo Electric Power Company

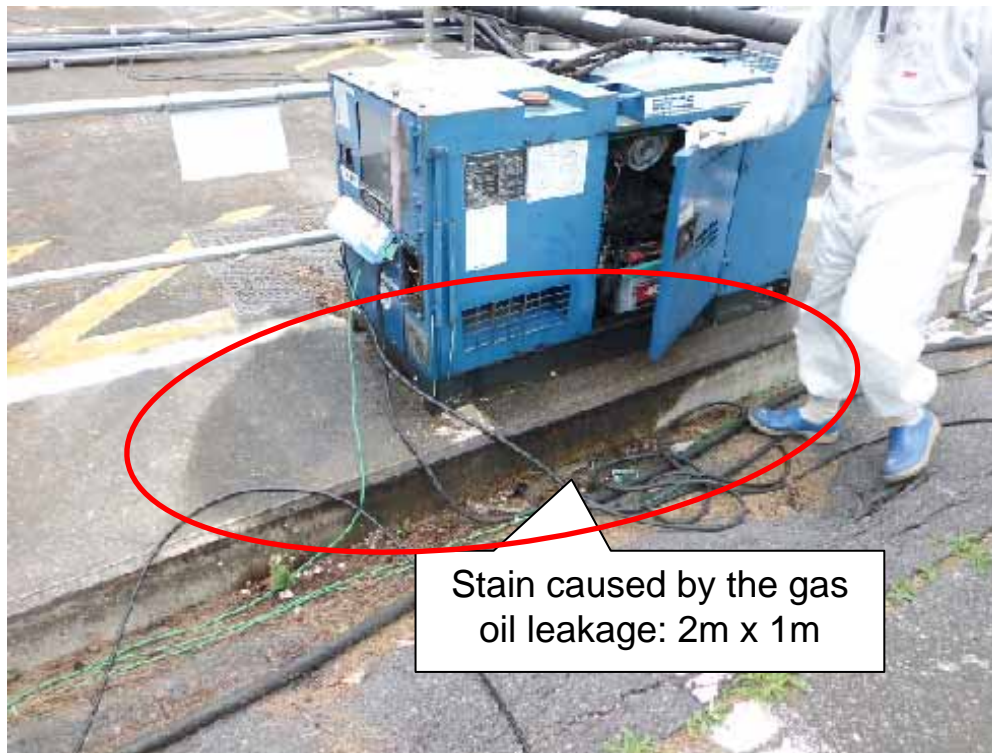
Gas oil leakage was found at the diesel generator (D/G) for the spare nitrogen supply equipment installed on the hill. Due to the leakage, the equipment was judged to be disabled and the operational requirements stipulated by the technical specification for the nuclear reactor facility were not fulfilled. An emergency measure (wrapping tape around) was implemented on the leakage areas and the leakage was stopped. Another diesel generator was installed in order to fulfill the operational requirements.

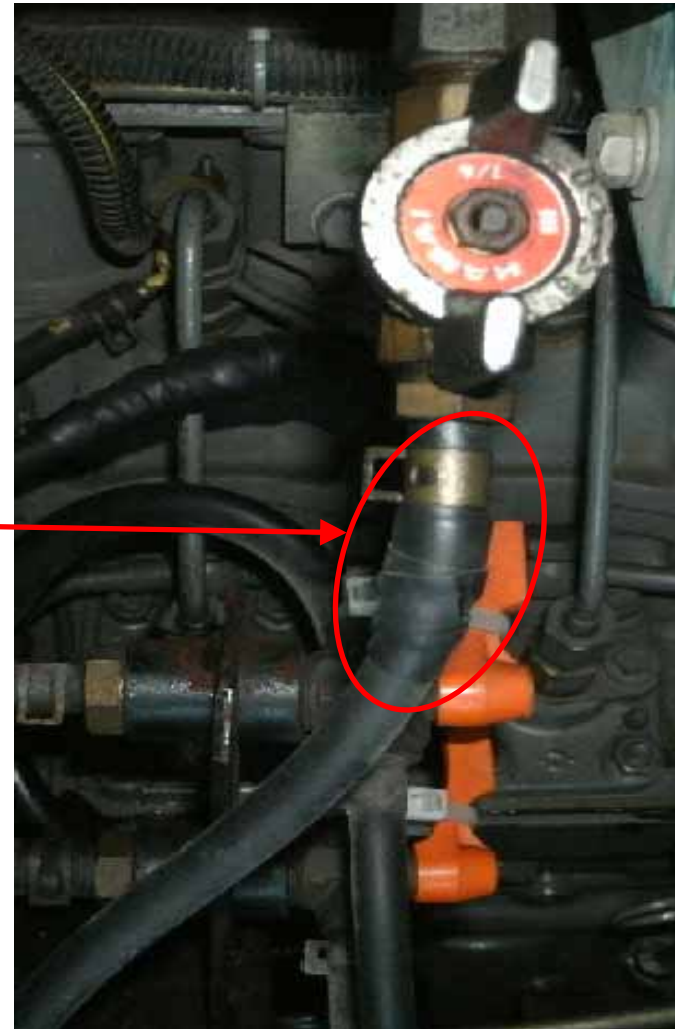
After emergency measure implementation (leakage stopped after wrapping tape around the hose)

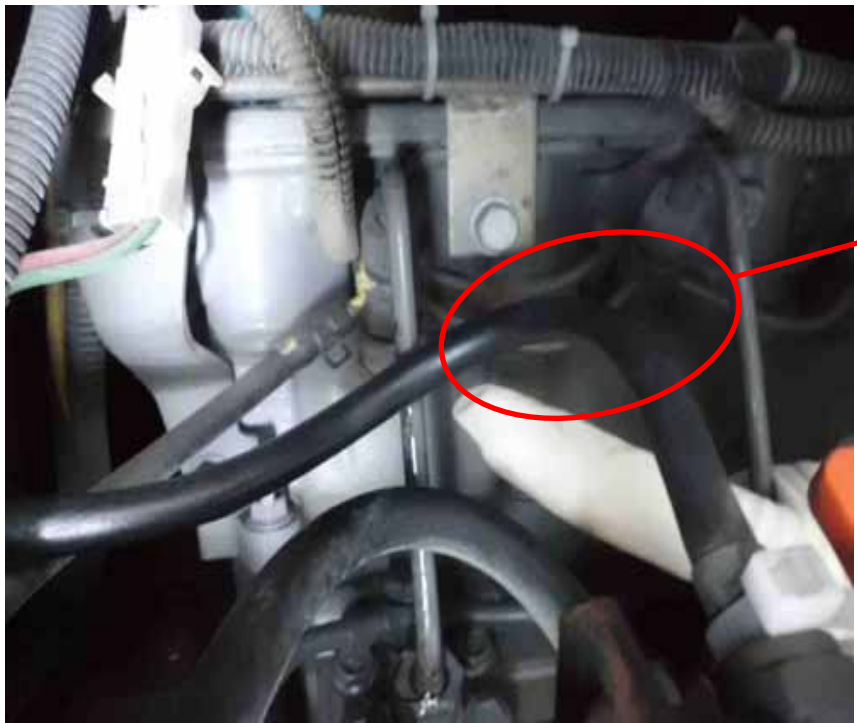
Before emergency measure implementation

Leakage Area (Rubber hose on the fuel oil filter)

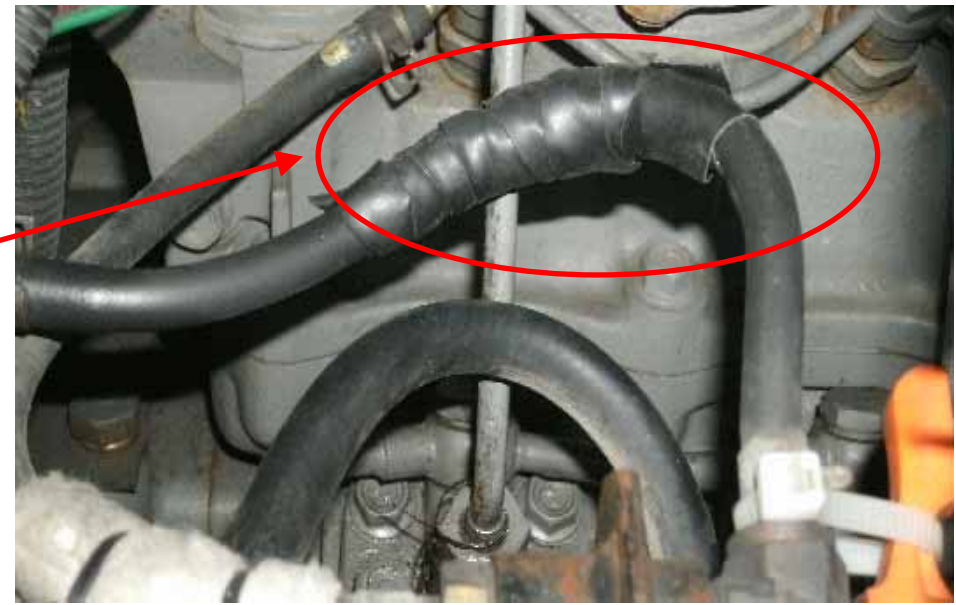
After emergency measure implementation (leakage stopped after wrapping tape around the hose)

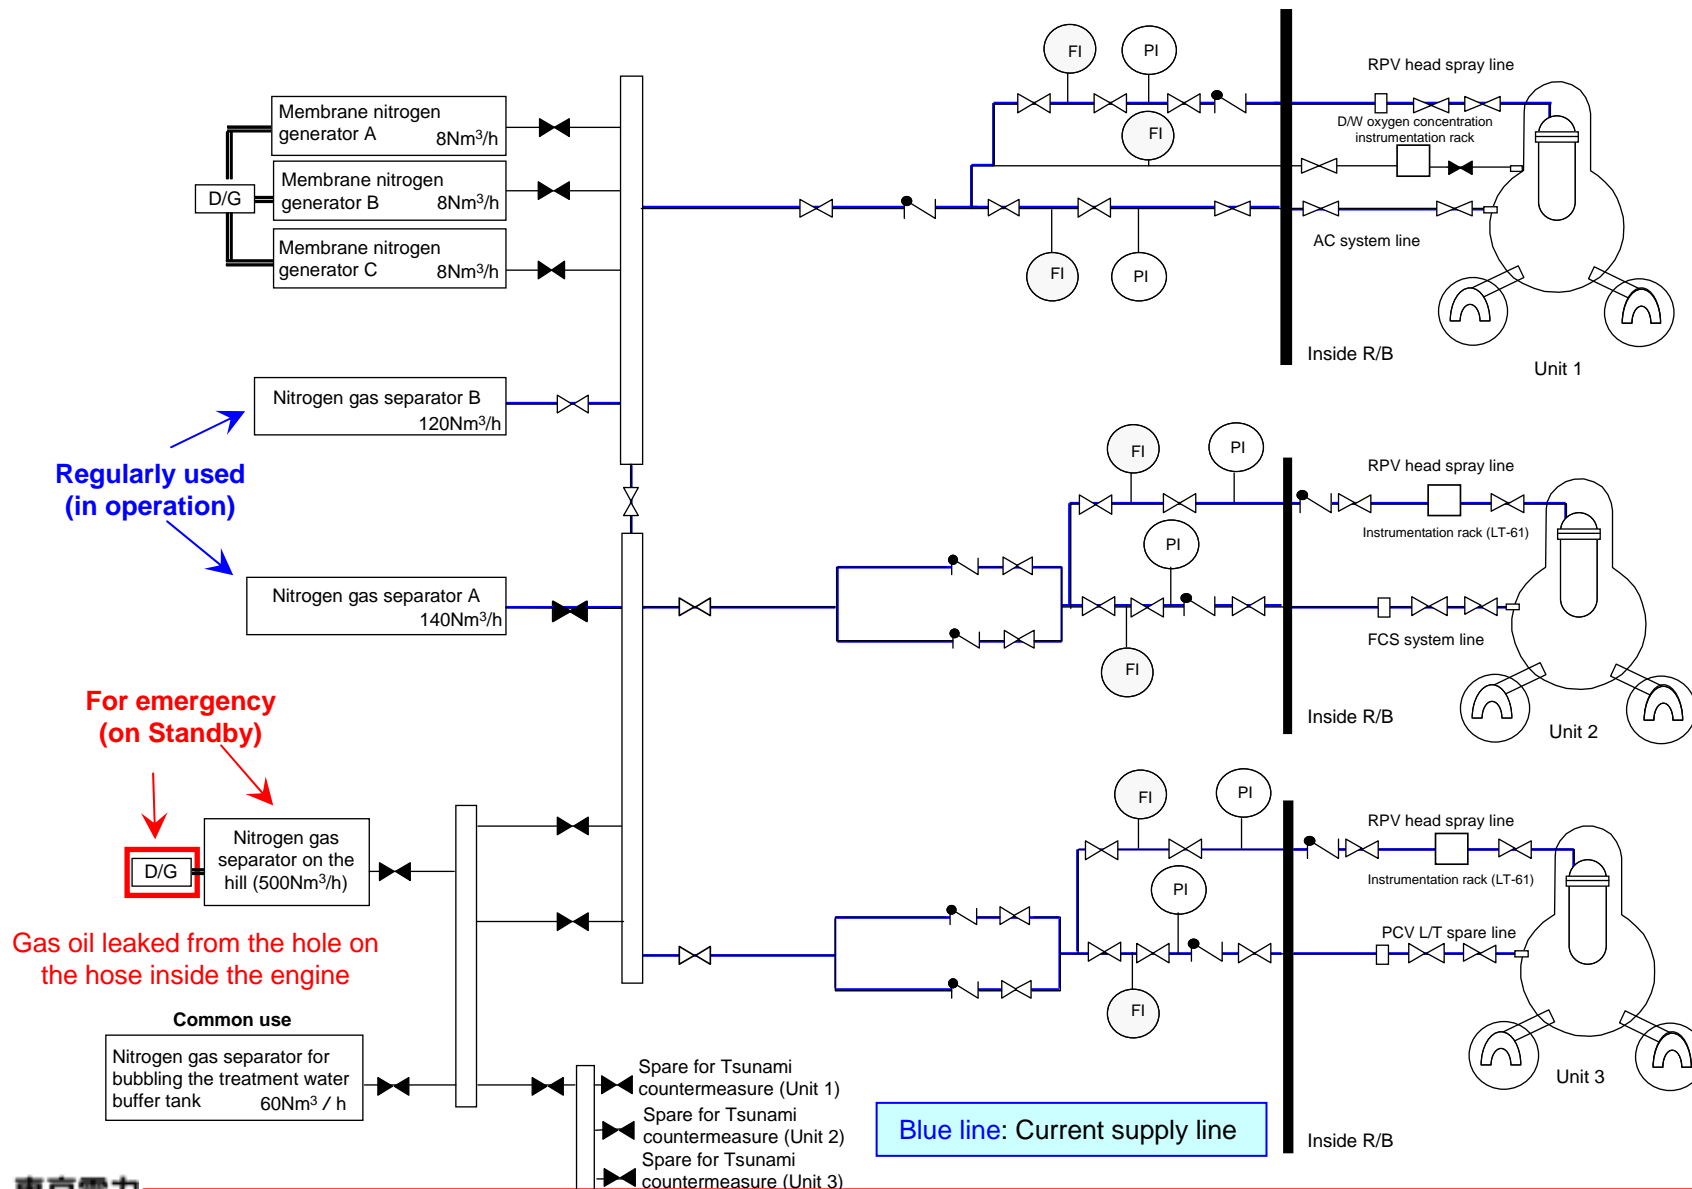
(Reference) Outline of the Nitrogen Gas Injection Equipment
