Decrease in the Reactor Injection Amounts at Unit 1-3 at Fukushima Daiichi Nuclear Power Station (Follow-up Report)

Buffer Tank Purification

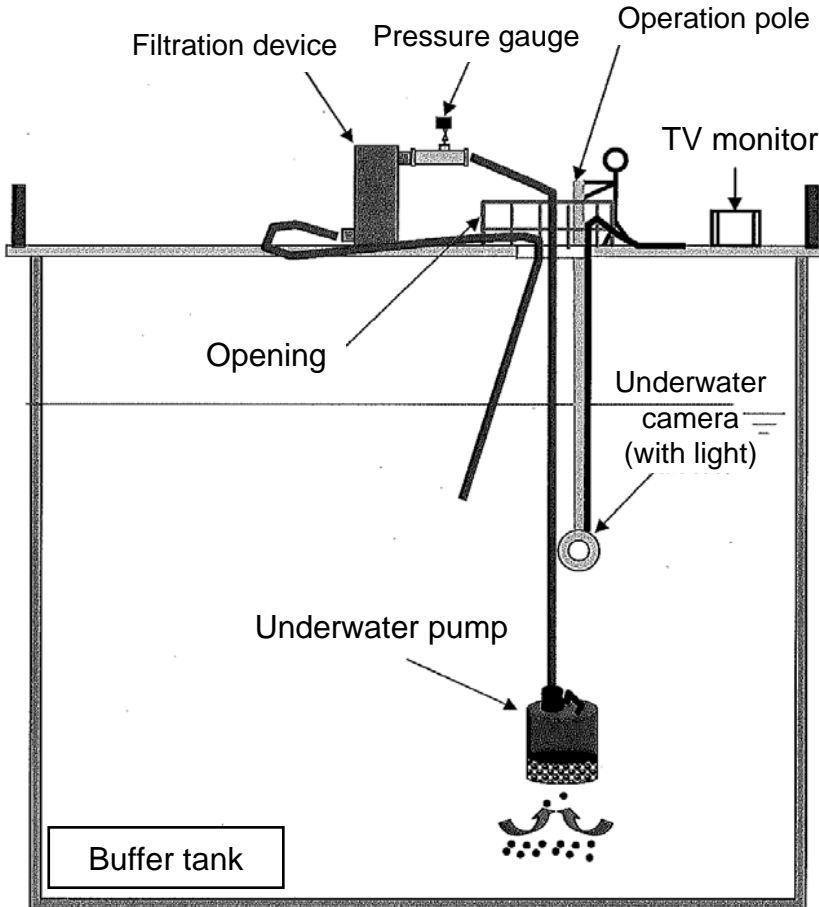
[Outline of the buffer tank purification equipment]

September 7: Equipment set-up / trial operation

September 8-10: Purification

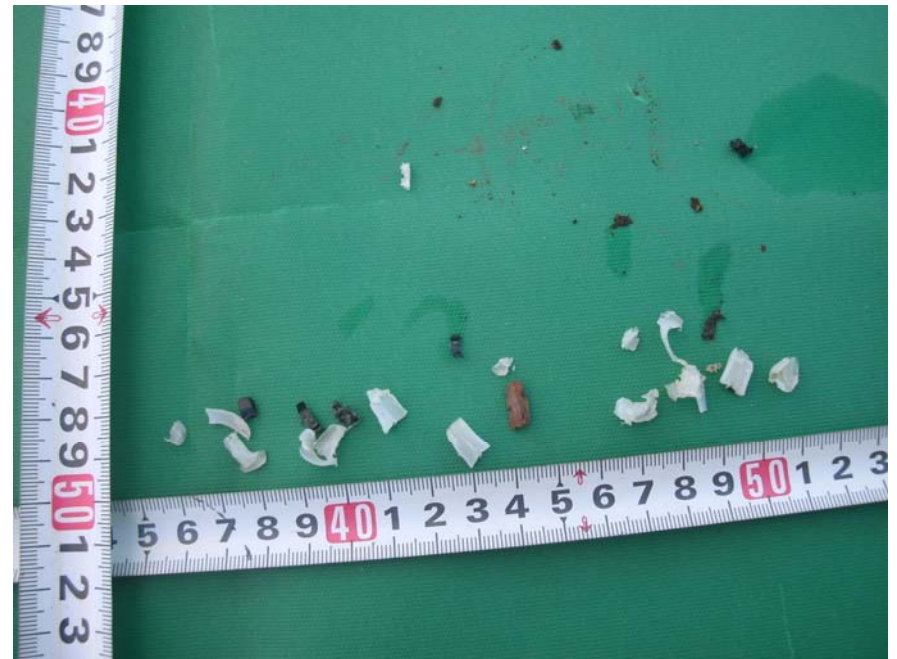
[Substances found during the purification done from September 8 to 10]

Photo taken on September 10, 2012 by TEPCO

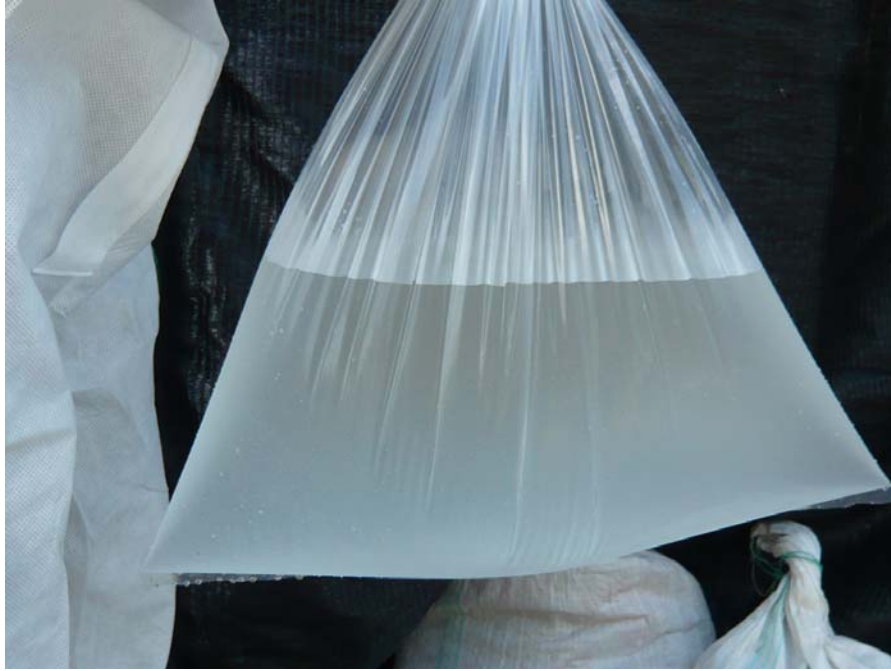
Buffer Tank Water Investigation

Buffer tank water

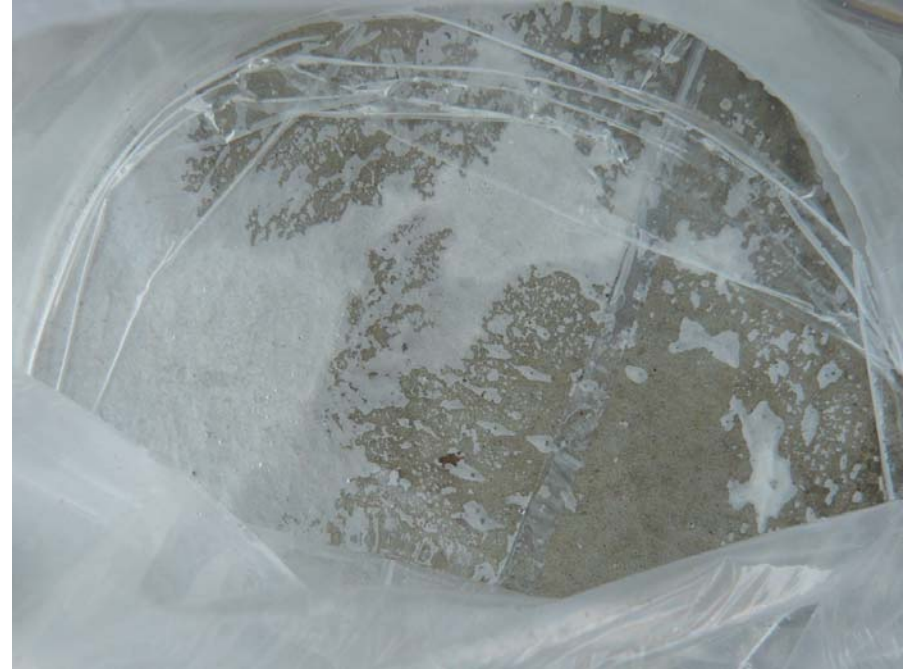
View from the above

Photos taken on September 10, 2012 by TEPCO
