Water Stop Work at the Common Pool Connecting Duct at Fukushima Daiichi Nuclear Power Station

October 29, 2012

Tokyo Electric Power Company

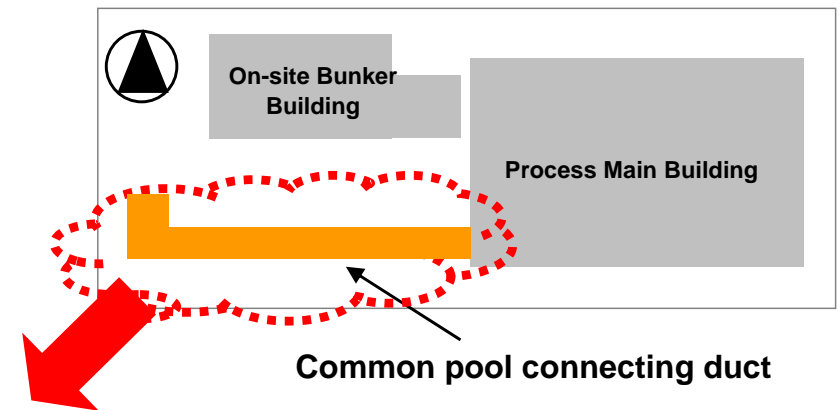
[Overview]

Fill the duct with cement material in order to prevent contaminated water leakage from the connection area with the Process Main Building and groundwater flow into the duct.
