# Progress Status Classified by Issues (Photos and Figures)

Issues	Progress etc.	Reference (Photos and Figures)
I. Cooling (1) Reactor	<p>[Unit 1]</p> <p><b>Improvement of working environment</b></p> <p>Removal of debris, measurement of radiation dose, entrance into buildings (May 9)</p> <p>RPV water level gauge calibration (May 10)</p> <p>PCV pressure gauge calibration (May 11)</p> <p>Installation of water level gauge at the basement of the reactor building (May 27)</p> <p>Installation of temporary RPV pressure gauge (Jun. 3)</p>	<div style="display: flex; justify-content: space-around;"> <div style="text-align: center;">

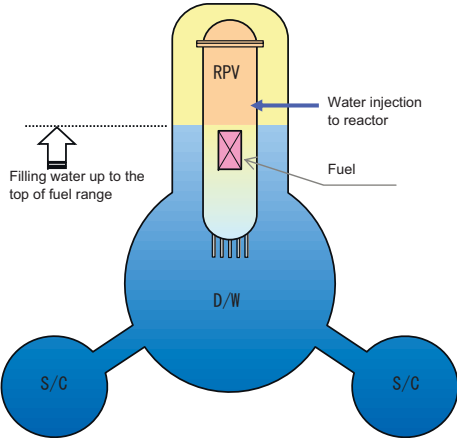
<p>The diagram shows a vertical reactor vessel with a central fuel rod (RPV) and a surrounding dilution water (D/W) chamber. Labels include 'Water injection to reactor', 'Fuel', 'RPV', 'D/W', and 'S/C' (Steam Condensers) at the base.</p> </div> <div style="text-align: right; margin: 20px 0;">

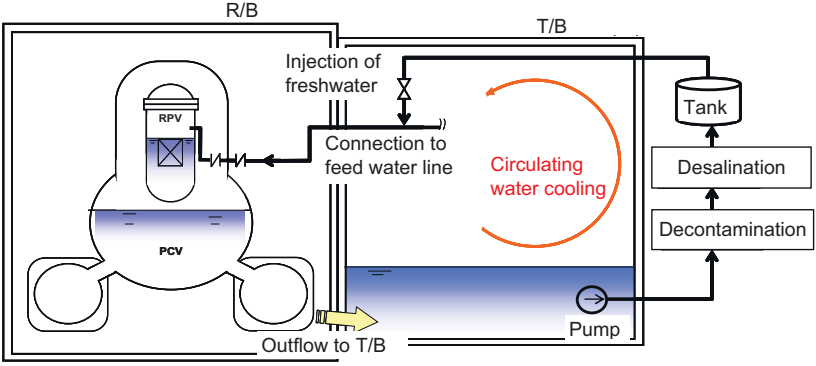
<p>The diagram illustrates a water reuse system. It shows a reactor vessel (PCV) connected to a Tank. The cycle includes 'Injection of freshwater', 'Connection to feed water line', 'Circulating water cooling' (indicated by a red arrow), and 'Outflow to T/B'. The water then passes through 'Desalination' and 'Decontamination' units before returning to the Tank. A 'Pump' is also shown in the system.</p> </div> <div style="text-align: center; margin: 20px 0;"> <div style="border: 1px solid black; padding: 5px; width: fit-content; margin: 0 auto;">System outline of water reuse as reactor coolant by processing accumulated water</div> </div>

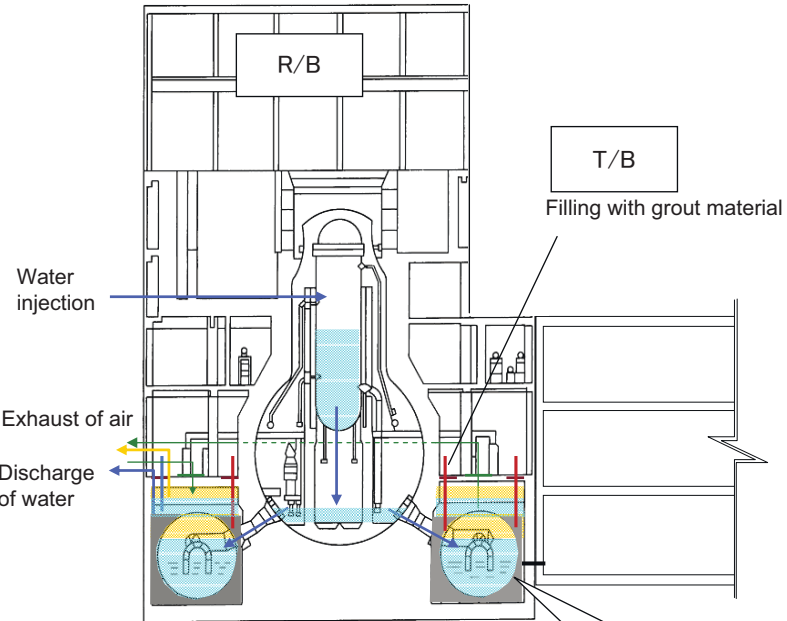
<div data-bbox="1527 1257 1926 1380" style="border: 1px solid black; padding: 5px; margin-top: 10px;"> <p>Drilling the 1st floor of the reactor building, filling the whole torus room with grout material.</p> </div>

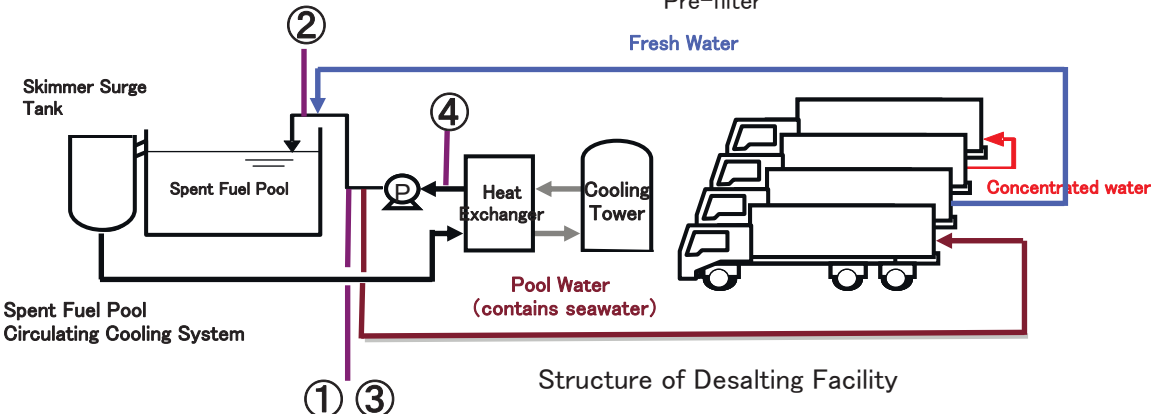
<p>Structure of Desalting Facility</p> <p>The diagram shows a 'Spent Fuel Pool Circulating Cooling System' with a 'Skimmer Surge Tank' and 'Spent Fuel Pool'. It includes a 'Heat Exchanger' connected to a 'Cooling Tower'. 'Fresh Water' (blue line) and 'Pool Water (contains seawater)' (red line) flow through the system. A 'Concentrated water' stream is shown exiting. Numbered points 1-4 are marked on the diagram.</p> </div> <div style="display: flex; justify-content: space-around; margin-top: 20px;"> <div style="text-align: center;">

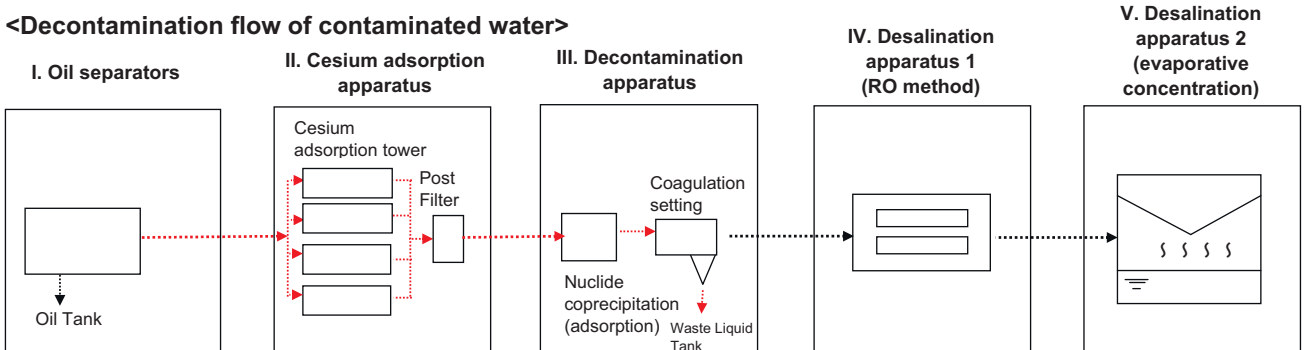
<p>I. Oil separators</p> <p>II. Cesium adsorption apparatus</p> <p>III. Decontamination apparatus</p> <p>IV. Desalination apparatus 1 (RO method)</p> <p>V. Desalination apparatus 2 (evaporative concentration)</p>

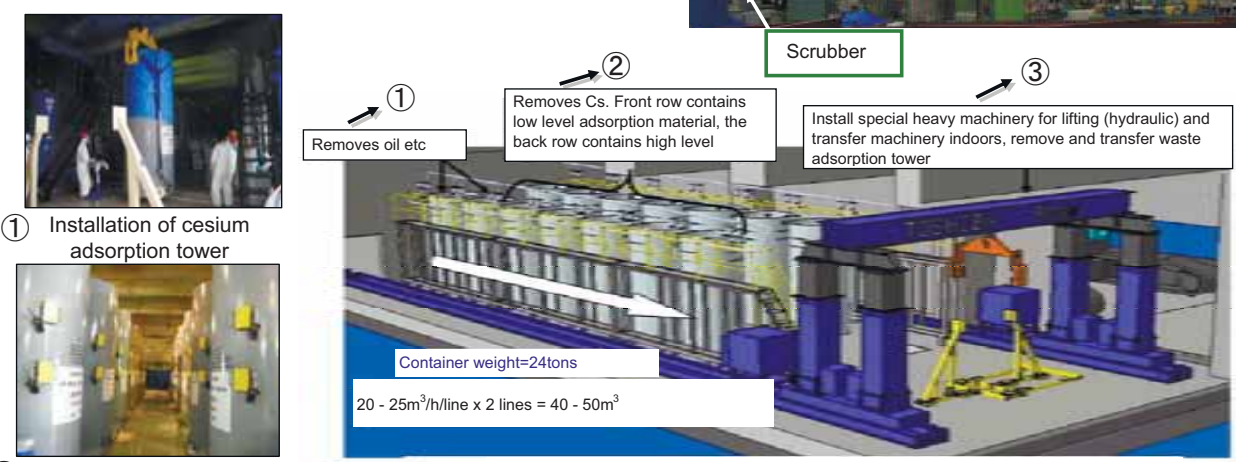
<p>① Removes oil etc</p> <p>② Removes Cs. Front row contains low level adsorption material, the back row contains high level</p> <p>③ Install special heavy machinery for lifting (hydraulic) and transfer machinery indoors, remove and transfer waste adsorption tower</p> <p>Container weight=24tons</p> <p>20 - 25m<sup>3</sup>/h/line x 2 lines = 40 - 50m<sup>3</sup></p> <p>Cesium adsorption apparatus (SARRY)</p>

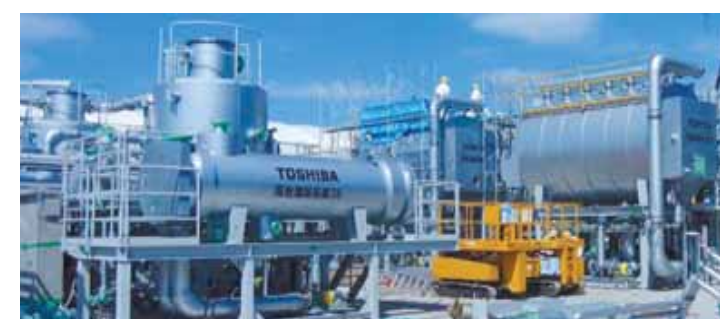
<p>① Installation of cesium adsorption tower</p>

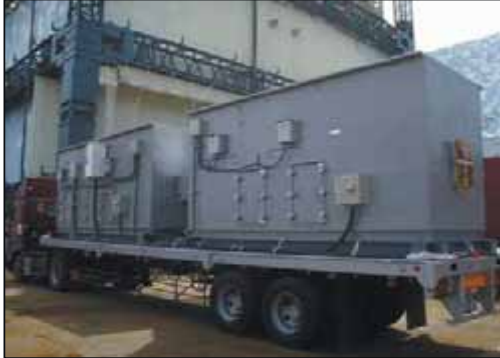
Completion of installation of cover on Oct. 28	Ancillary facility Filter units		Ancillary facility Exhaust pipe

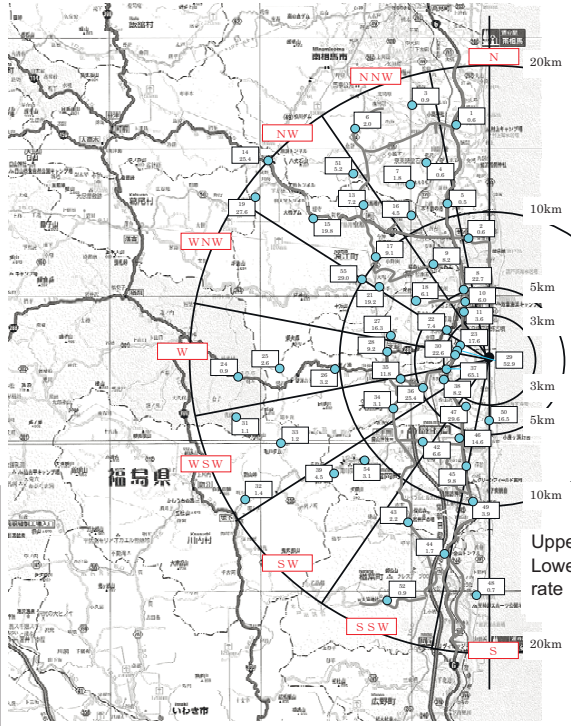
<p>Upper: Point No.                      Lower: Air dose rate (μSv/h)</p> <p>Measurement result of radiation dose rate in the air within 20 km radius (date: Dec. 6, 2011)</p>

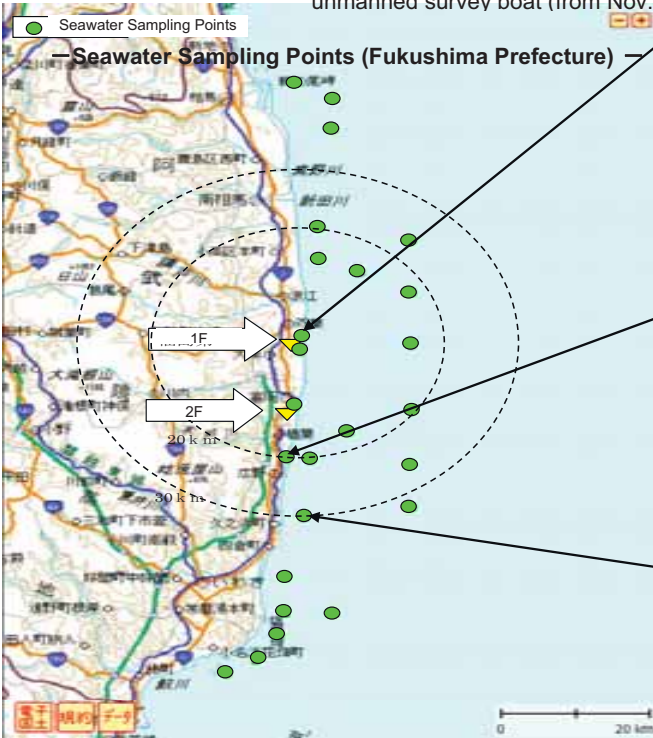
<p>Seawater Sampling Points (Fukushima Prefecture)</p>

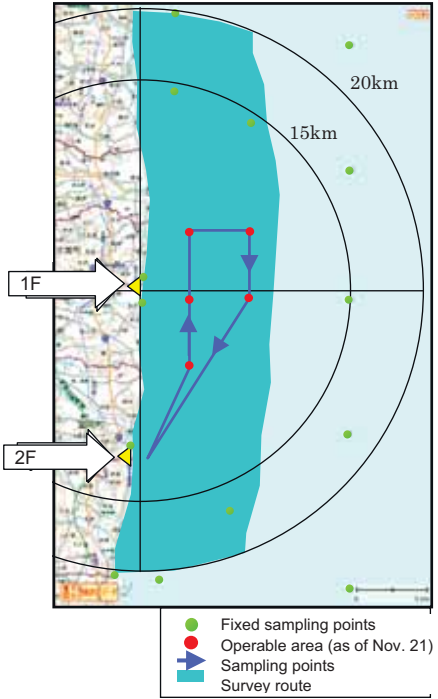
<p>Survey route and sampling points by an unmanned survey boat</p>

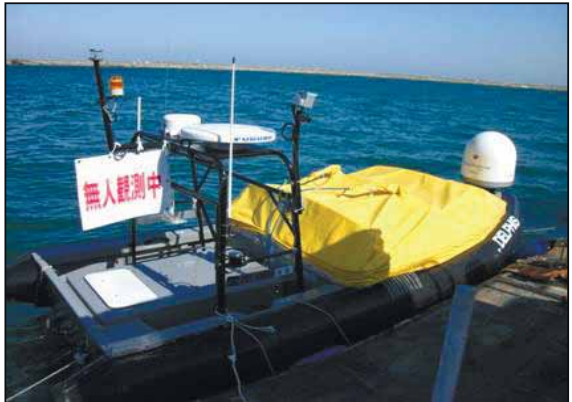
<p>Overview of an unmanned survey boat [DELPHIS]</p>

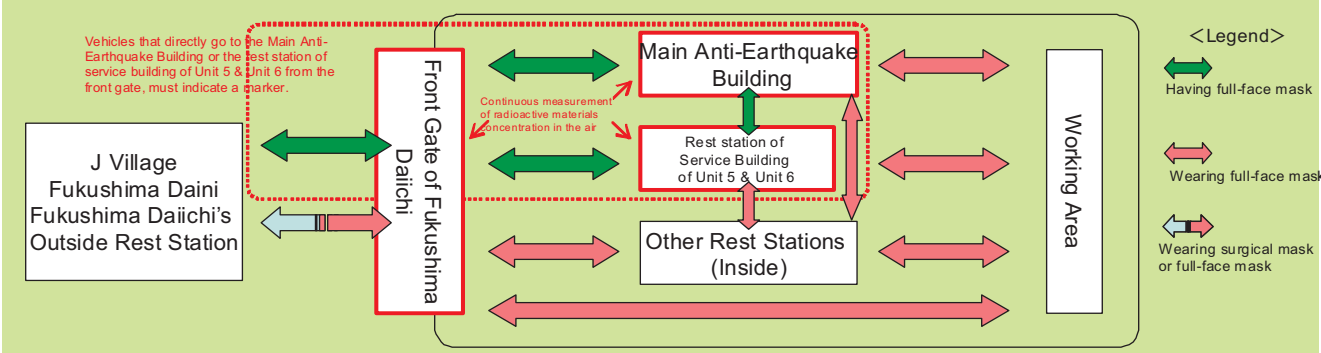
<p>Vehicles that directly go to the Main Anti-Earthquake Building or the rest station of service building of Unit 5 &amp; Unit 6 from the front gate, must indicate a marker.</p> <p>Continuous measurement of radioactive materials concentration in the air.</p> <p><b>&lt;Legend&gt;</b></p> <ul style="list-style-type: none"> <li>Having full-face mask (Green double-headed arrow)</li> <li>Wearing full-face mask (Red double-headed arrow)</li> <li>Wearing surgical mask or full-face mask (Blue double-headed arrow)</li> </ul>
