Report on initial responses to the accident at Tokyo Electric Power Co.'s Fukushima Daiichi Nuclear Power Plant

December 22, 2011
Tokyo Electric Power Co., Inc.

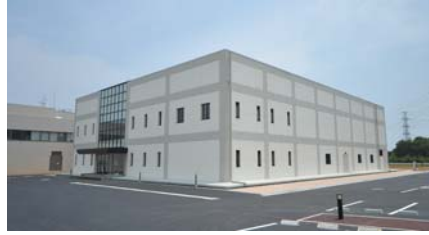
Seismically isolated important facility

- In the Fukushima Daiichi Nuclear Power Plant, the staff members under emergency conditions in the seismically isolated important facility started to take actions just after the earthquake, whereas the general office employees confirmed the safety of the entire staff beforehand in the parking area, which is an evacuation site, next to the facility and entered the facility. This seismically isolated important facility was constructed based on the experience we had at the Kashiwazaki-Kariwa Nuclear Power Plant suffering from the Niigataken Chuetsu-Oki Earthquake in 2007, which has been designed to endure the intensity-7 level on the 7-point Japanese intensity scale and equipped with a gas turbine generator as self-generation facility, telecommunications system, video conference system, ventilation equipment with highly efficient filter and so on. The facility also served as a local base to deal with the disaster.

(Left - Appearance, Right – Emergency countermeasures headquarters)

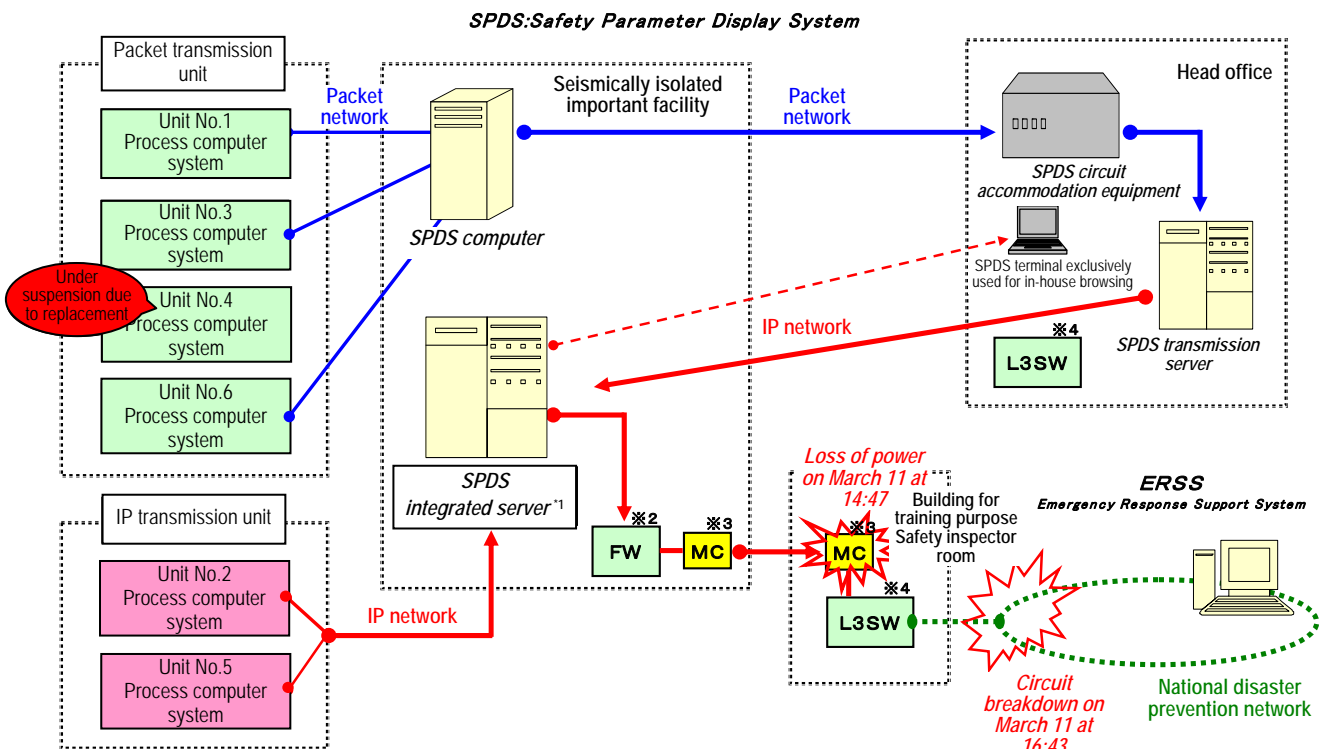
Structure of Fukushima Daiichi Nuclear Power Plant' SPDS: Transmission conditions on March 11, 2011 when the earthquake occurred

- The communication equipment which transmits the plant data between ERSS (country's system) and SPDS (our system) was located in the safety inspector room in the building for training purpose inside the power plant, and AC power supply functioned as its main power supply. The battery owned by the country was planned to be used as a backup power supply in the event of loss of AC power supply. However, because our operation to make its connection was not completed, the data transmission stopped at about 14:47 when the external power source was lost which was caused by the earthquake.

- In addition, the data transmission from the Fukushima Daiichi Nuclear Power Plant was made without any problem, whereas the data transfer became impossible because of transmission shutdown of the dedicated network to nuclear disaster prevention (public communication service) owned by the Japanese government to which the ERSS (country's system) is connected, which occurred at about 16:43. (This dedicated network is provided for common use of the Fukushima Daiichi and Daini Nuclear Power Plants.)

¹ Backup power supply consists of gas turbine generator dedicated to seismically isolated important facility and equipment, and batteries.
² FW: Firewall
³ MC (Media converter): It is the equipment that interconnects different transmission media, such as optical fiber and copper lines, of different standards and converts signals.
⁴ L3SW (Layer-3 switch): It performs routing control based on IP address and transfers packets to the output port adapted to the desired IP address.

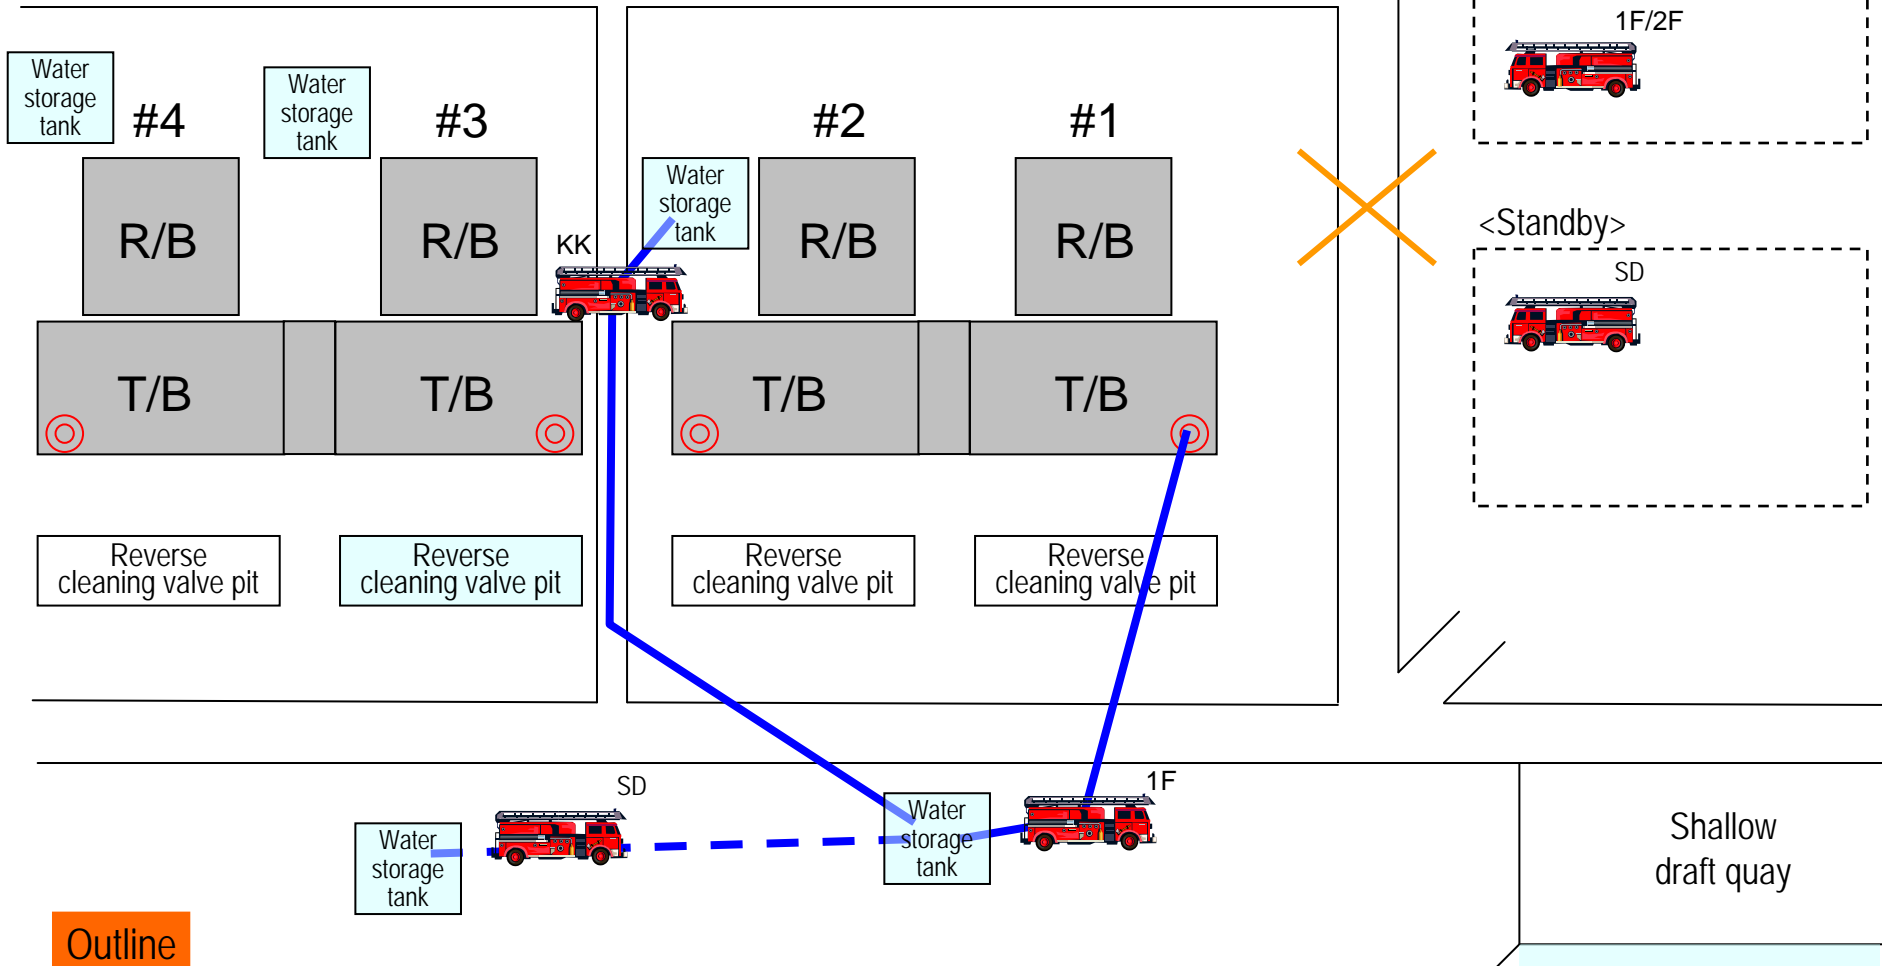
(4) Start of continuous injection, and arrival of support fire engines
(Mar 12 in the morning)

- Outline**
- Continuous water injection line from the water storage tank to water supply inlet was installed to inject water.
 - KK arrived at the site around 10:30, and the fire engine of Self-Defense Forces arrived before noon. Water was supplied from water storage tanks around the site to the water storage tanks to the Unit 1 side.
 - In addition, 1 chemical fire engine shared by 1F and 2F was moved from 2F. (The fire engine was not used actually because of its old model.)
