Findings from the latest analyses using MAAP5

1. Latest analysis of Unit-1 by MAAP5.01

1.3 Results of MAAP analysis

2.3 Results of MAAP analysis

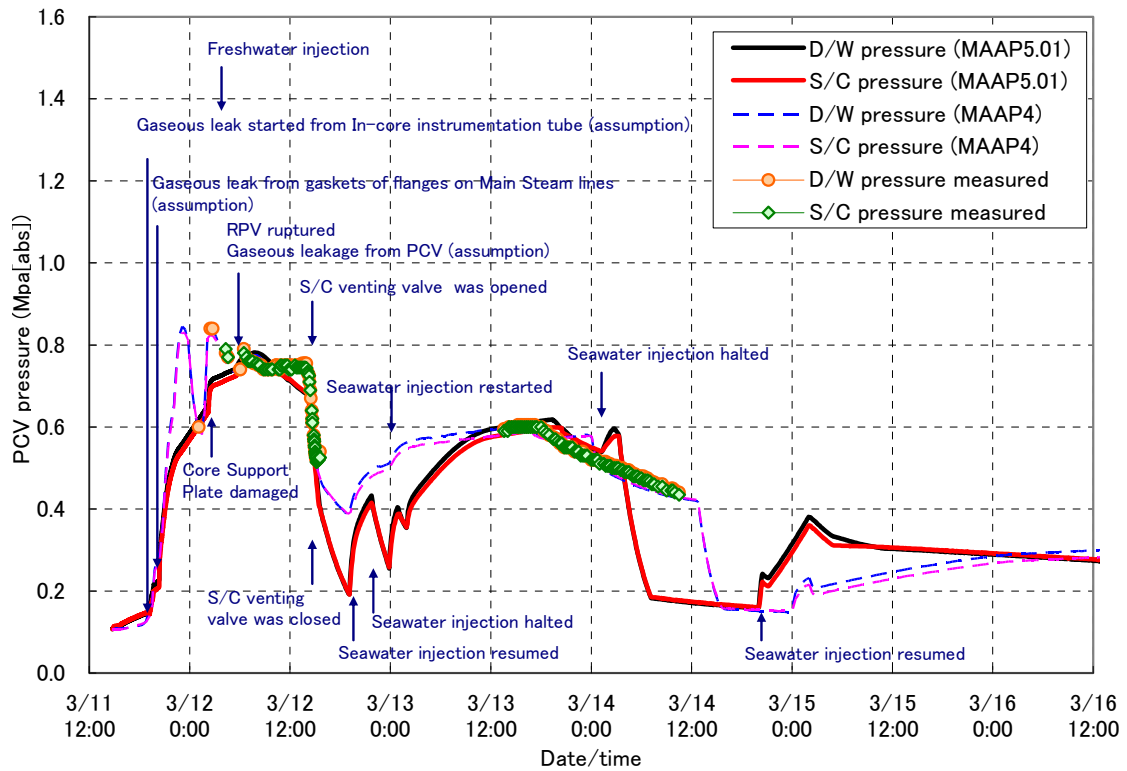
Figure 1-3 PCV pressure changes of Unit-1

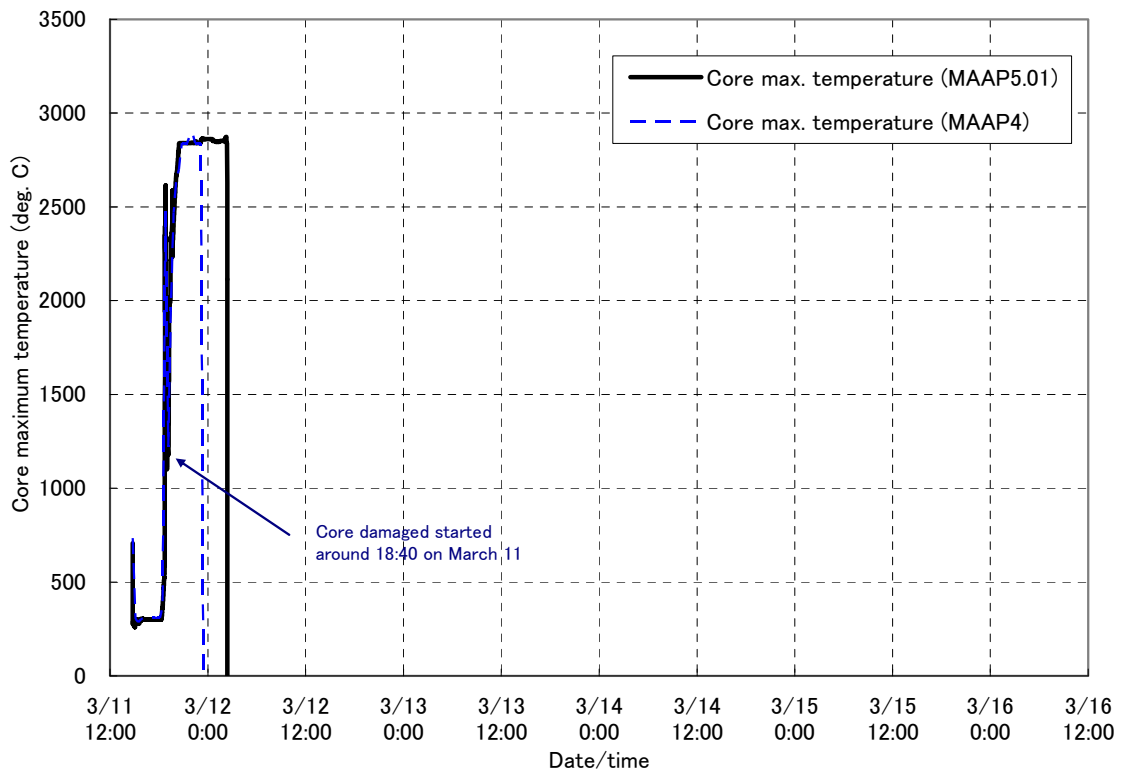
Figure 1-4 Core temperature changes of Unit-1

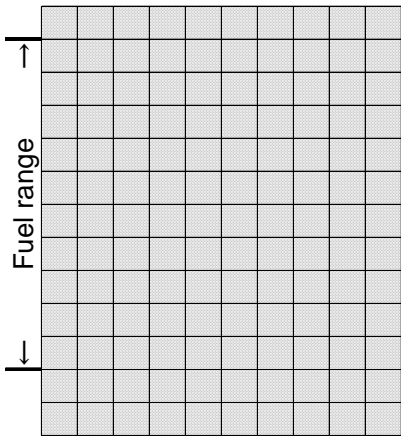
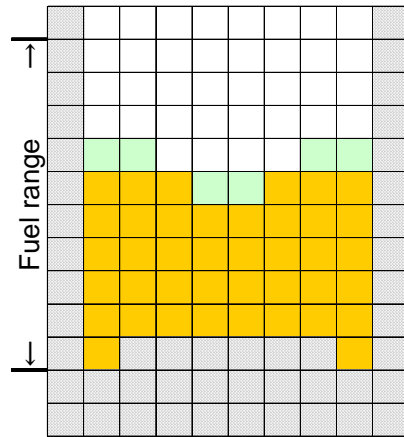
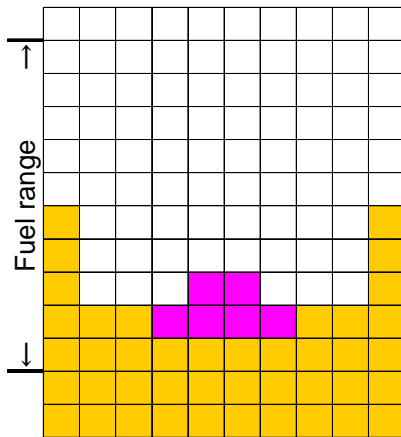
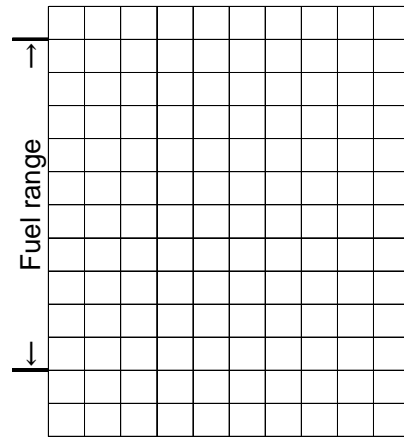
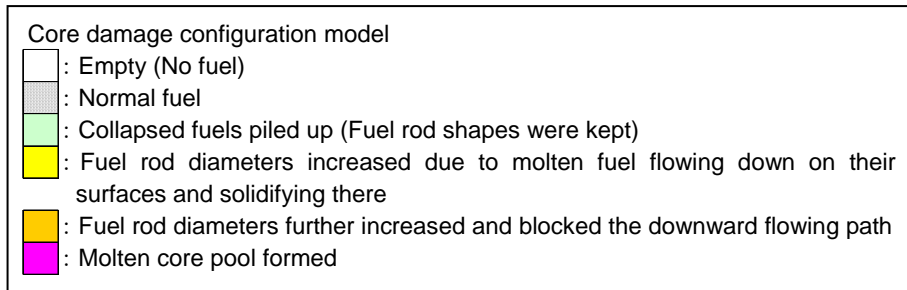
About 3.9 hours after SCRAM

About 5.0 hours after SCRAM

About 11.5 hours after SCRAM

About 12.0 hours after SCRAM

Figure 1-14 Core status of Unit-1

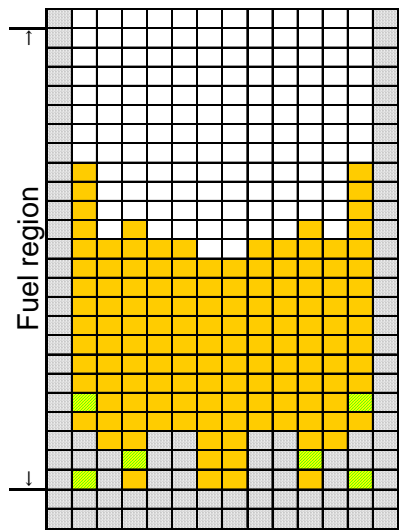
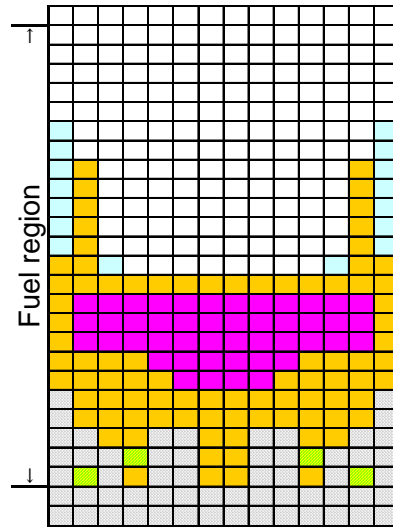
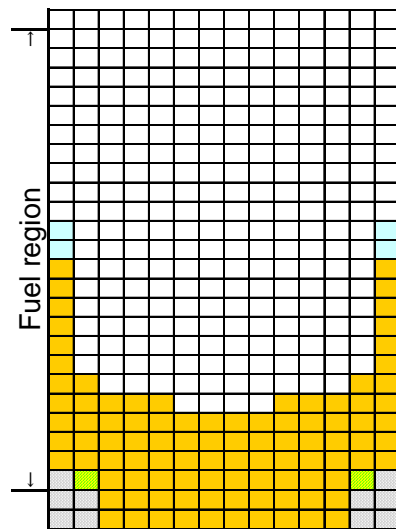
About 80 hours after SCRAM

About 105 hours after SCRAM

About 130 hours after SCRAM

About 155 hours after SCRAM

Figure 2-13 Core status of Unit-2

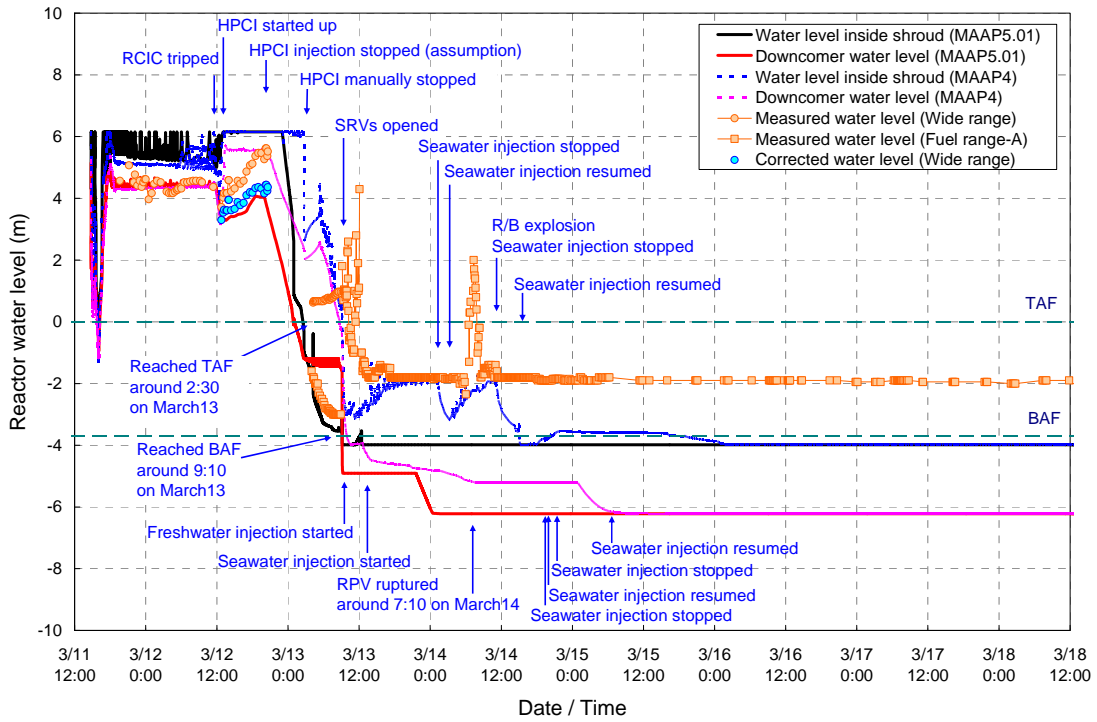
Figure 3-1 Reactor water level changes of Unit-3

- The reactor water level decrease significantly advanced, and it reached near the TAF by the time when the operators manually stopped the HPCI at about 02:42 on March 13th. The core was not covered already by around this time.
- As a result, the timing of core damage also advanced. By the time when the water

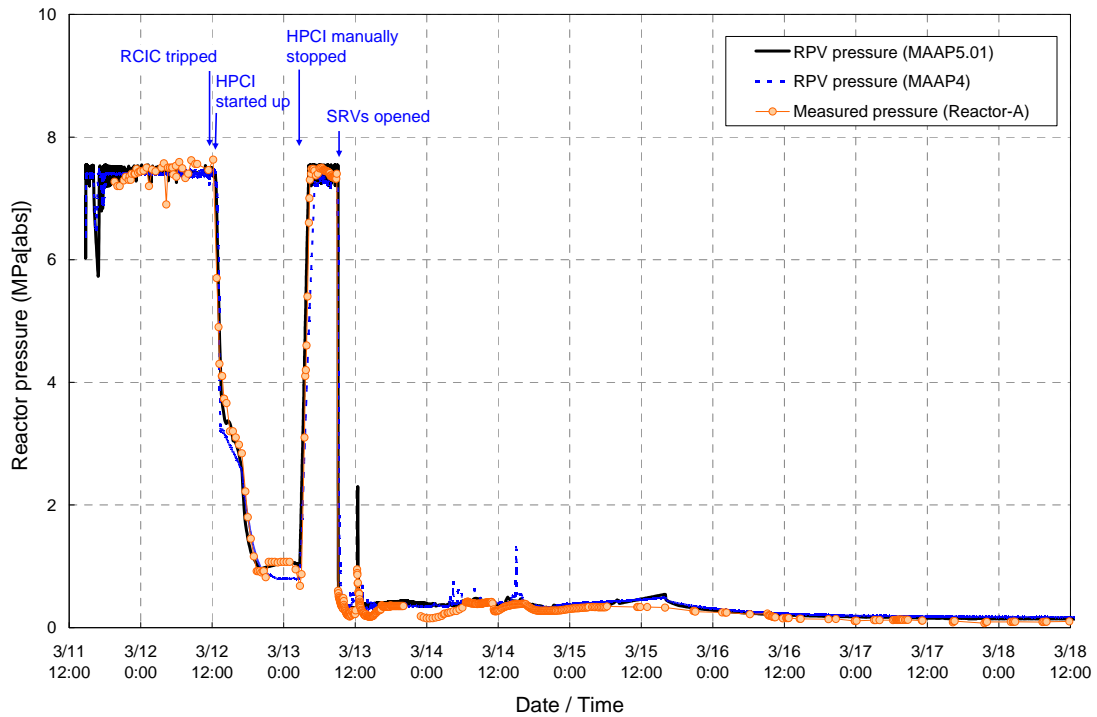
Figure 3-2 RPV pressure changes of Unit-3

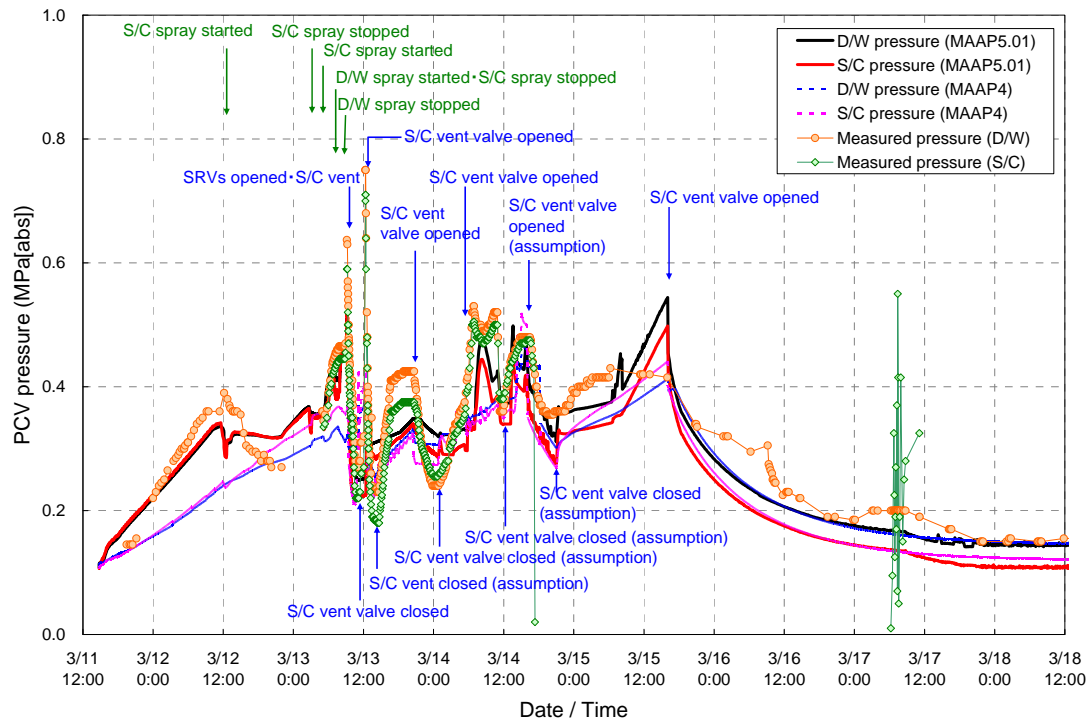
Figure 3-3 PCV pressure changes of Unit-3

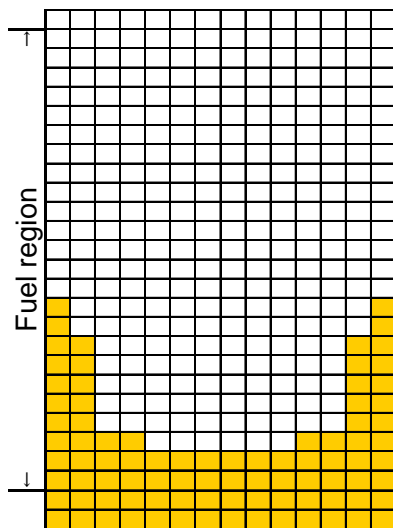
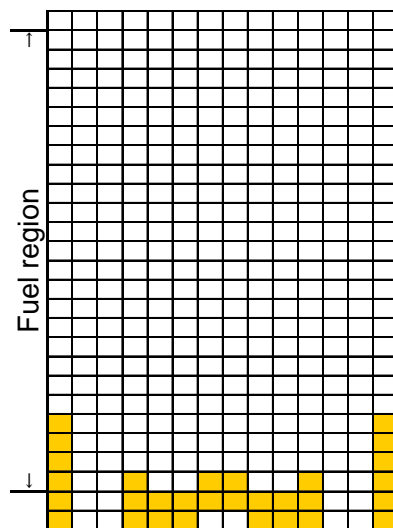
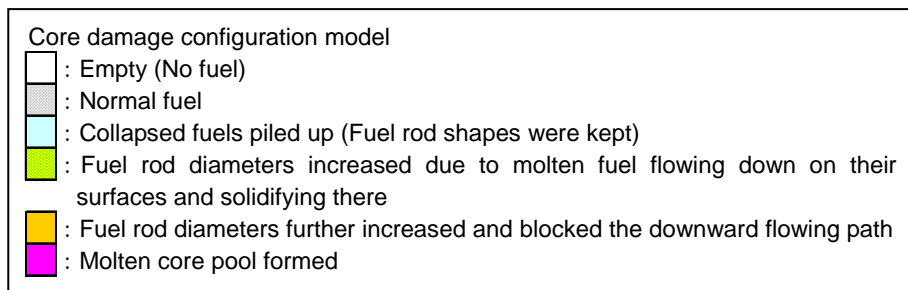
About 42 hours after SCRAM

About 44 hours after SCRAM

About 46 hours after SCRAM

About 64 hours after SCRAM

Figure 3-13 Core status of Unit-3
