Arrival times of tsunami at the Fukushima Daiichi Nuclear Power Station site

1. Overview

The following analyses and evaluations were newly done in order to provide the exact timings of the tsunami wave arrivals at the Fukushima Daiichi Nuclear Power Station site.

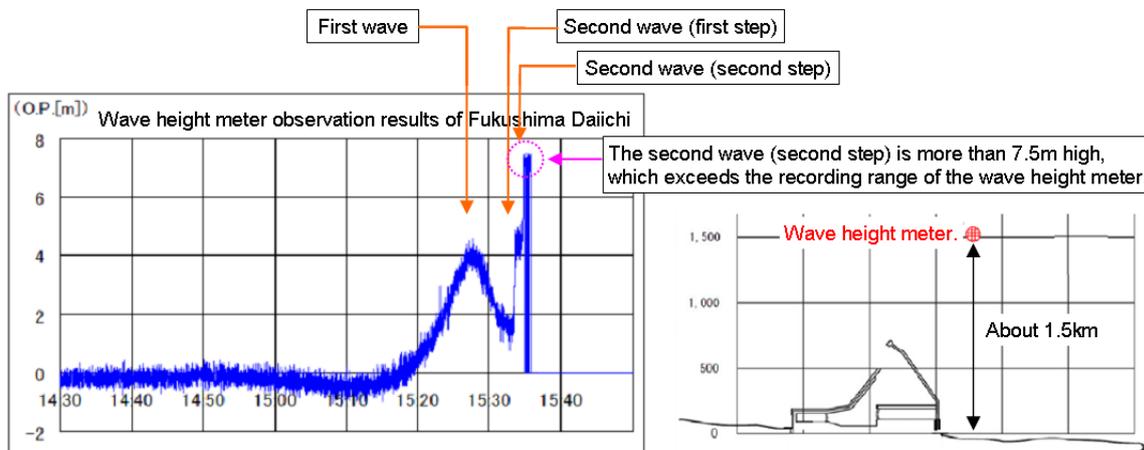
Figure Wave height meter observation results and the positional relation between the Fukushima Daiichi Nuclear Power Station site and the wave height meter

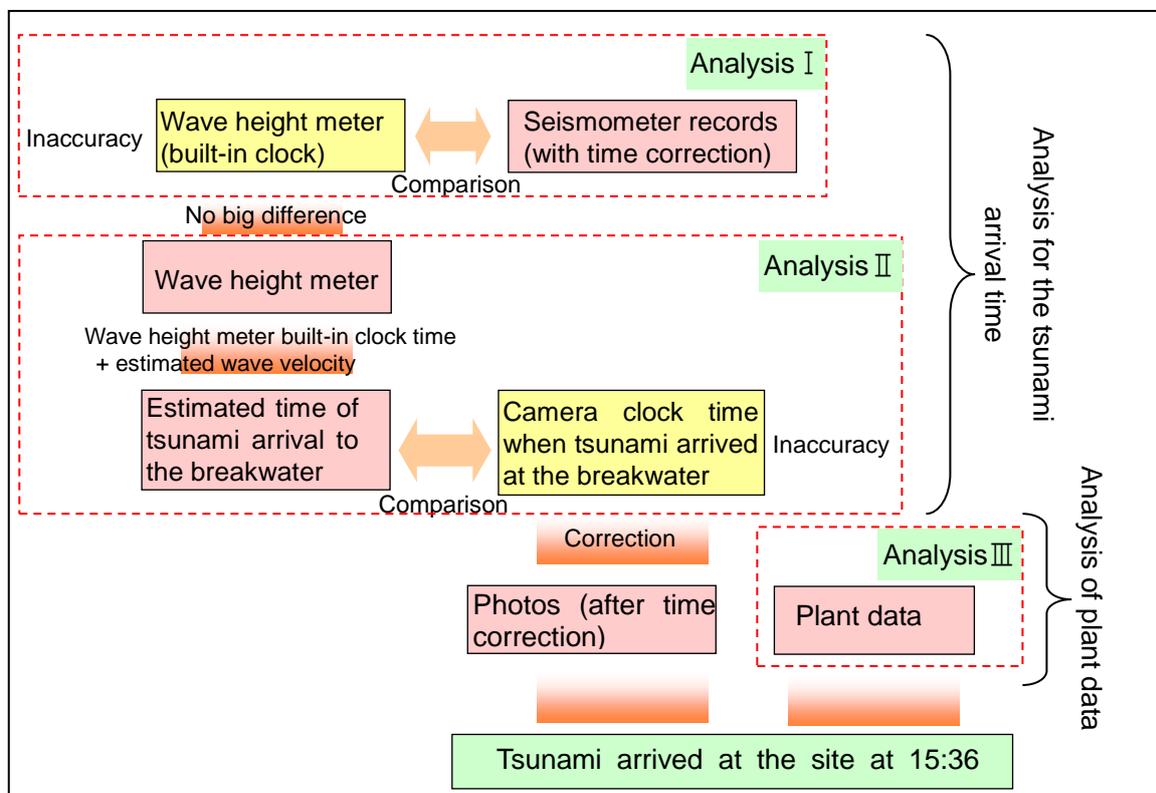
Figure Approach for the analyses of the tsunami arrival times at the site

The following approach has been taken to analyze the tsunami arrival timing at the Fukushima Daiichi Nuclear Power Station site. The results of analyses are given in later sections: the results of analyses I and II as “Analysis by the use of wave height meter records and photos” and those of analysis III as “Analysis using plant data.”

In Analysis I, the accuracy of the wave height meter built-in clock was analyzed, which was known to have inaccuracies. Seismometers installed on each unit of the Fukushima Daiichi Nuclear Power Station, which had been calibrated on the each hour, were used as the reference and compared with the water pressure wave time history recorded on the wave height meter for the necessary time calibration.

In Analysis II, the timing of the tsunami wave passing over the wave height meter after its correction by Analysis I and the estimated tsunami wave velocity were used to estimate the tsunami arrival timing when the tsunami reached the southern breakwater flexion.

There is a photo of the tsunami second wave (first peak) arriving at the southern breakwater flexion. The times of the continuous photos recorded have been corrected by comparing the time recorded on the camera and the estimated tsunami arrival time to the southern breakwater flexion obtained above.

In Analysis III, the tsunami arrival time was estimated based on the recorded plant data (times when the seawater pumps, power panels and diesel generators lost their functions).

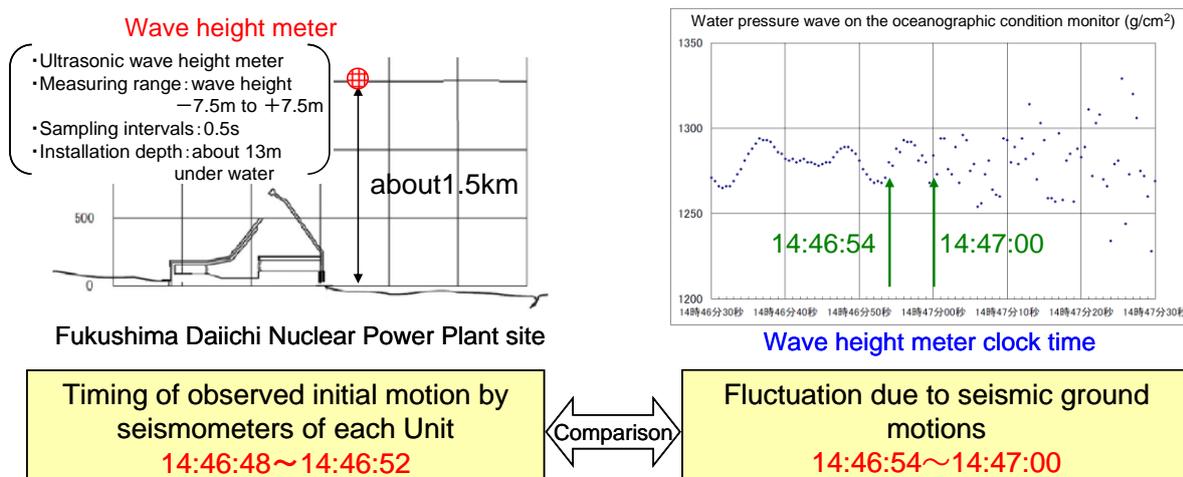
Timing accuracy has been verified by comparing the slight initial motion recorded on the seismometers of each unit and the water pressure wave (responding to the seismic ground motion) recorded on the wave height meter.

Fluctuation noticed in the graph generated by the wave height meter can be considered to be due to the seismic motions, that is, the time when the seismic motion reached the wave height meter can be regarded as around 14:46:54 to 14:47:00 according to the wave height meter built-in clock.

On the other hand, the seismometers installed on each unit (their built-in clocks were calibrated on the hour) recorded that the seismic ground motion started at 14:48:48 to 14:48:52. As the seismic wave propagation speed is regarded as several kilometers per second or more, the time needed for propagation over 1.5 km is almost negligible, which was the distance separating the wave height meter and the seismometers at the power plant.

From deliberations above, the wave height meter built-in clock seemed to be about 4 to 10 s fast, when compared with the median value of the seismometers records of 14:46:50 as the seismic motion starting time. Thus, wave height meter timing would be considered to have no big discrepancy.

Figure Comparison between timing of observed motion by seismometers and fluctuation on wave height meter measurement

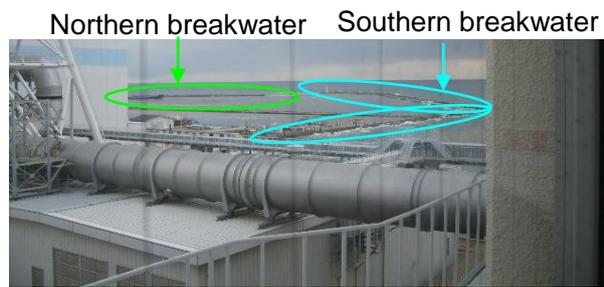
1 (00:00)

The sea level conditions on the southern breakwater shows a gradual sea level drop over the time span of 1 min 26 s from Shot 1 to Shot 4. The sea level clearly declines over the following 3 min 34 s from Shot 4 to Shot 5.

Excluding Shot 1, the sea level in the bay seemed to be declining gradually at least from Shot 2 to Shot 5 (4 min 26 s or longer).

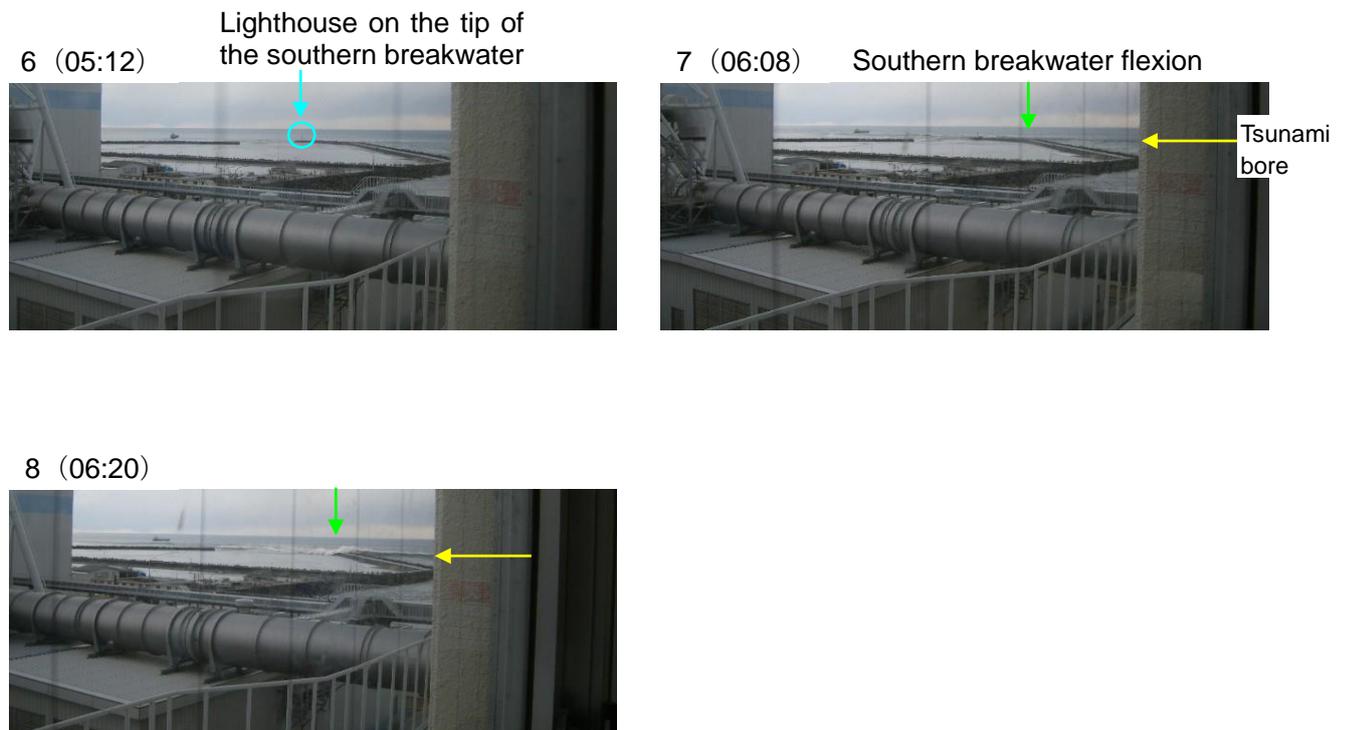
Shot 7 clearly shows the approach of the bore-type tsunami. At this moment the bore had not yet reached the main part of the southern breakwater and the lighthouse on its tip; the bore was clearly outside the bay. Judging from the positions of the bore and a ship in the photo, Shot 7 was taken immediately after the ship had passed the bore.

In Shot 8, the bore reached the southern breakwater and the lighthouse on its tip was behind the tsunami, so that at this moment the bore had reached the flexion of the southern breakwater.

When having a look at portions that were not flooded on the land side base of the southern breakwater and the eastern seawall bank, Shot 5 and Shots 6 to 8 have similar conditions of not being flooded. Therefore, it may be understood that the tsunami bore, on the order of several meters in height as seen in Shots 7 and 8, reached that point immediately after the gradual drop of the sea level.

In other words, it can be judged that water drop in Shots 1 to 5 was after the peak of the first wave, and the bore in Shots 7 and 8 was the second wave (first step).

There were four shots, 5 to 8, during 1 min 20 s. Then it was judged that these shots could catch the arrival of second wave (first step) and there was nothing more missing.

As mentioned before, the bore of the second wave (first step) reached the southern breakwater flexion in Shot 8, which allows correction of the time when the shot was taken. The procedure is:

The time when the second wave (first step) reached the wave height meter was about 15:33:30. When the estimated time for propagation is added to this, the time when Shot 8 was taken is estimated to be between 15:34:55 and 15:35:16. On the other hand, the time recorded on the camera built-in clock was 15:41:36.

From the above, the camera built-in clock is estimated to be fast by 6 min 20 s to 6 min 41 s. From considerations (b)-a and (b)-b above, it is expected that 6 min 41 s is closer to reality.

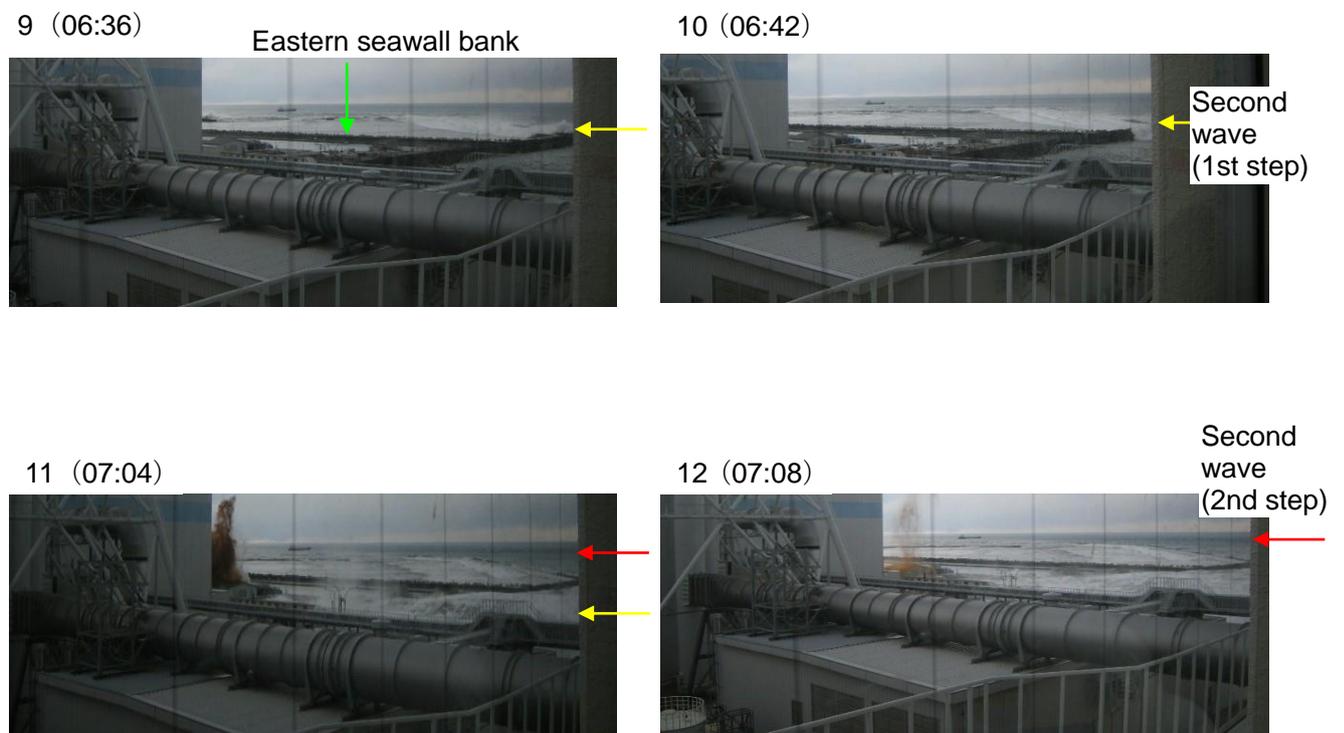
Shots 9 to 12 show tsunami bore running along the southern breakwater, i.e., the tsunami second wave (first step).

In Shot 11 the base area of the southern breakwater is covered by the tsunami water, while the bore cannot be confirmed to have reached the eastern seawall bank. Therefore, the brown water column seen is due to the tsunami which did not come from bay area (from east) but from southeast into the front side of Unit4. But it cannot be judged from this shot only whether it resulted when the tsunami collided with some structures after running up to the 4-m ground level above O.P. (O.P. : Onahama Port construction standard surface, hereafter described as 4-m ground level) or it ran through a water discharge canal and rose from its opening. The location can be considered to be around the border between the 4-m ground level and 10-m ground level, because the column appeared immediately northeast of a hut on the 10-m ground level in front of the Unit-4 building.

In Shots 11 and 12, a wave, probably the second wave (second step), can be seen off the coast. The water column in Shot 11, therefore, can be considered to have risen when the second wave (first step) in the order of several meters in height as observed in Shots 6 to 8 reached the area near the border between the 4-m ground level and 10-m ground level.

The time difference between Shot 8, showing the arrival of the tsunami second wave (first step), and Shot 12 is 48 s, and it can be considered that no phenomenon has been overlooked and consequently the water column was generated due to the second wave (first step).

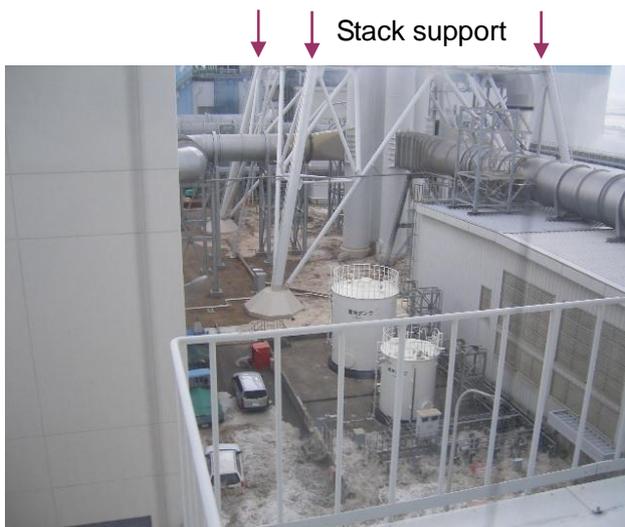
13 (07:24)

Shot 13, 20 s after Shot 11 with the water column, shows inundation to the 10-m ground level.

- With the same correction, it was at about 15:36:06, when the second wave (first step) reached the southern breakwater flexion (Shot 8), at about 15:36:10 when small scale inundation could be confirmed to have started around the tanks on the 10-m ground level (Shot 13).

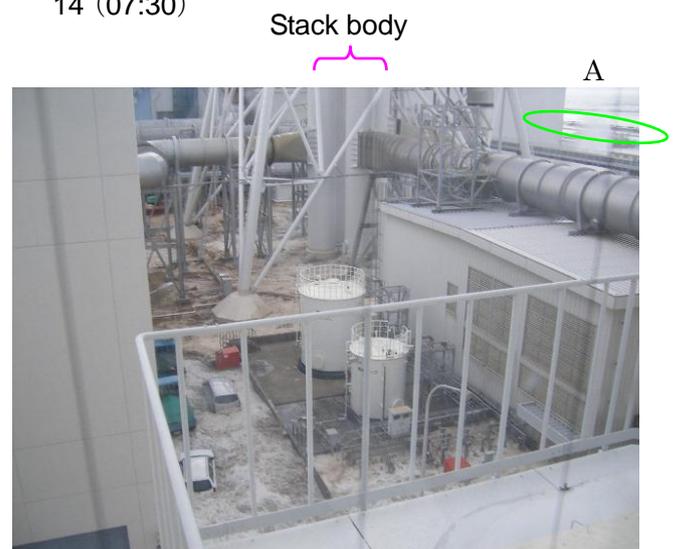
14 (07:30)

On the upper right of Shot 14, 6 s after Shot 13, a structure, probably the eastern seawall bank, can be recognized (A). This timing will be around the time when the second wave (first step) in the order of several meters height as recognized in Shots 7 and 8 reached the 10-m ground level. In Shots 15 and 16, the base of the stack is seen (B), and no big tsunami run-up like those in Shots 17 and 18 is visible. Based on these observations, it can be understood that in Shots 13 to 16 the second wave (second step) in the order of 10 meters high had not reached the 10-m ground level yet and that the run-up to the 10-m ground level recognized in Shots 13 and 14 by the second wave (first step) was a limited scale.

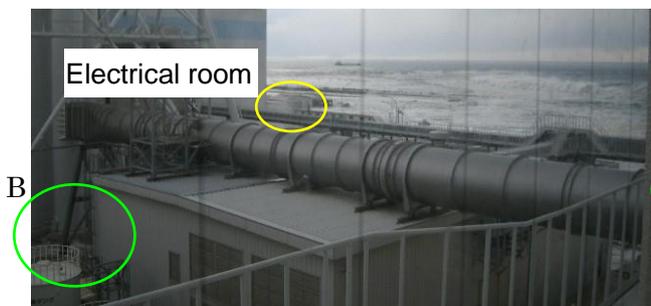
15 (07:42)

In Shot 15, 12 s after Shot 14, tsunami water covers the southern and northern breakwaters. In Shot 16, taken 14 s after Shot 15, the eastern seawall bank is also covered by the tsunami water in addition to the southern and northern breakwaters and big bores are recognized in the bay.

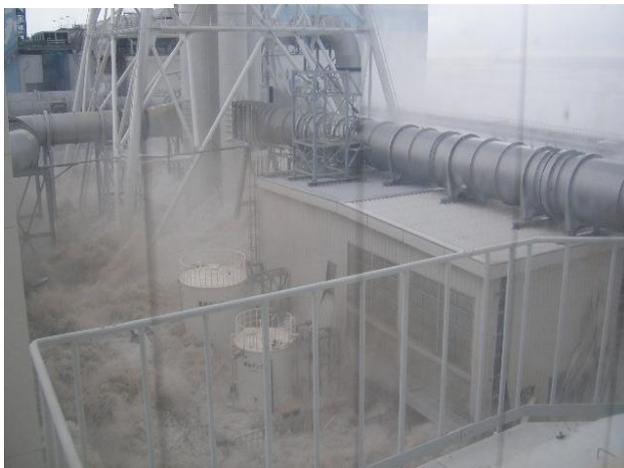
17 (08:10)

In Shot 17, taken 14s after Shot 16, a large amount of seawater flows over the 10-m elevation level and continues in the scenes of Shots 18 and 19. The scene inside the bay is not clear in Shot 17. In Shots 18 and 19, the elevated sea surface can be confirmed, but breakwaters and seawall bank cannot be recognized. This means that, besides the second wave (first step), there was another wave that was big enough to flood completely the breakwaters and seawall bank.

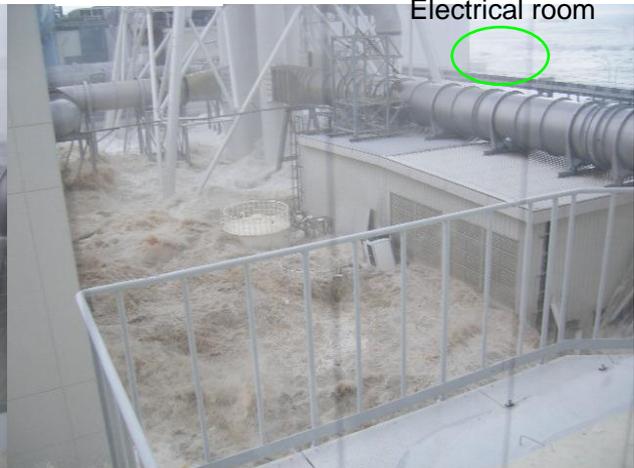
18 (08:20)

Shot 18 was taken 24 s after Shot 16 which shows a massive tsunami rushed into the bay. Further, in Shots 18 and 19, the electrical room on the 10-m ground level is almost completely flooded; which had been seen in Shots 15 and 16. As this electrical room was 5.15 m high, tsunami in Shots 18 and 19 can be regarded as about O.P. +15 m.

From these examinations, it can be concluded that at around the time Shot 18 was taken the second wave (second step) of about O.P. +15 m high had reached the areas near all reactor buildings of the Fukushima Daiichi Nuclear Power Station site.

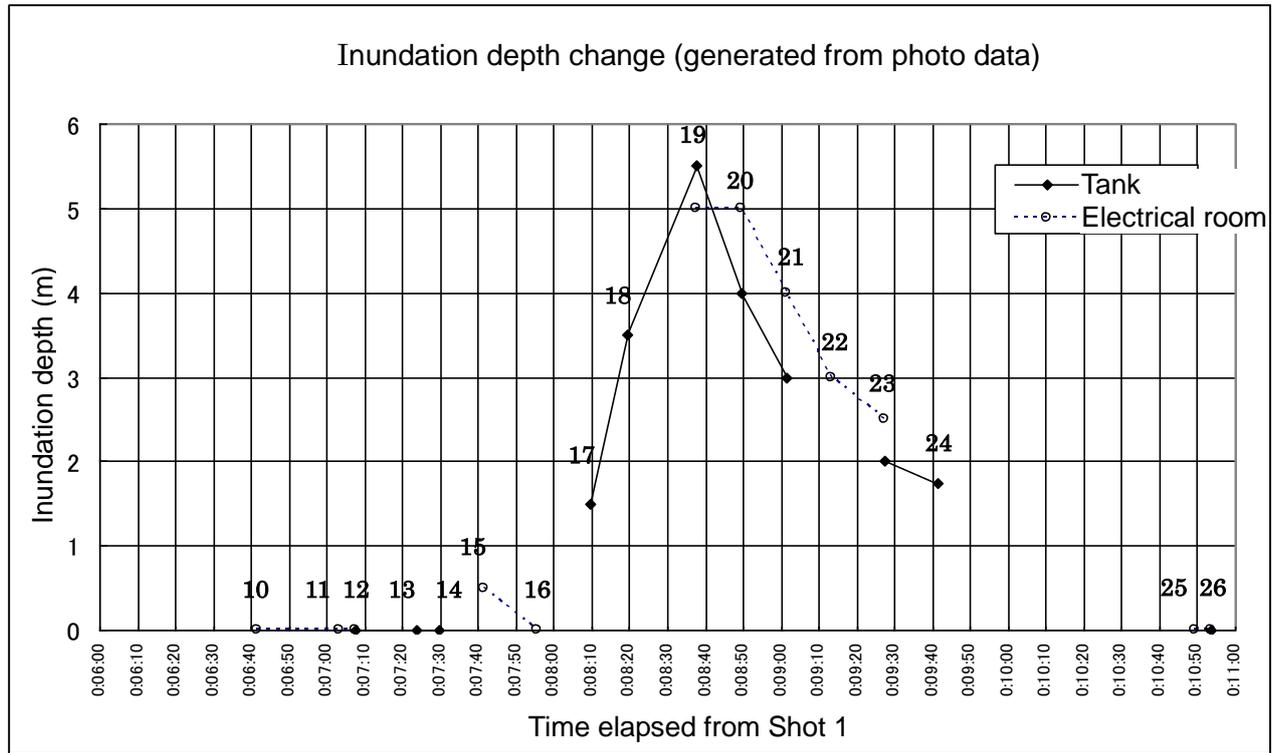
The time history chart of the tsunami level on the wall of a light oil tank and the electrical room in these shots indicates that the run-up of the tsunami in Shots 13 to 16 was a limited scale and the run-up became large scale from just before Shot 17. This observation agrees with the results of the photo analysis.

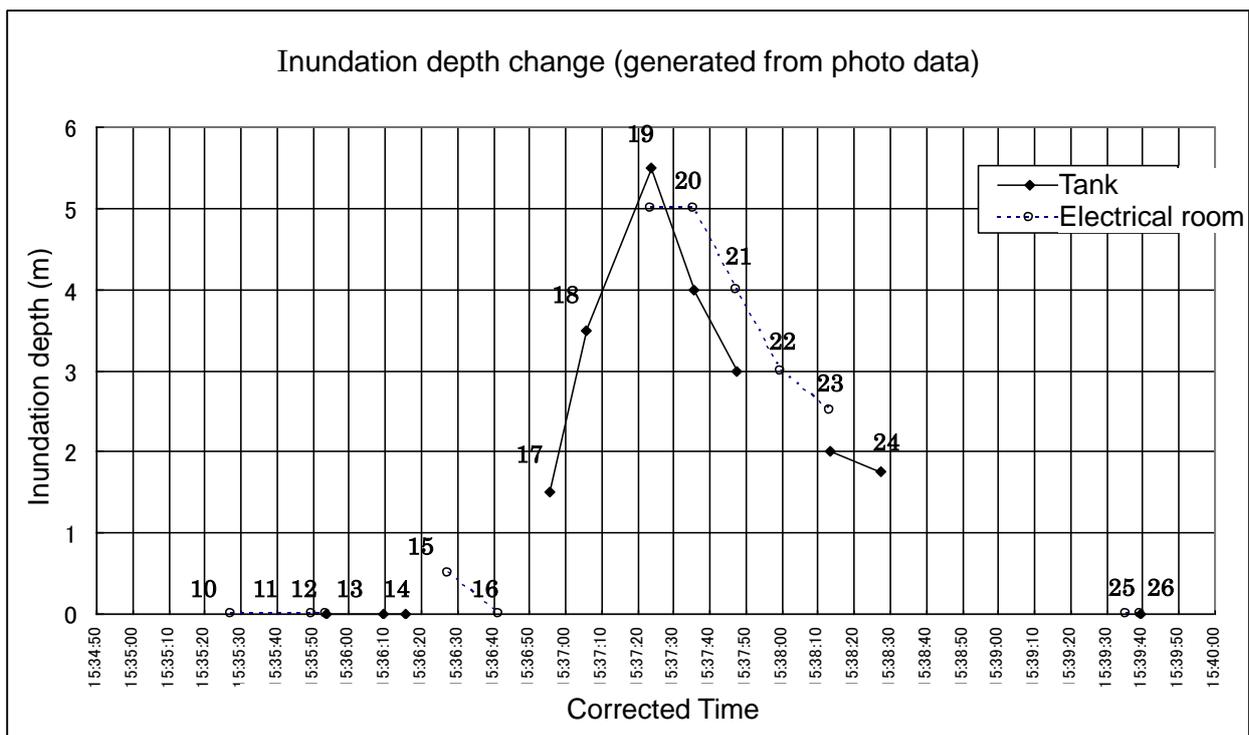
- The following figure shows the inundation situations of the tanks, etc. with the same time correction.
- Run-up of the second wave (first step) to the 10-m ground level remained as a limited one, but it can be understood that the second wave (second step) ran up to the 10-m ground level and almost completely covered the breakwaters and seawall bank.

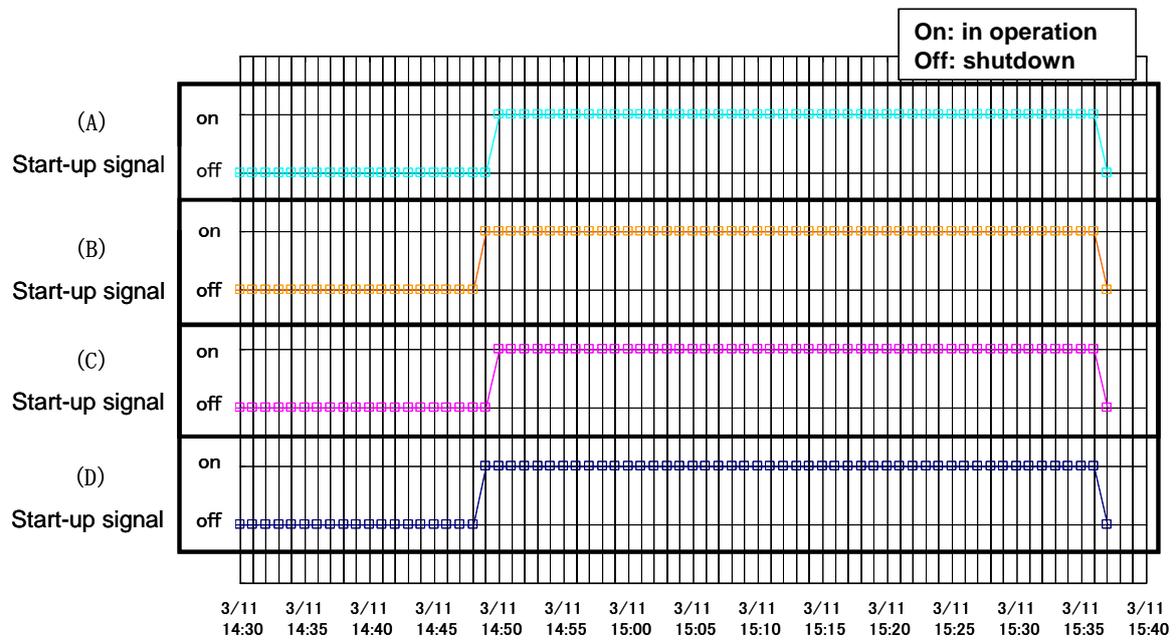
The CCSW pumps (A) to (D) had anomalies between 15:35:59 and 15:36:59 and lost their functions, according to the one minute cycle data recorded on the transient recorder.

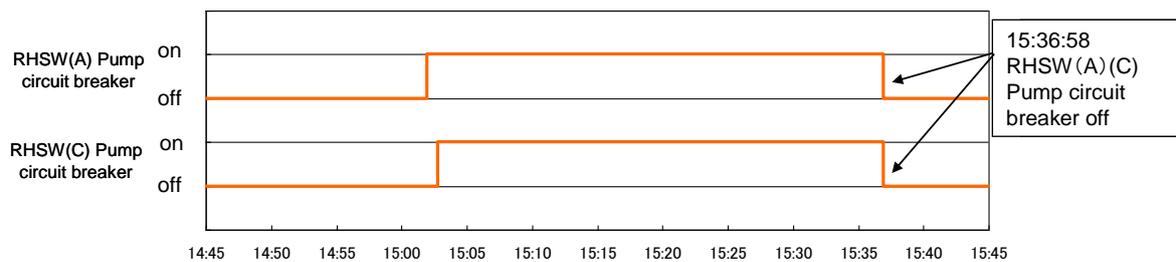
- ✓ Residual heat removal sea water system(RHSW) pumps of Unit-2

The circuit breakers of RHSW pumps (A) and (C) were opened and lost their operating functions at 15:36:58, according to the records in the process computer.

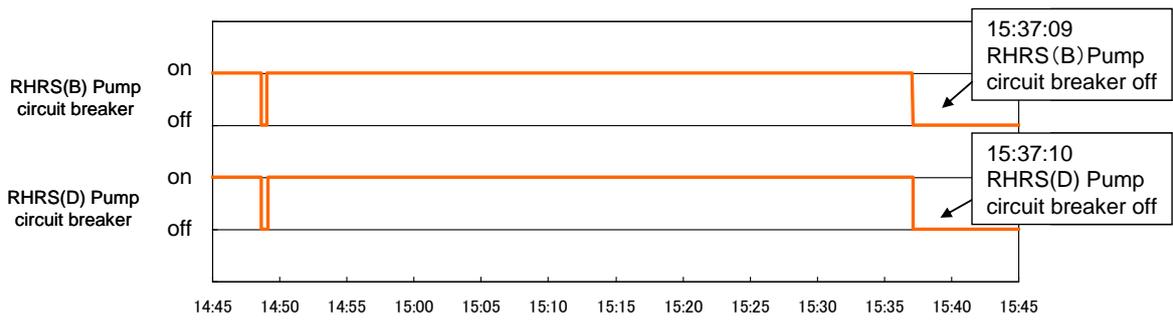
- ✓ Residual heat removal sea water system (RHRS) pumps of Unit-5

The RHRS pumps (B) and (D), which had started operation after the earthquake, had anomalies and lost operating functions at 15:37:09 and 15:37:10 according to the records in the process computer.

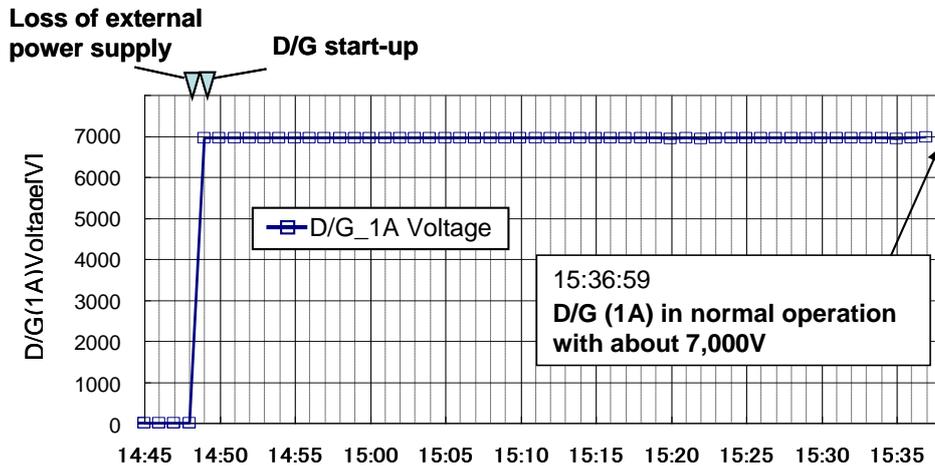
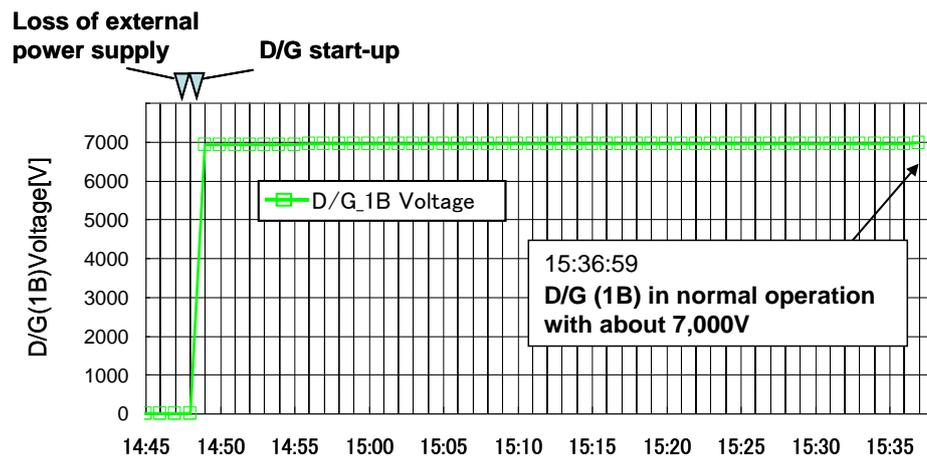
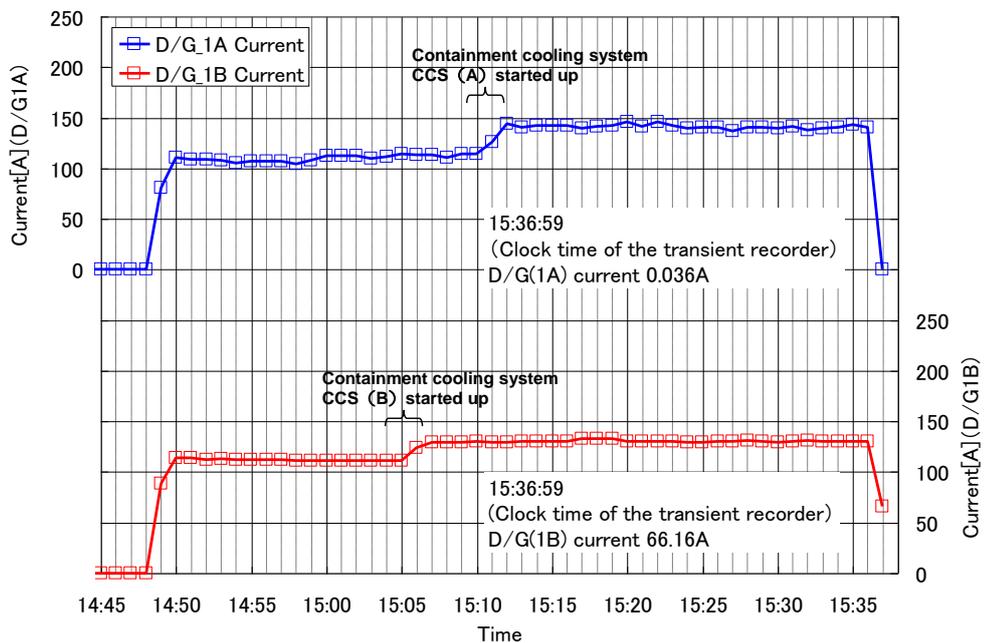
✓ D/Gs (1A) and (1B) of Unit-1

The voltage of the D/Gs (1A) (1B) of Unit-1 had been established until 15:36:59 while the transient recorder was recording data. This confirms their function losses were sometime after 15:36:59.

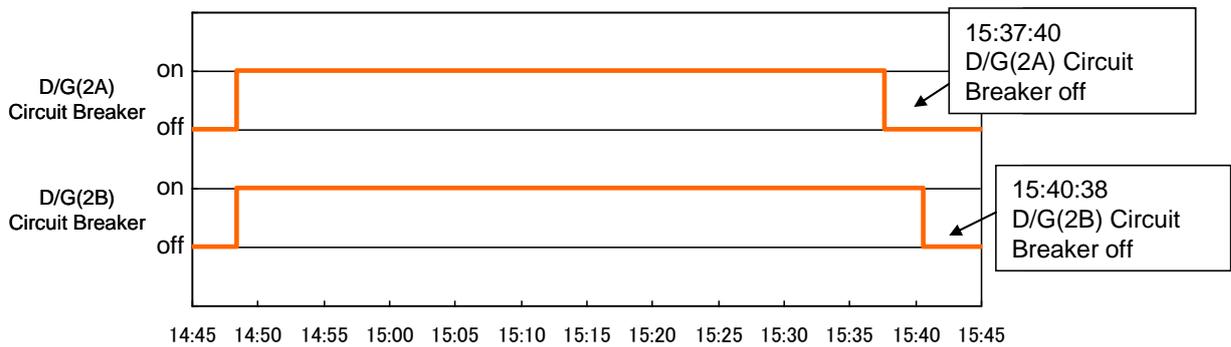
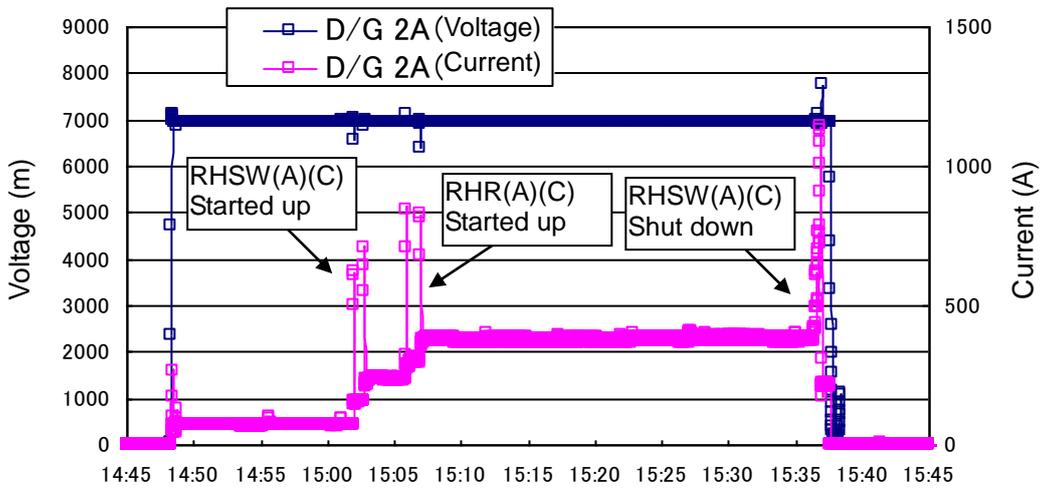
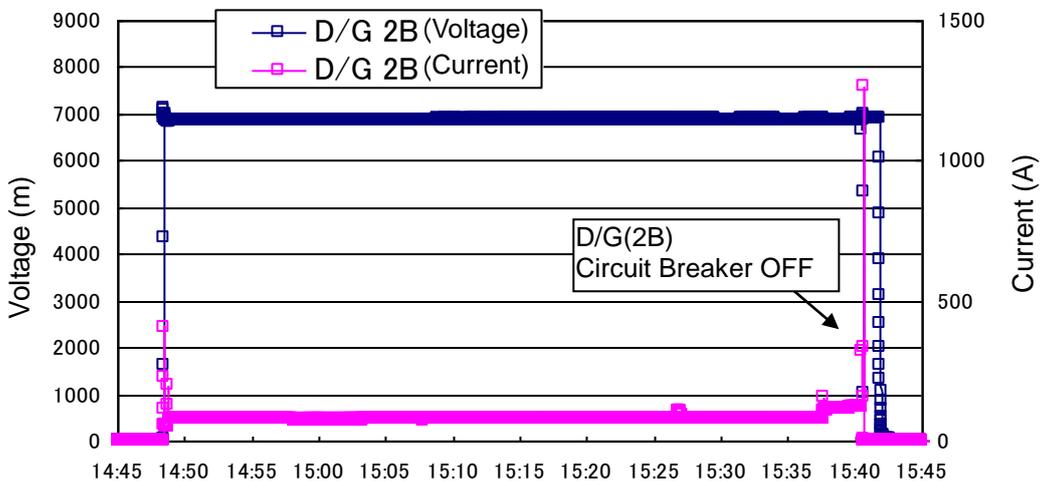
✓ D/Gs (2A) and (2B) of Unit-2

The power receiving circuit breaker of D/G (2A) opened at 15:37:40, according to the data recorded on the process computer.

The D/G (2B) was installed in another building (the common pool building) and its body was not damaged. But its breaker opened at 15:40:38. The function is assumed to have been lost due to the effect of damage to its related facilities or flooding of the emergency power panels to which the D/G (2B) was supplying power.

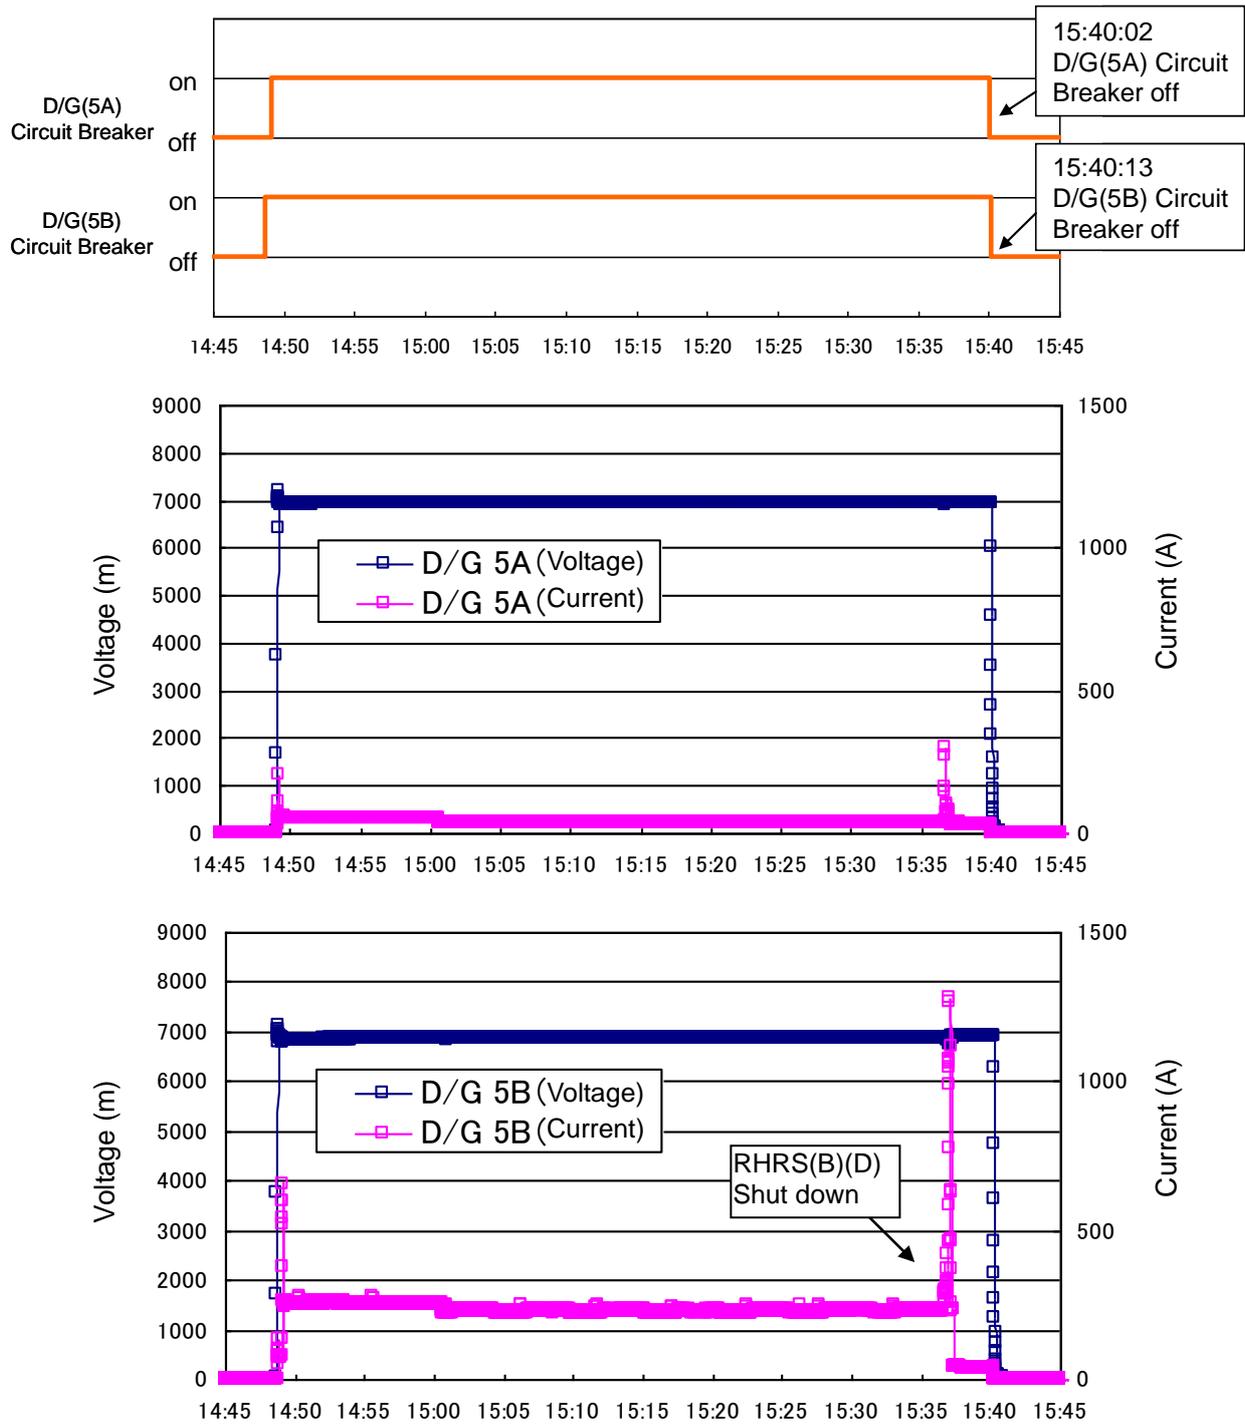
✓ D/Gs (5A) and (5B) of Unit-5

The D/Gs (5A) (5B) had anomalies at around 15:40 and lost their function, according to the data recorded on the process computer.

The bodies of D/Gs (5A) (5B) were confirmed in later investigation to have had no damage by flooding. The function is assumed to have been lost due to damage of their related facilities or flooding of the emergency power panels.

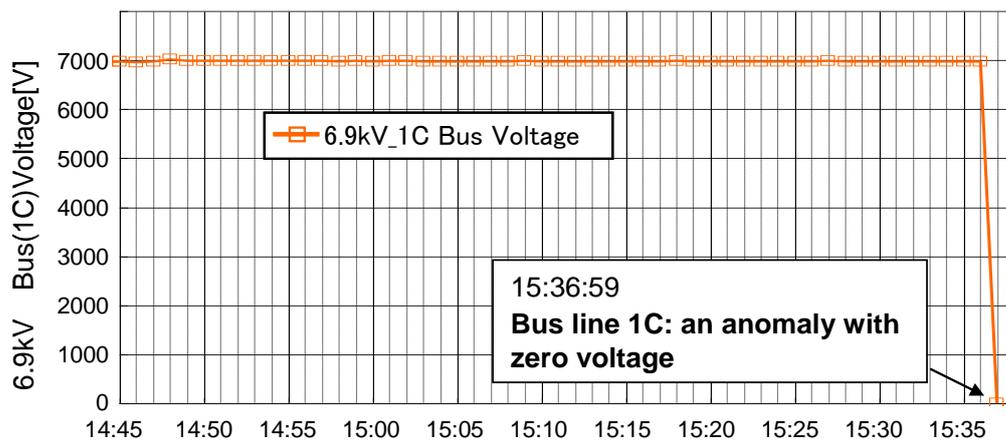
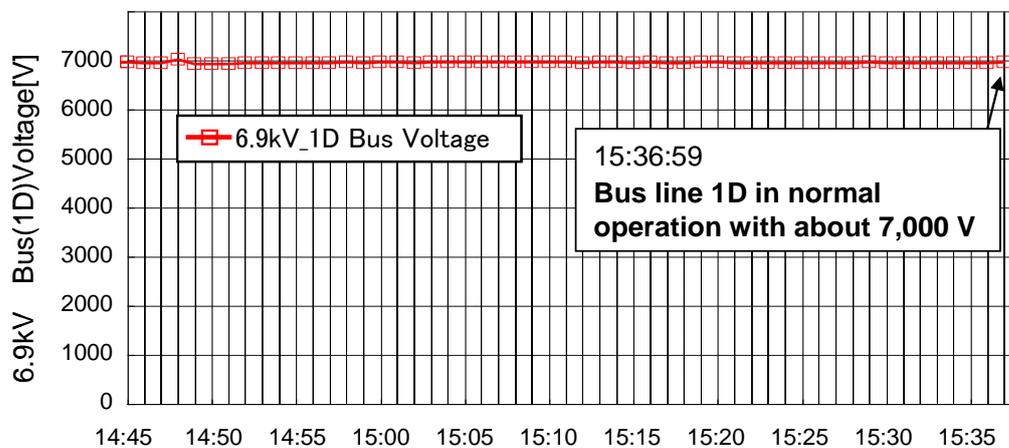
✓ Emergency power panels 1C and 1D of Unit-1

The emergency power panel 1C lost the emergency bus voltage between 15:35:59 and 15:36:59, while the emergency bus voltage of the emergency power panel 1D has been established until 15:36:59, according to the one minute cycle data recorded on the transient recorder. This confirms the function losses of the emergency power panel 1C was sometime after 15:36:59.

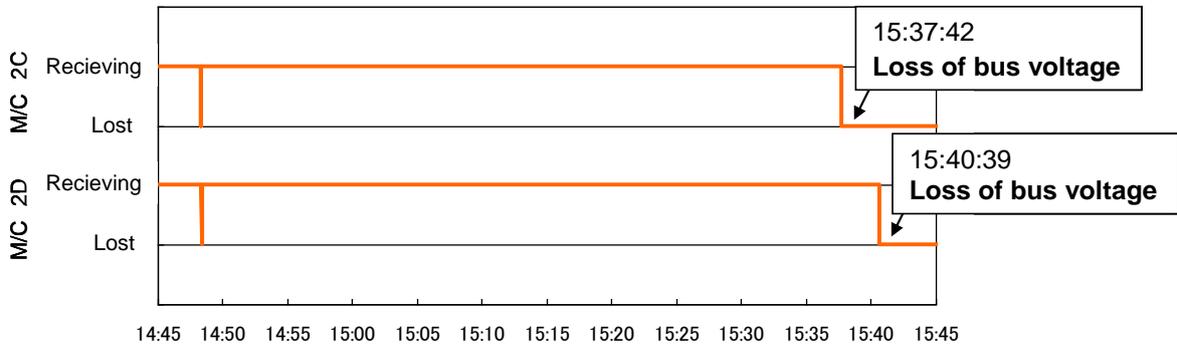
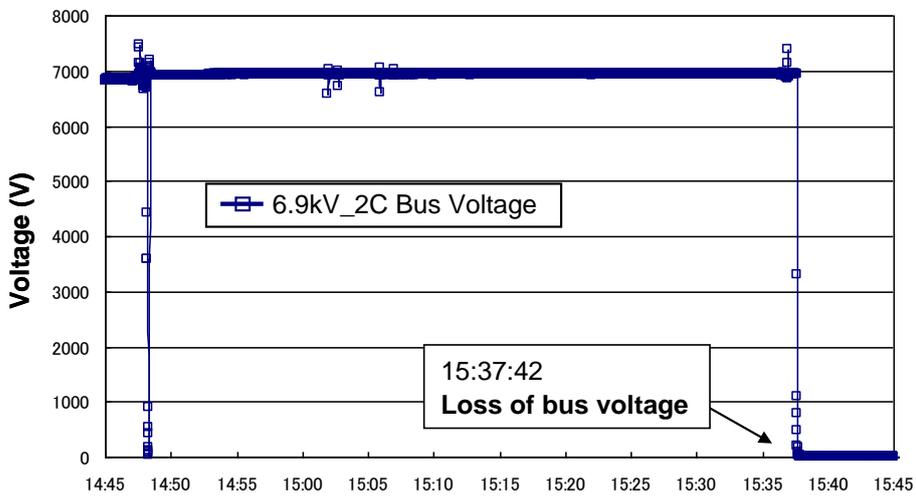
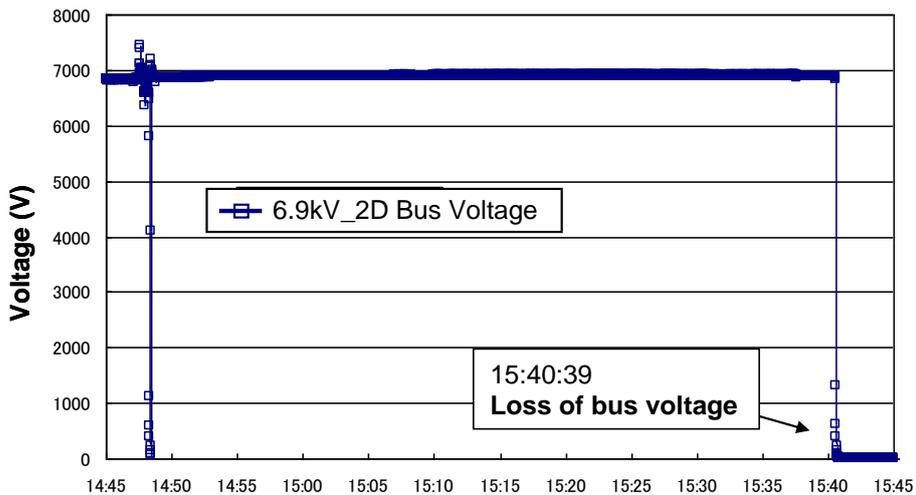
✓ Emergency power panels 2C and 2D of Unit-2

The emergency power panel 2C lost the emergency bus voltage at 15:37:42, while the emergency power panel 2D lost it at 15:40:39, according to the data recorded on the process computer for emergency power panels.

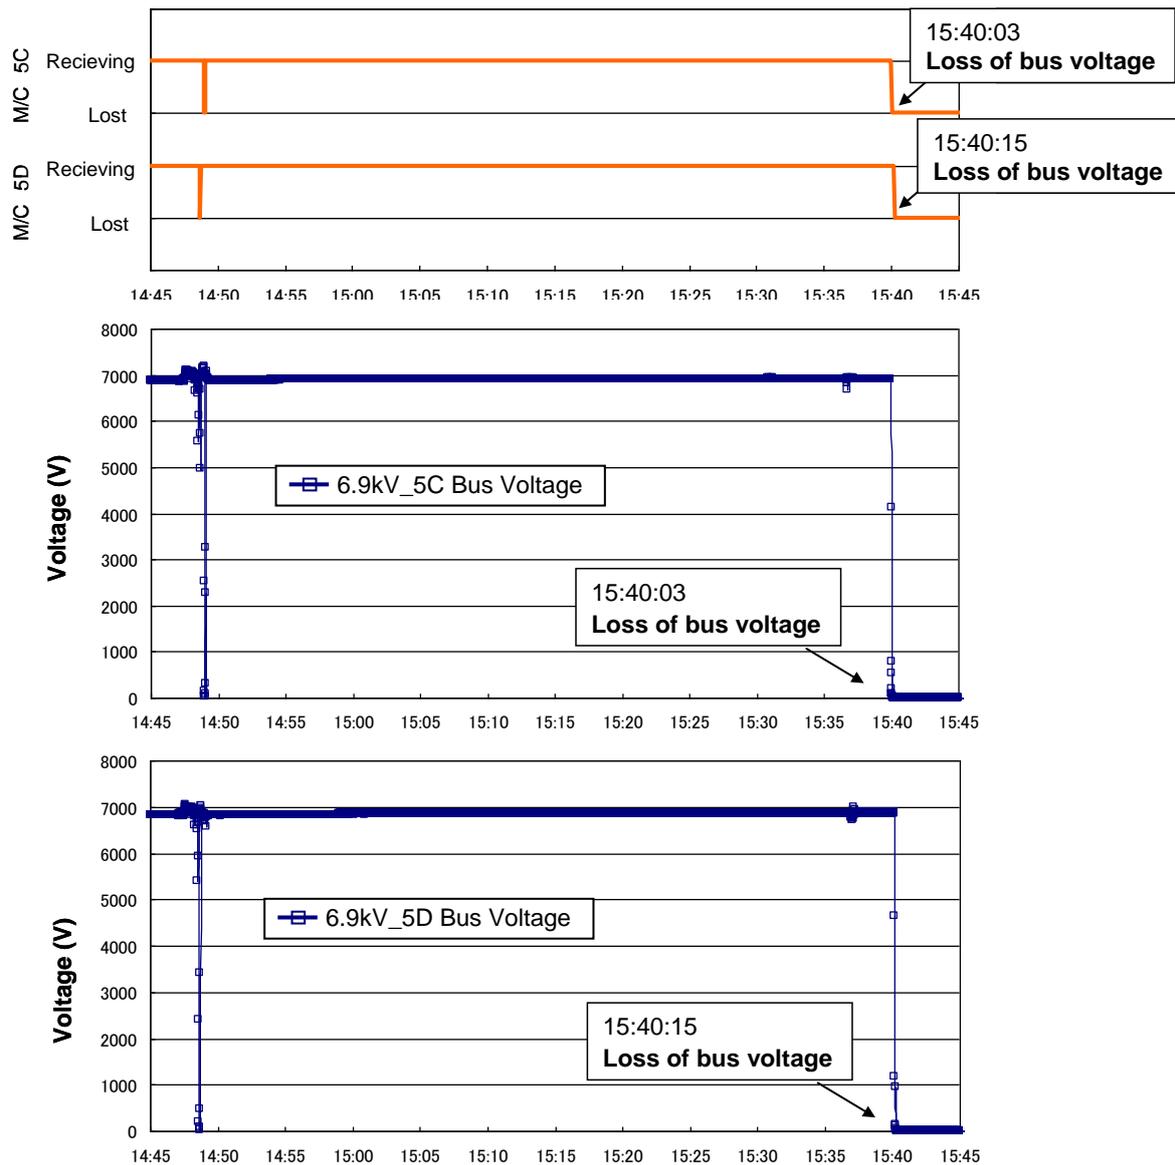
✓ Emergency power panels 5C and 5D of Unit-5

The emergency power panel 5C lost the emergency bus voltage at 15:40:03, while the emergency power panel 5D lost it at 15:40:15, according to the data recorded on the process computer.

The D/Gs showed no anomalies in a post-accident investigation. The loss of function is assumed to have been caused by that of the metal-clad switchgear (M/C) or D/G related facilities, which were flooded.

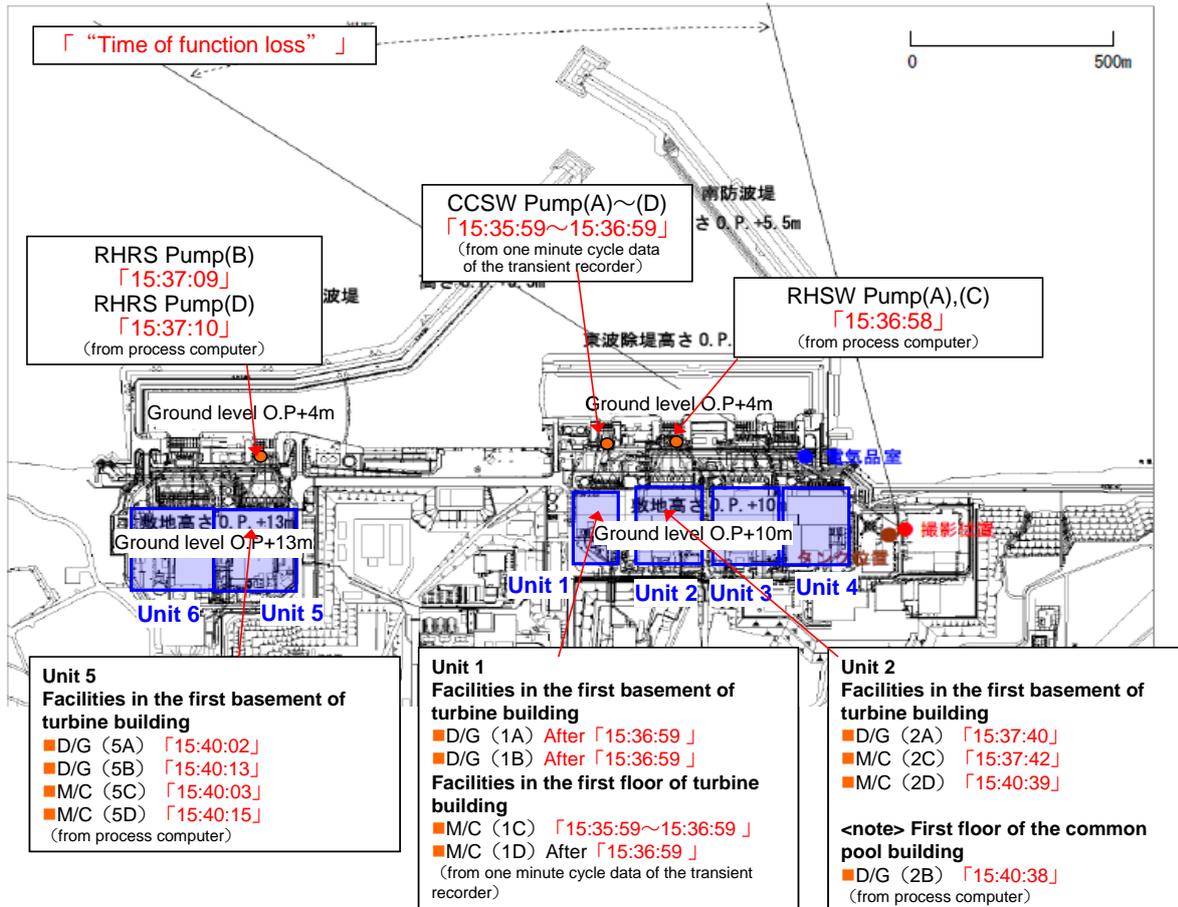
Seawater pumps closest to the sea (installed on the 4-m ground level) lost their function mostly at the 15:36 level, which is thought to be due to the arrival of tsunami second wave at the site.

In other main buildings, the timing of function loss varied depending on the installed locations, but the emergency bus function was lost mostly at around 15:40 caused by tsunami, resulting in the loss of all AC power supplies.

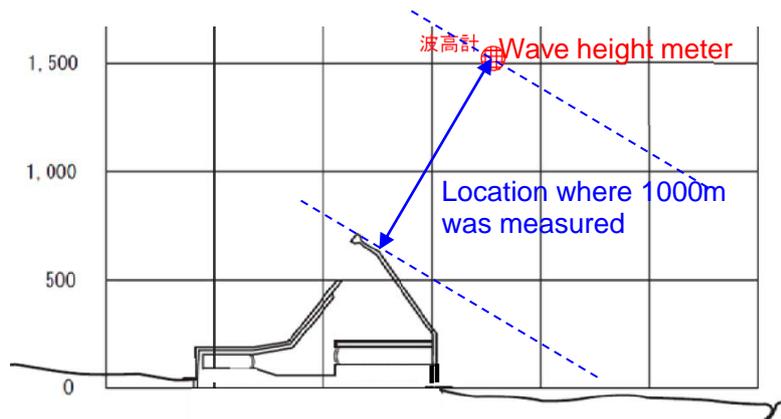
In this current examination, the distance was set as 1,000 m from the wave height meter to the southern breakwater flexion.

The positional relation for setting 1,000 m is seen below, which means that the tsunami wave-front shown by the broken line is assumed to be perpendicular to the two-way arrow).

The distance from the wave height meter to the tip of the southern breakwater was about 1000m.

This distance was set slightly longer, i.e., there was a slightly longer time for propagation in this estimation. This is further explained in [Appendix 3].
