Arrival times of tsunami at the Fukushima Daiichi Nuclear Power Station site

1. Overview

The following analyses and evaluations were newly done in order to provide the exact timings of the tsunami wave arrivals at the Fukushima Daiichi Nuclear Power Station site.

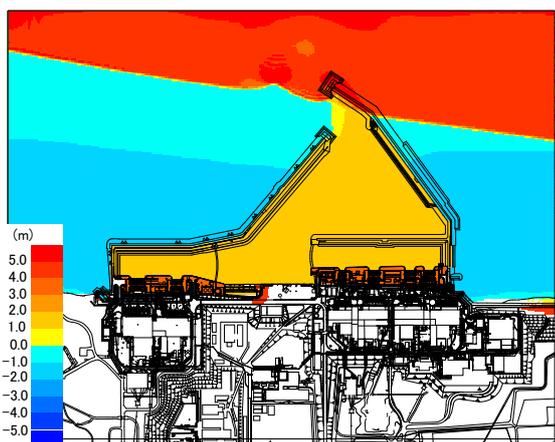
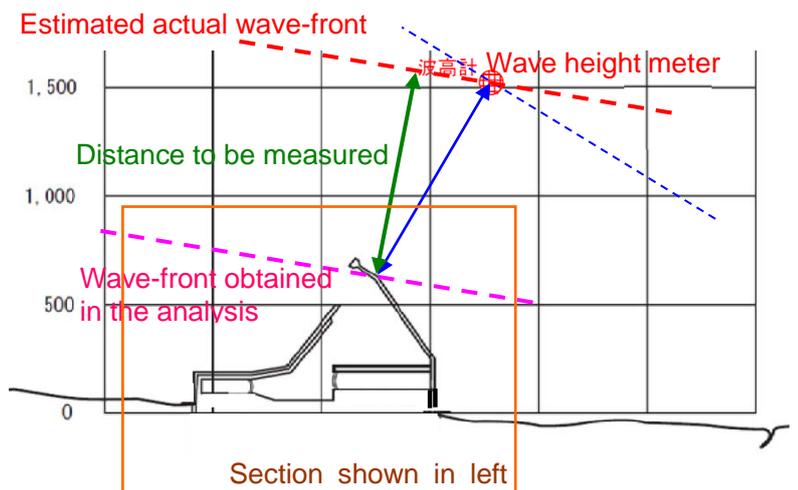
Analytical result (bird's eye view)

The wave-front obtained by a simulation for tsunami reproduction has the angles shown in the figure below.

In the simulation, wave forms and the arrival timing cannot be precisely reproduced, but the direction of the simulated wave-front can be considered to be close to the real one, because the wave-front is controlled by the seabed topography.

From this consideration, the distance of 1,000 m is considered to be longer than the real propagation distance of the tsunami, and, therefore, leads to estimation of a longer propagation time.
