Fukushima Daiichi Nuclear Power Station Unit 2 Primary Containment Vessel Internal Investigation Results (Preliminary Report)

February 13, 2019

Tokyo Electric Power Company Holdings, Inc.

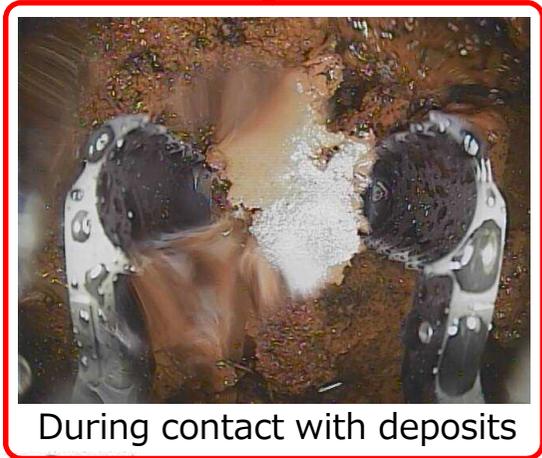
2. Investigation results (Preliminary report) (1/3)

- We succeeded in touching deposits at the bottom of the pedestal in the PCV for the first time.
- During this investigation the investigation unit was brought in contact with deposits at six locations at the bottom of the pedestal. The deposits (pebble-like deposits, etc.) at five locations moved.
- The investigation unit was also brought in contact with deposits on top of the platform.
- Furthermore, images, dose and temperature data were obtained from locations closer to the deposits than during prior investigations. The obtained images and dose/temperature data will now be analyzed.
- The investigation was completed with workers subjected to exposure doses within planned dose limits.
- There were no significant fluctuations in monitoring post or dust monitor readings neither prior to, nor after, the investigation, and there was no radiological impact on the surrounding environment.
