Fukushima Daiichi Nuclear Power Station Unit 2 Primary Containment Vessel Internal Investigation Results

February 28, 2019

Tokyo Electric Power Company Holdings, Inc.

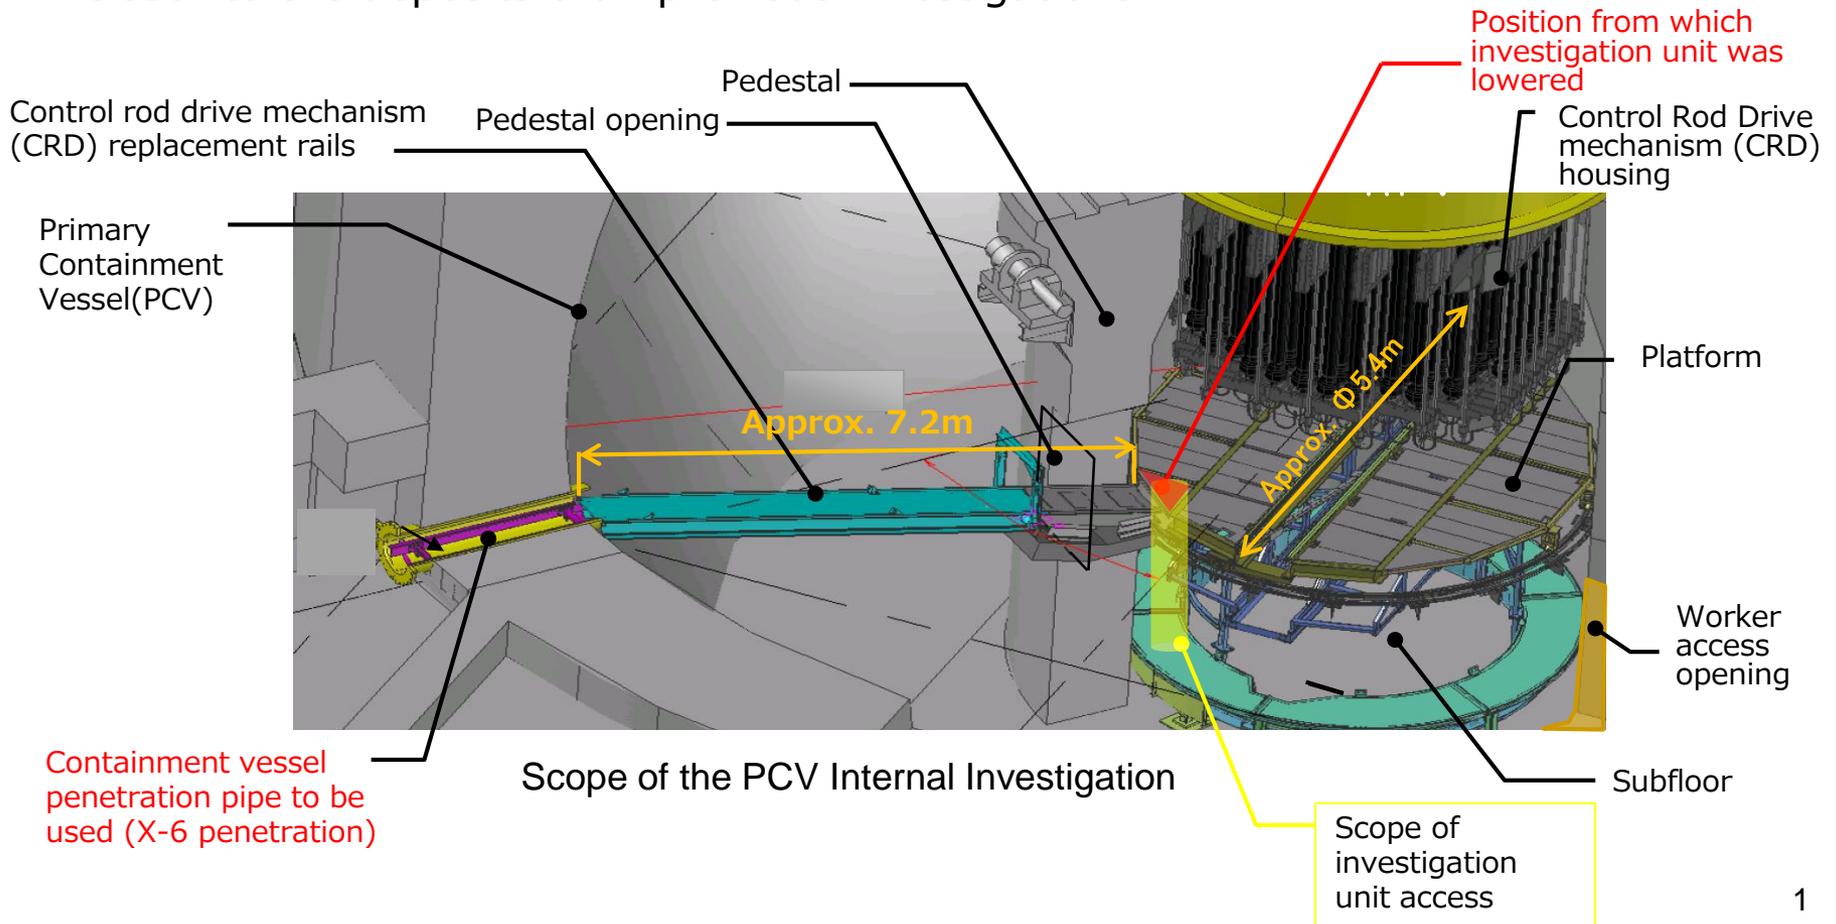
- The investigation unit was lowered from the same location as the previous investigation (January 2018) to investigate the primary containment vessel (PCV).
- During this investigation we purposely let the investigation unit come in contact with the deposits at the bottom to observe the behavior of said deposits. Video images, and dose and temperature readings were also obtained from locations closer to the deposits than previous investigations.

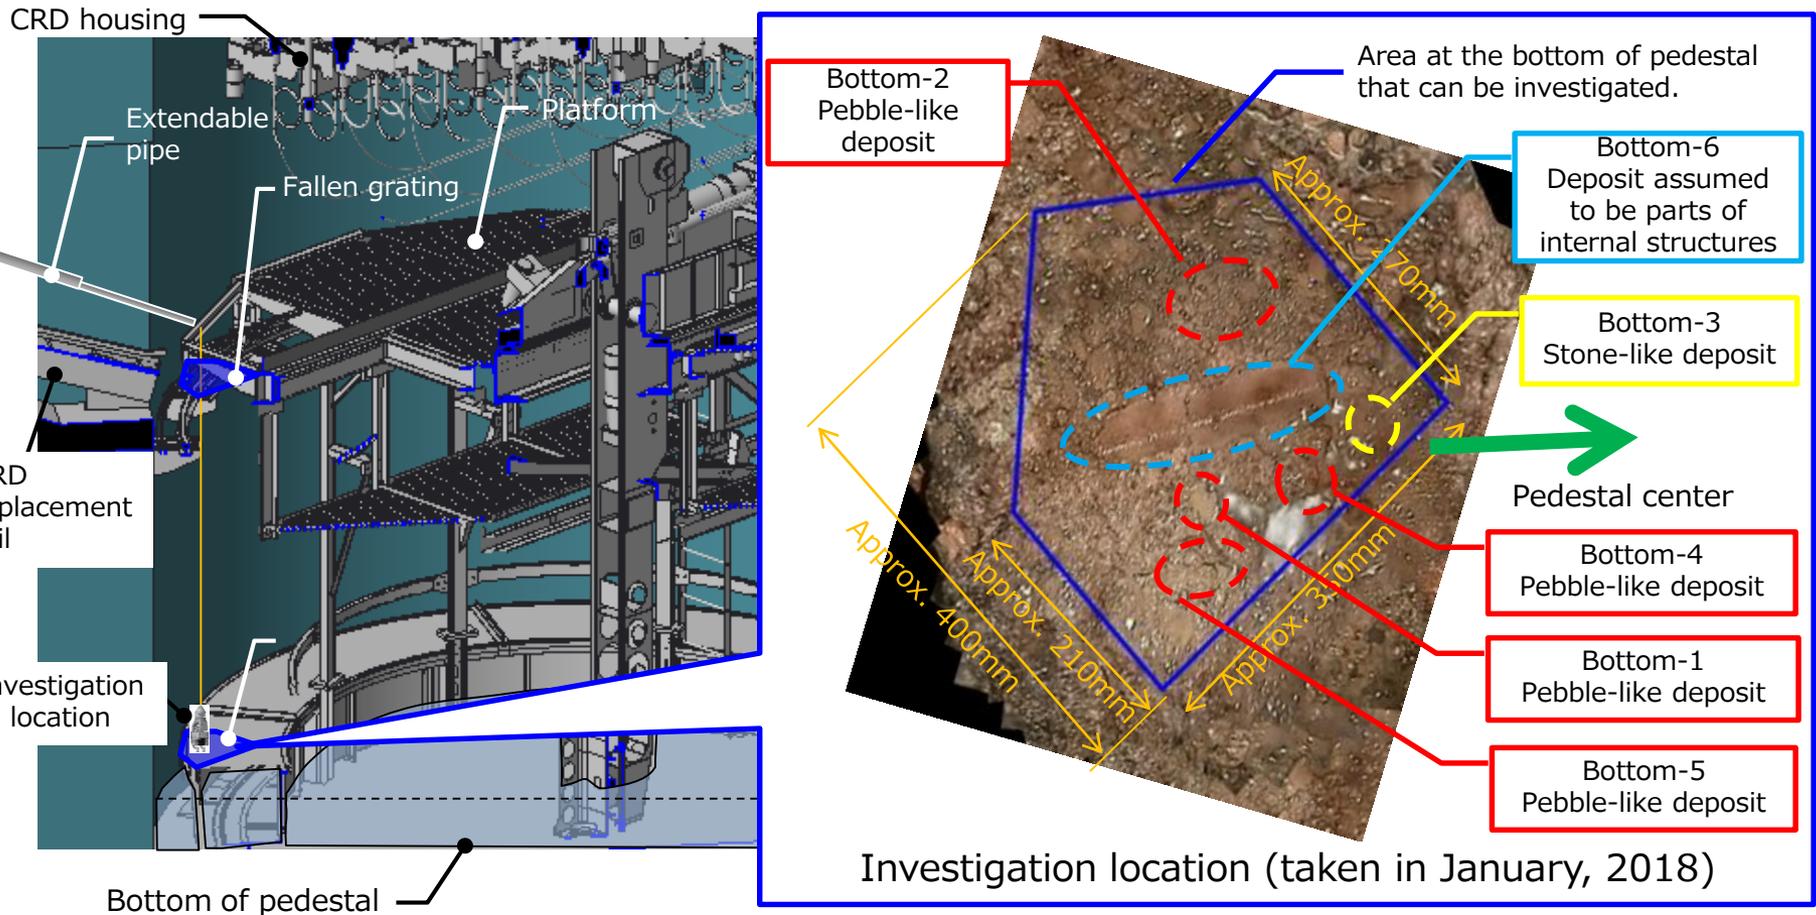
2. Contact locations during the investigation (1/2)

- We classified deposits touched during this investigation into the following three groups to summarize the results: ①Pebble-like^{※1} deposits ②Stone-like^{※1} deposits ③Deposits assumed to be parts of internal structures

※1 We defined "pebble-like" as having apparently a clear shape and "stone-like" as not having such a shape.

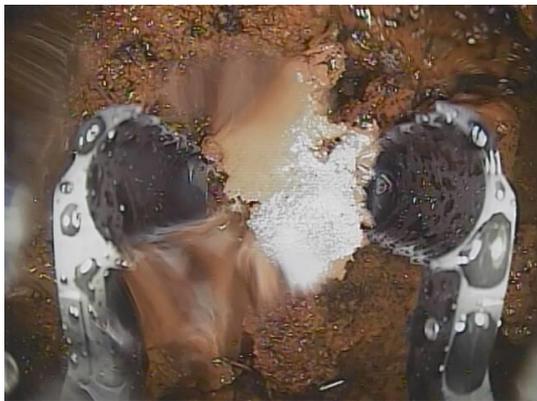
Conditions at the bottom-1

- It was found that pebble-like deposits can be moved.

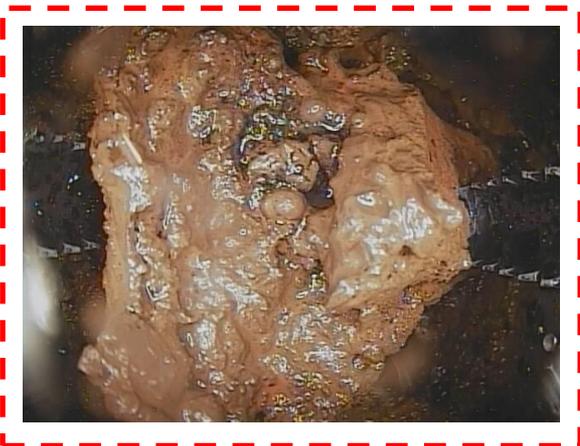
Conditions at the bottom-5

- It was found that pebble-like and structure-shaped deposits can be moved.

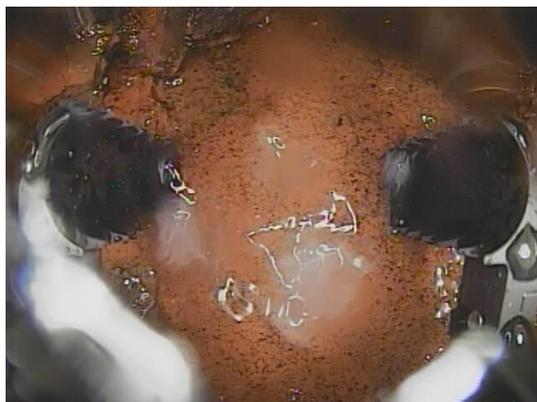
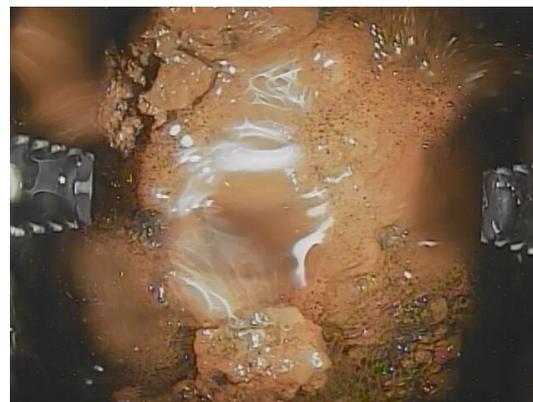
- It was found that the stone-like deposit did not move. And, the video showed no contact marks left on the deposit.

While grasping deposit

After grasping deposit

- ✓ Grasping with finger (left)
- ✓ Investigation unit was hoisted while it grasped the deposit, but it did not move (right).

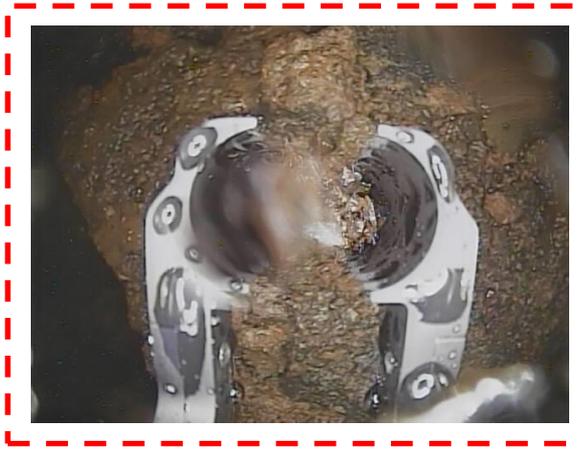
Conditions at the top of platform-1

- It was found that pebble-like and structure-shaped deposits can be moved.

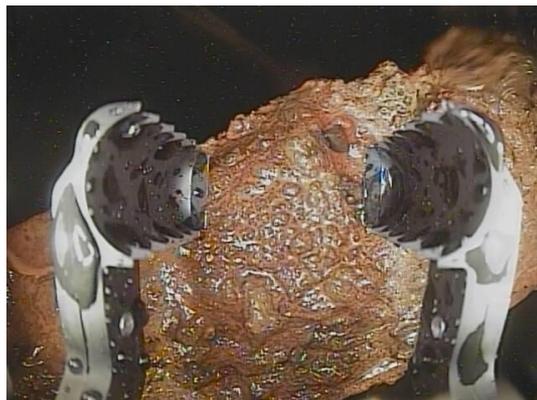
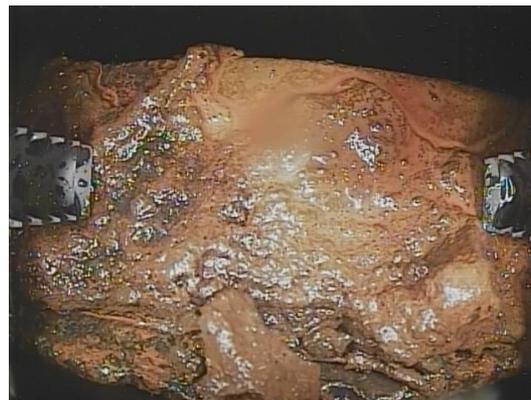
- It was found that the stone-like deposit did not move. And, the video showed no contact marks left on the deposit.

While grasping deposit

After grasping deposit

- ✓ Grasping with finger (left)
- ✓ Investigation unit was hoisted while it grasped the deposit, but it did not move (right).

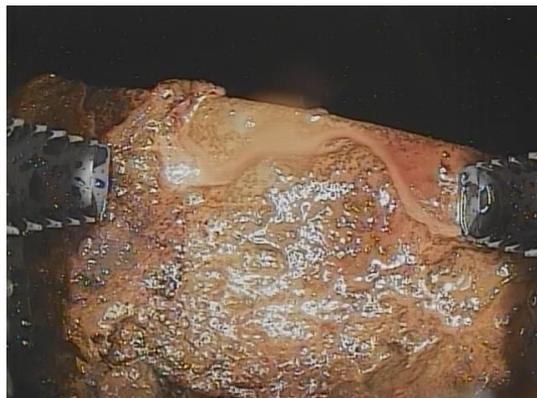
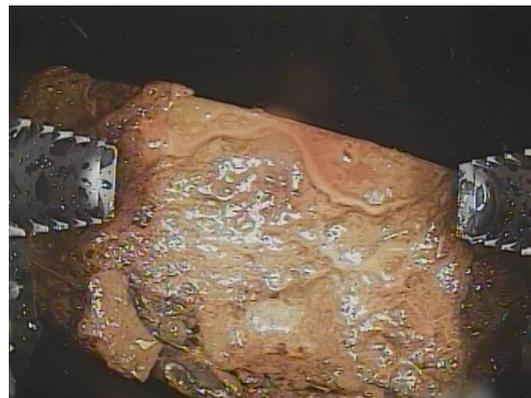
- It was found that stone-like deposit did not move. And, the video showed no contact marks left on the deposit.

While grasping deposit

After grasping deposit

- ✓ Grasping with finger (left)
- ✓ Investigation unit was hoisted while it grasped the deposit, but it did not move (right).

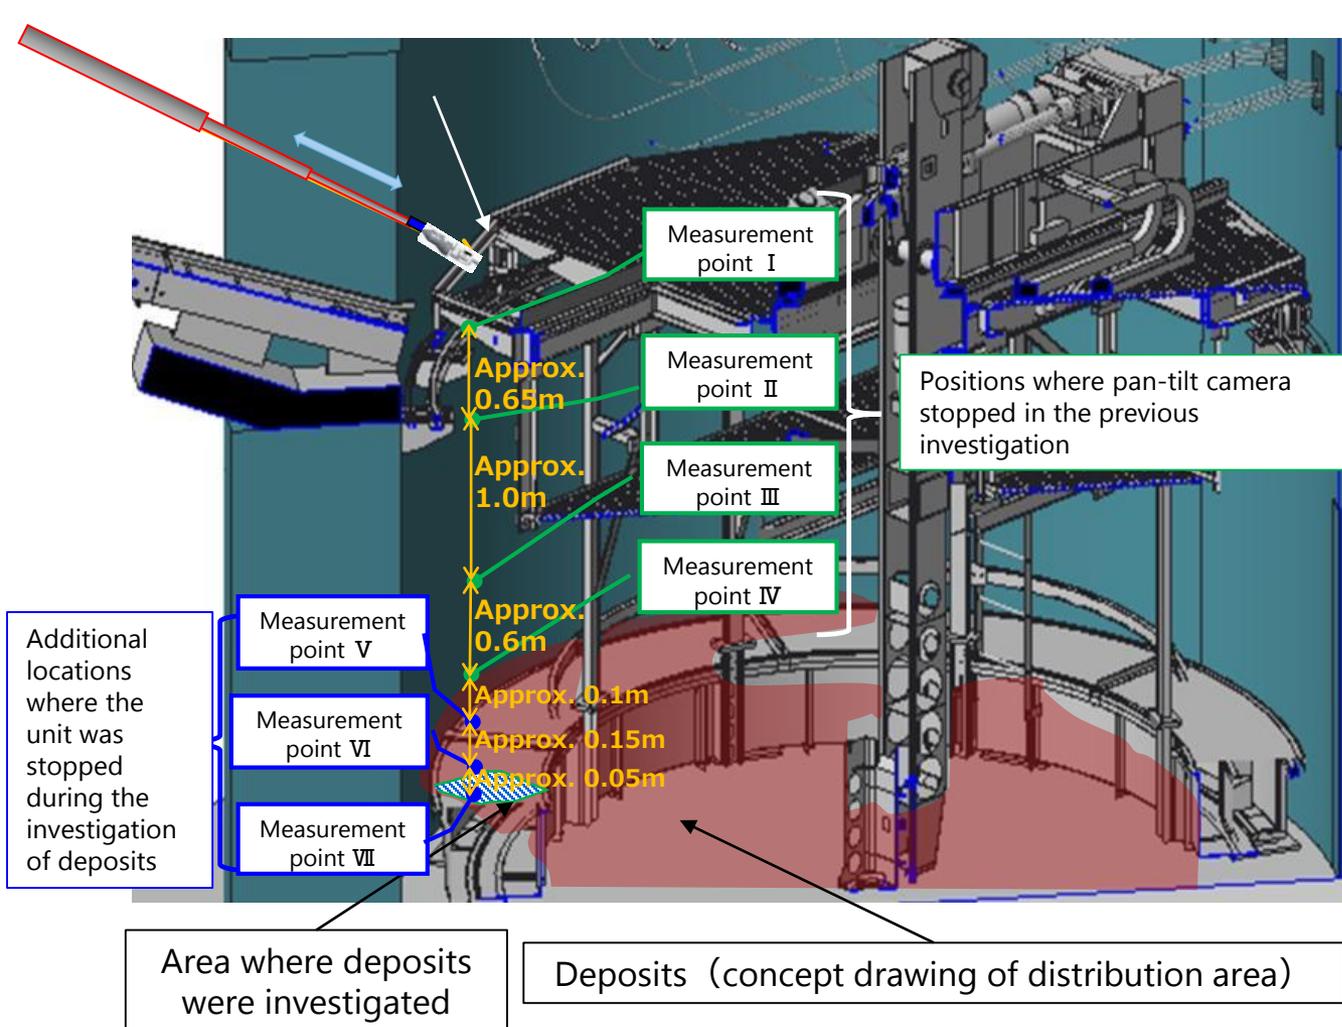
4. Measured dose and temperature

- Temperature was approximately constant regardless of measurement height.
- Dose inside the pedestal tended to increase as we approached the bottom of pedestal.

Measurement point	Dose rate ^{※1,2} [Gy/h]	Temp. ^{※2} [°C]
I	6.4	23.2
II	6.8	23.1
III	6.5	23.1
IV	7.0	22.9
V	7.2	22.8
VI	7.5	22.9
VII	7.6	22.9

【Reference : Outside the pedestal^{※3}】
 Dose rate : Max. 43[Gy/h]
 Temp. : Max. 23.7[°C]

- ✓ We confirmed for the first time that dose levels tend to increase as we approached the bottom of the PCV inside the pedestal. And, as observed during the previous investigation, it was confirmed that dose levels inside the pedestal tend to be lower than outside the pedestal, and that temperature is approximately constant regardless of measurement height.

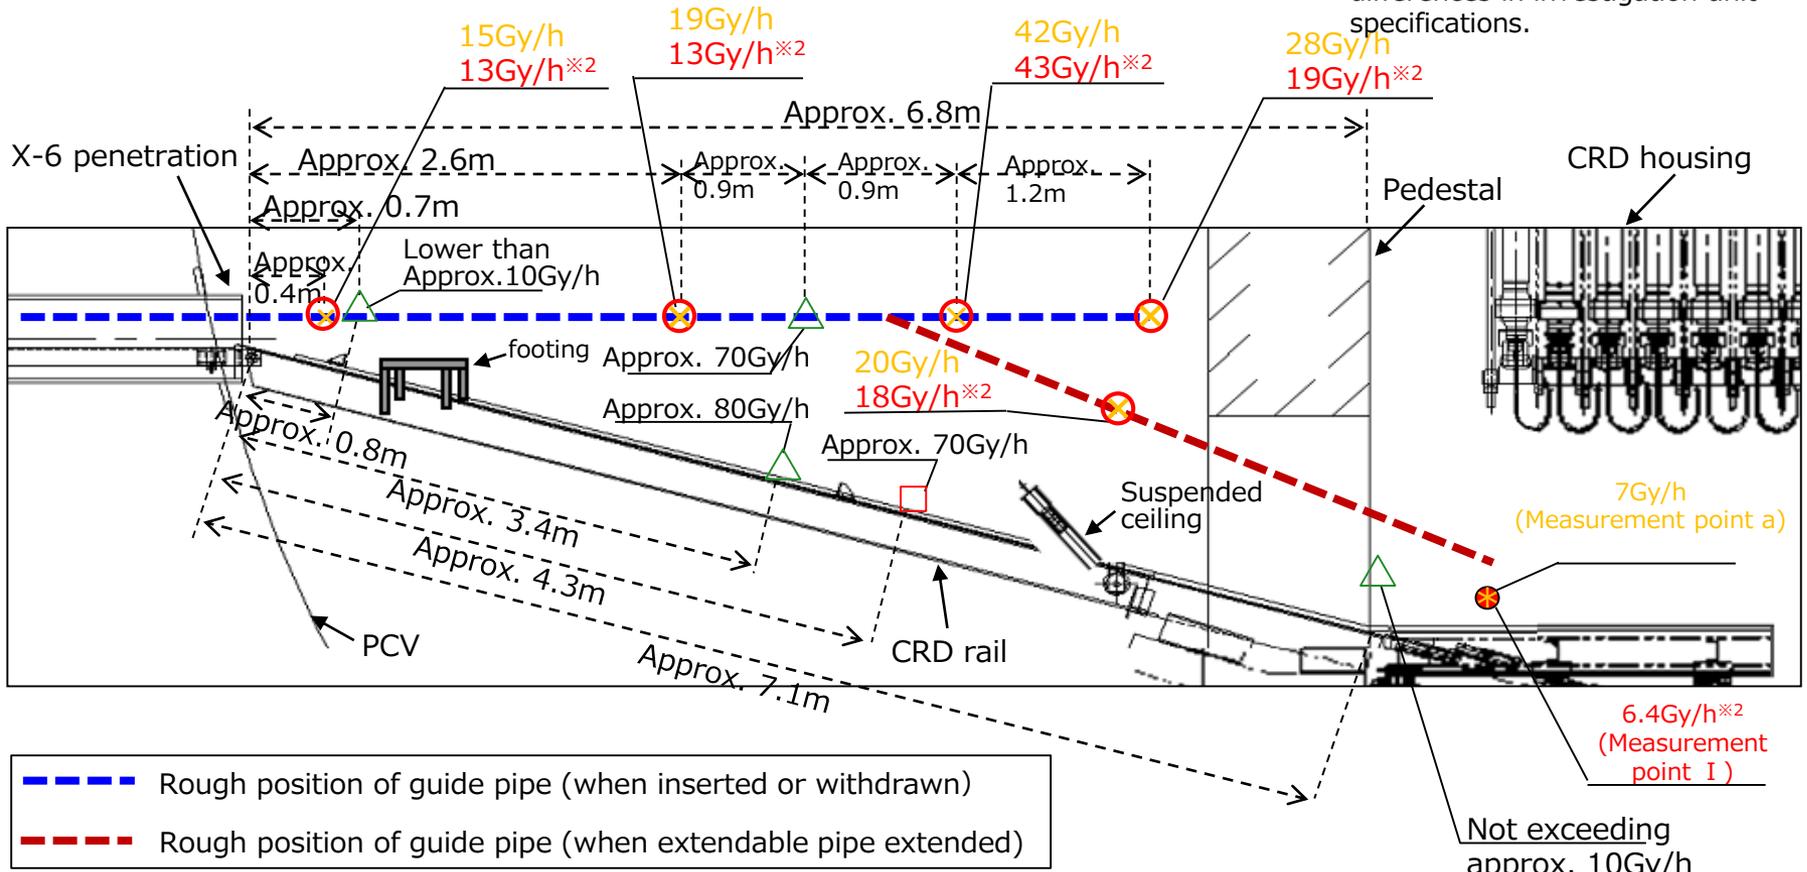
Reference: Measurement points of reference dose rate

- Measured during this investigation
- Measured for reference during this investigation^{※1}
- * Measured in January, 2018 ✕ Measured for reference in January, 2018^{※1}
- △ Measured in 2017 (estimated from noise of camera image)
- Measured in 2017 (calculated by integral dosimeter)

※1 : Reference value because measurement equipment is housed inside the investigation unit
 ※2 : Measurement points used during this investigation are not all the same as the previous investigation because of the differences in investigation unit specifications.

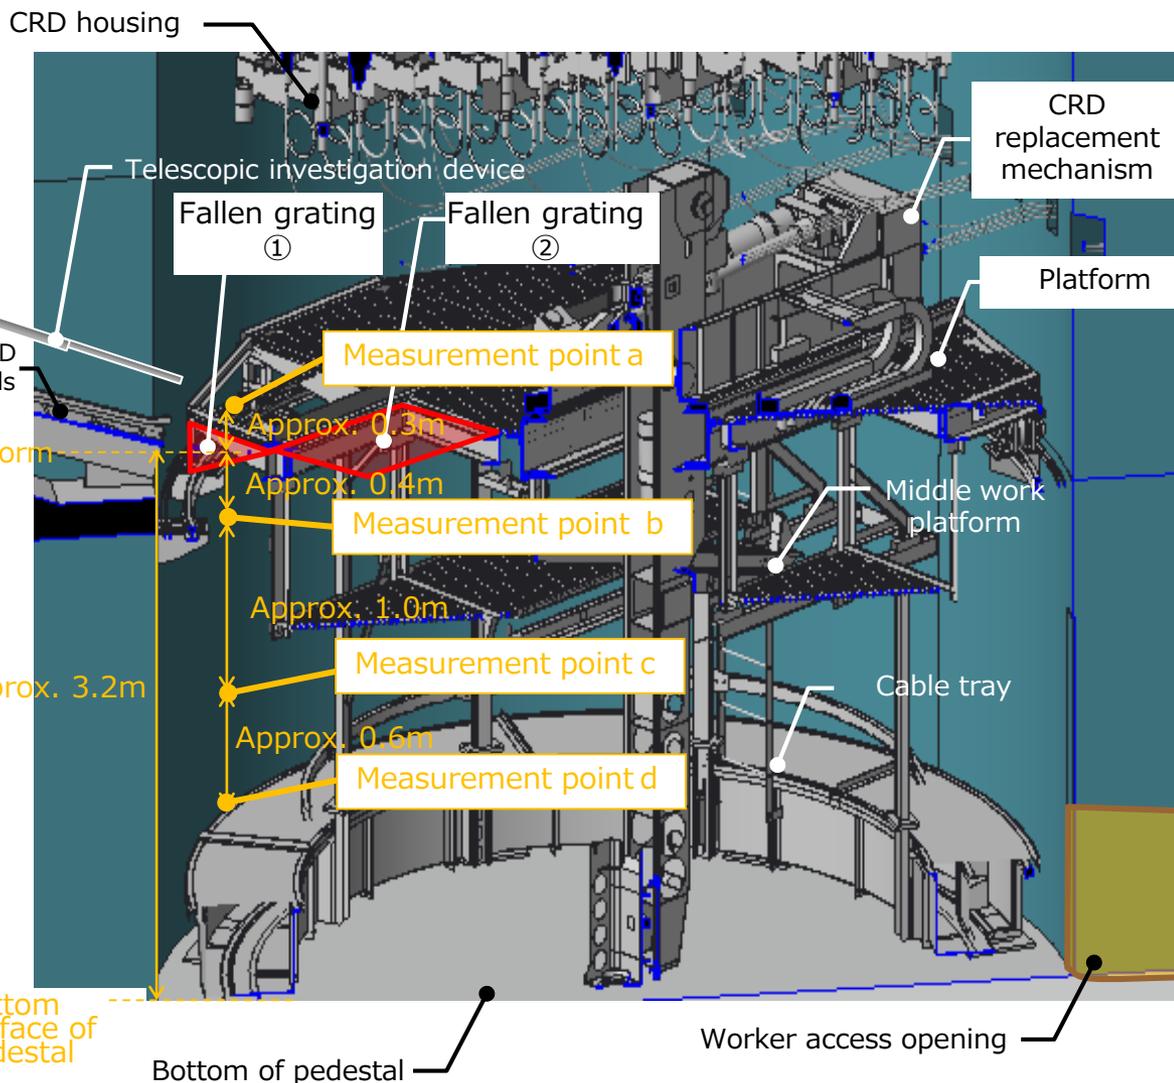
Reference: Previous investigation results (January, 2018)

Measurement point	Dose rate ^{※1,2} [Gy/h]	Temp. ^{※2} [°C]
a	7	21.0
b	8	21.0
c	8	21.0
d	8	21.0

【Reference : Outside the pedestal^{※3}】
 Dose rate : Max. 42[Gy/h]
 Temp. : Max. 21.1[°C]
