# Regarding the integrity of the spent fuel pool at unit4

July.24.2012

TEPCO Nuclear power & Plant siting division

## Regarding the integrity of the spent fuel pool at unit4

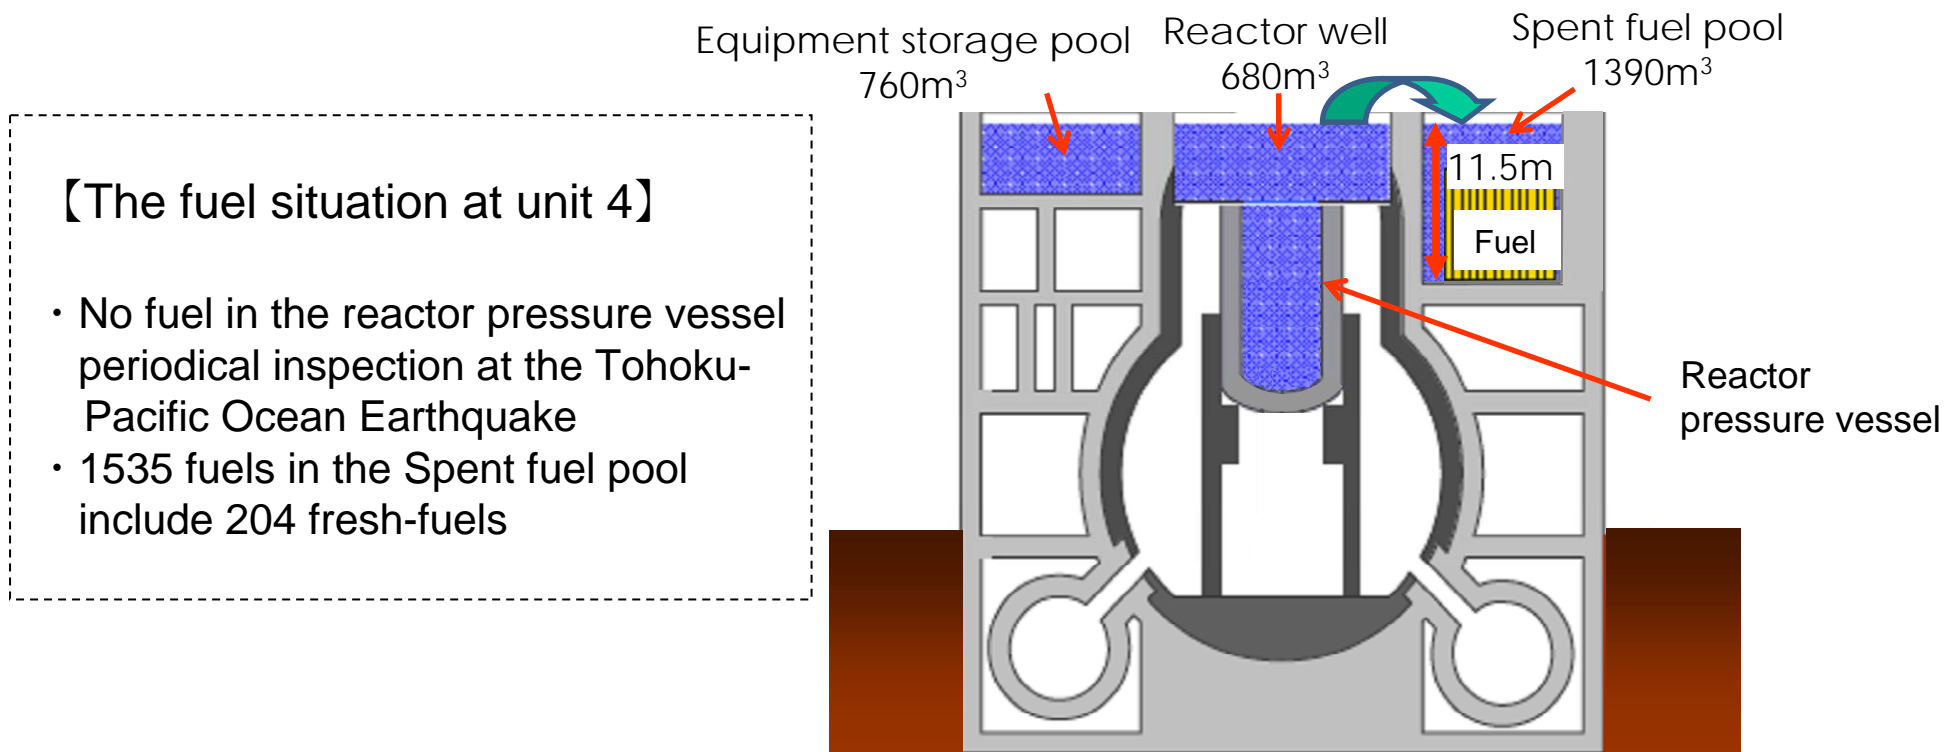
# (1) The spent fuel pool at unit4

- On and after Mar. 17, 2011, each unit including unit4 was supplied with water using a water-cannon vehicle, a fire engine, a concrete pump vehicle, etc..
- Since unit4 especially had been shutdown for outage, the reactor well water level was full. It is presumed that the reactor well water flowed into the spent fuel pool as a result of the lowered water level in the spent fuel pool, and that the fuel in the pool was not exposed and was not damaged according to the decay heat evaluation etc..

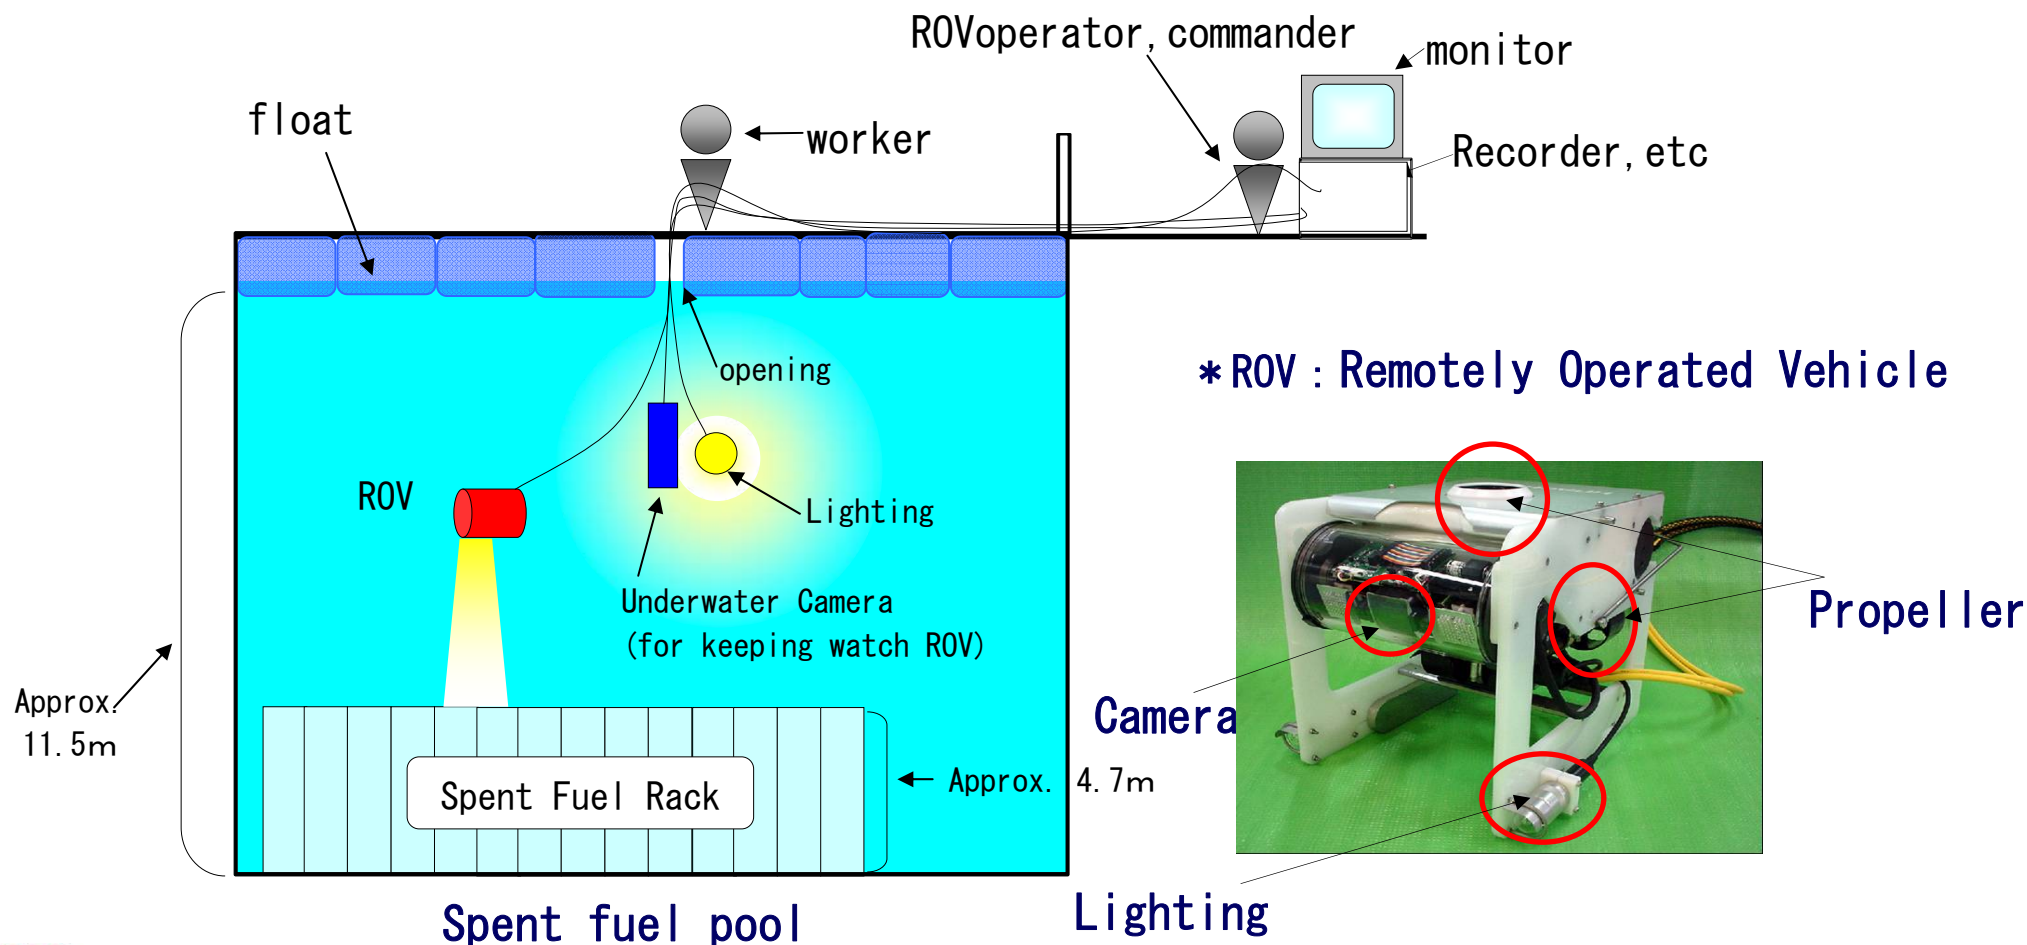
### (3) The outline of the investigation

From Mar. 19 to 21, in order to develop a plan to remove the fuels from the spent fuel pool, we investigated the rubble distribution inside the pool using an ROV.

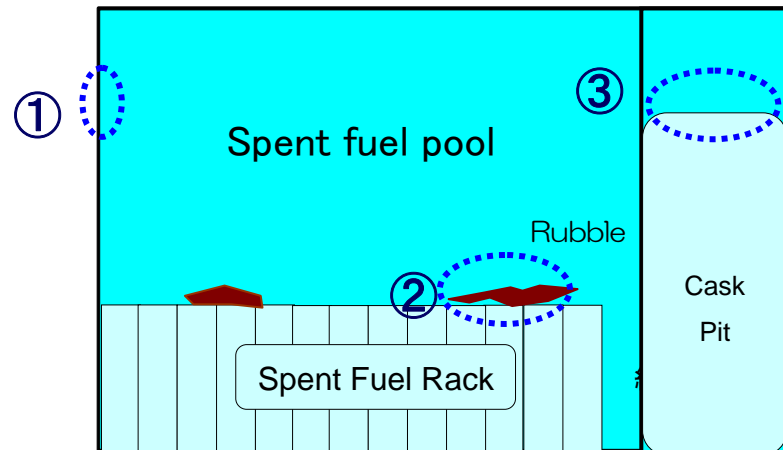
③ Cask Pit Inside

- The investigation of the rubble distribution conditions inside the spent fuel pool was performed.
- The results showed that no abnormalities of fuel racks were recognized.

It was estimated that the majority of fuel in the pool was sound, because the low level concentration of radioactive material was confirmed and no abnormalities of fuel racks were recognized.

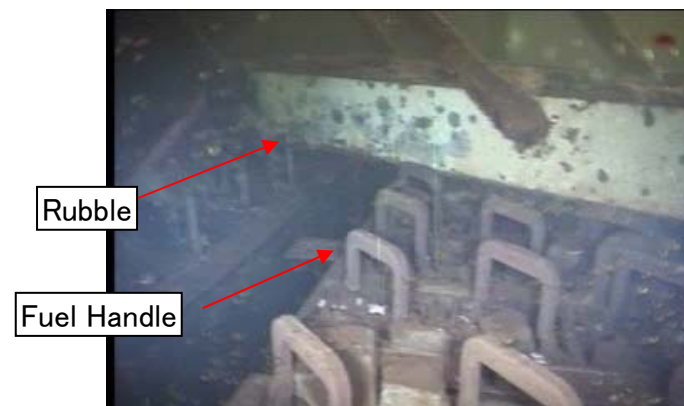
② Rubble and Upper Part of Spent Fuels

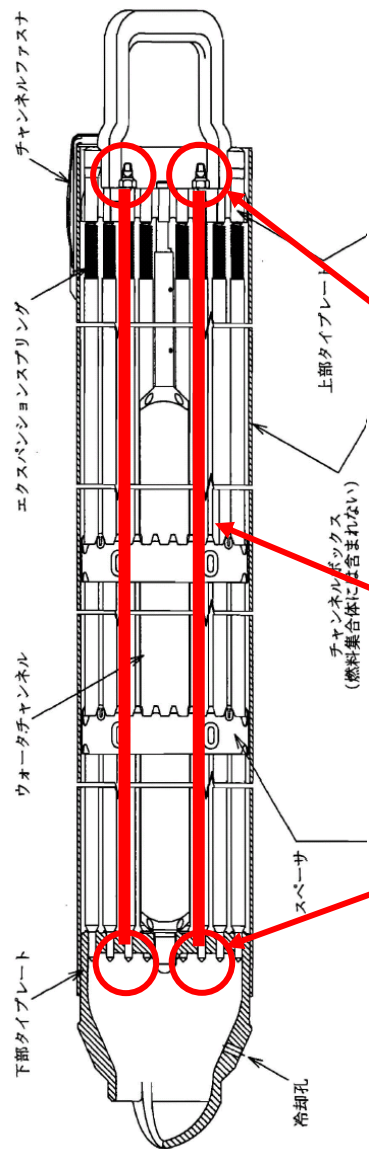
- According to the knowledge so far accumulated, it is presumed that the structural member of the fuel is free from corrosion.
- Feasibility study of fuel removal will be performed just in case by investigating corrosion condition.

Connecting fuel rods / rock not  
(Zircaloy-2 / stainless steel  
=the connecting area of different kinds of metal)

Connecting fuel rods (Zircaloy-2)  
(2 rods on one side, Total 8 rods)

Connecting fuel rods is connected with lower tie plate by screwing  
(Zircaloy-2 / stainless steel  
=the connecting area of different kinds of metal)

- Upper tie plate and lower tie plate are connected by 8 connecting fuel rods.
- Fuel rods without 8 connecting fuel rods are not connected upper tie plate and lower tie plate. These rods are only loaded on lower tie plate and upper tie plate.

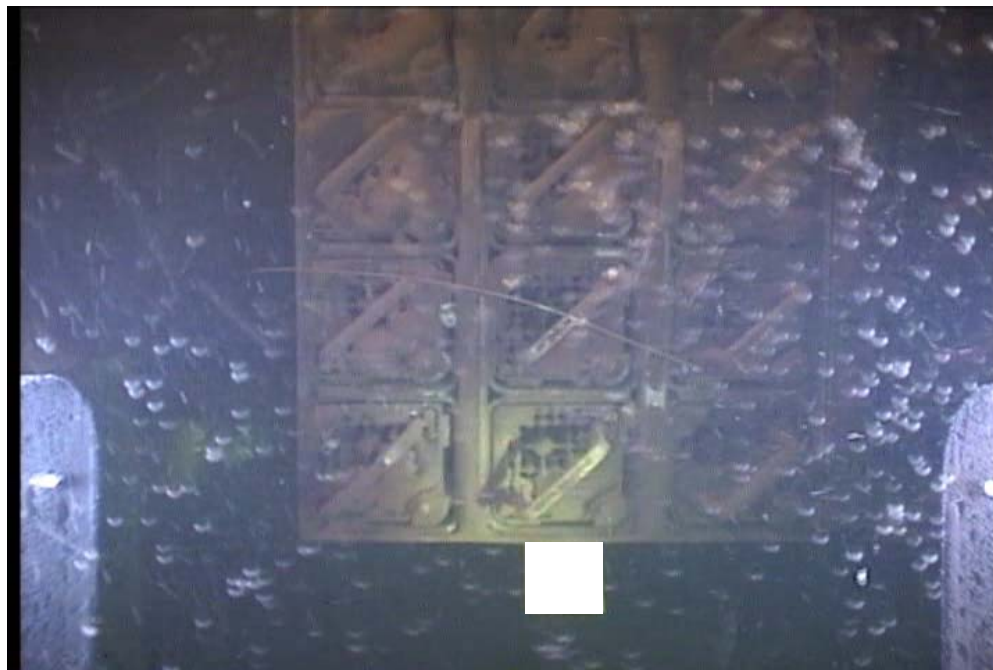
Inside the spent fuel pool  
(photo on Mar.19.2012 )

- According to the result of the investigation inside spent fuel pool in Mar.2012, no abnormalities of the target fuel were recognized.
- Handling fresh fuel outside the pool causes no problem from the viewpoint of radioactivity and residual heat.
- Since the target fresh fuels are displaced from irradiated fuels, dropping fresh fuel causes no problem of radiation exposure.

Type of the removing fuel:  
STEP3 (Type B)
