Investigation result of inside of the Primary Containment Vessel (PCV), 1F-2

January 21, 2012

Tokyo Electric Power Company

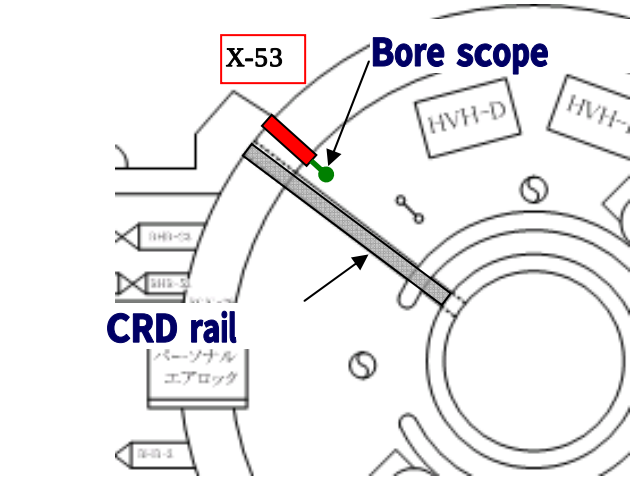
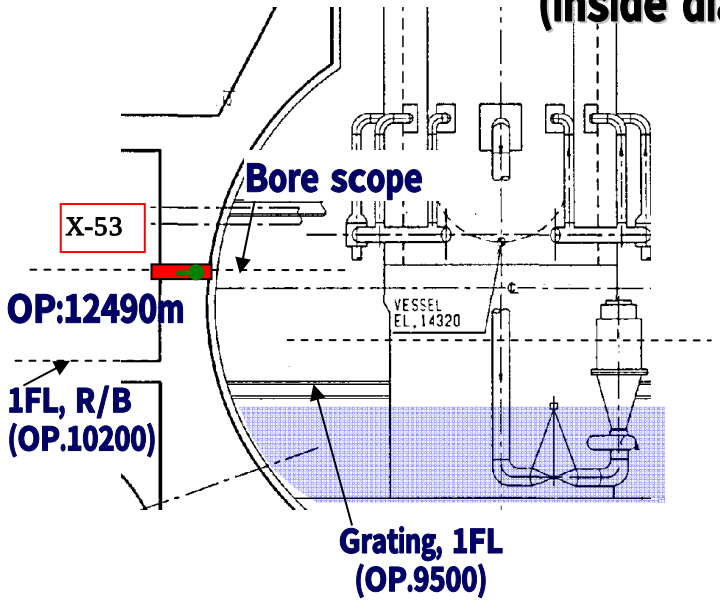
3. Photos inside of PCV, 1F-2①

Inside the guide pipe located in X-53 penetration
(Before the borescope enters the PCV)

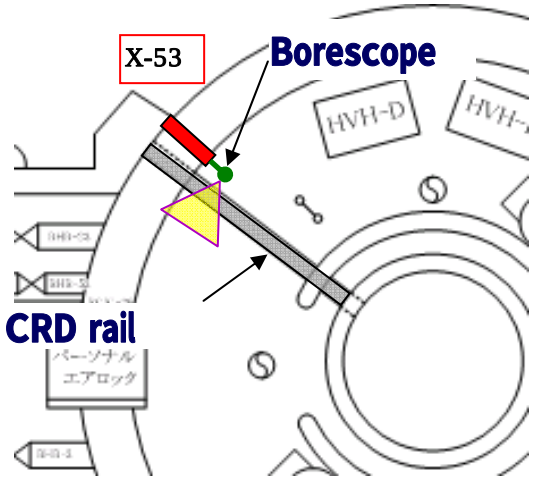
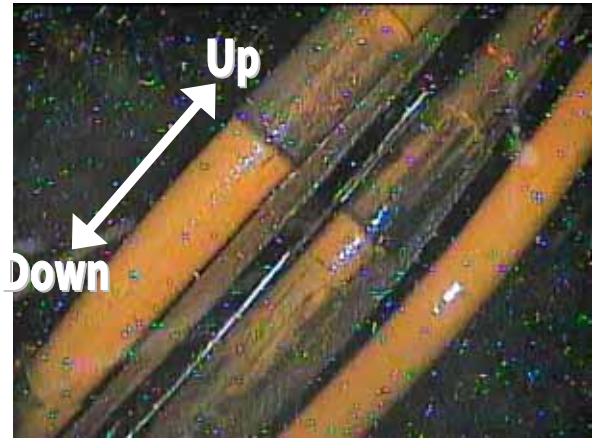
3. Photos inside of PCV, 1F-2②

Structures assumed to be small size piping or cable conduit

Internal wall of PCV

- The visibility was extremely low (tens of cm) as numerous waterdrops were falling from above. We could not take similar quality pictures as Unit 5. We could see the internal wall of the PCV (with reddish brown deposits), part of piping, part of support, part of OP9500 gratings.
- We could not see the water surface in the PCV.
- We assumed that the water level in the PCV was around 9500 ～OP10000. But there was no water at OP9500 gratings (water surface was below).
- The atmospheric temperature in the PCV was around 45 Celsius. We could not check whether the thermo couple reached water (The measured temperature was constantly around 45 Celsius. We could not assess the water level from change of temperature.)
- We could see the internal wall of PCV (with reddish brown deposits) and part of piping etc.

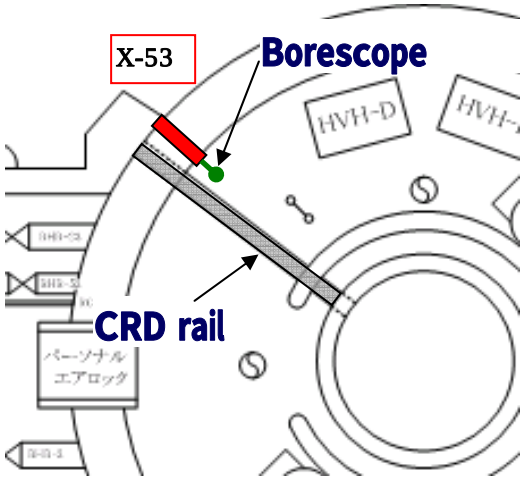
3. Photos inside of PCV, 1F-2③

Around the grating, 1FL, Dry well

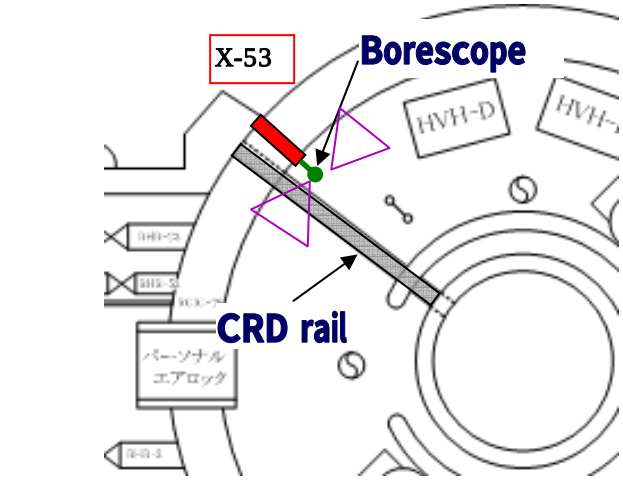
3. Photos inside of PCV, 1F-2④

Structures assumed to be piping

Looking up from X-53 penetration

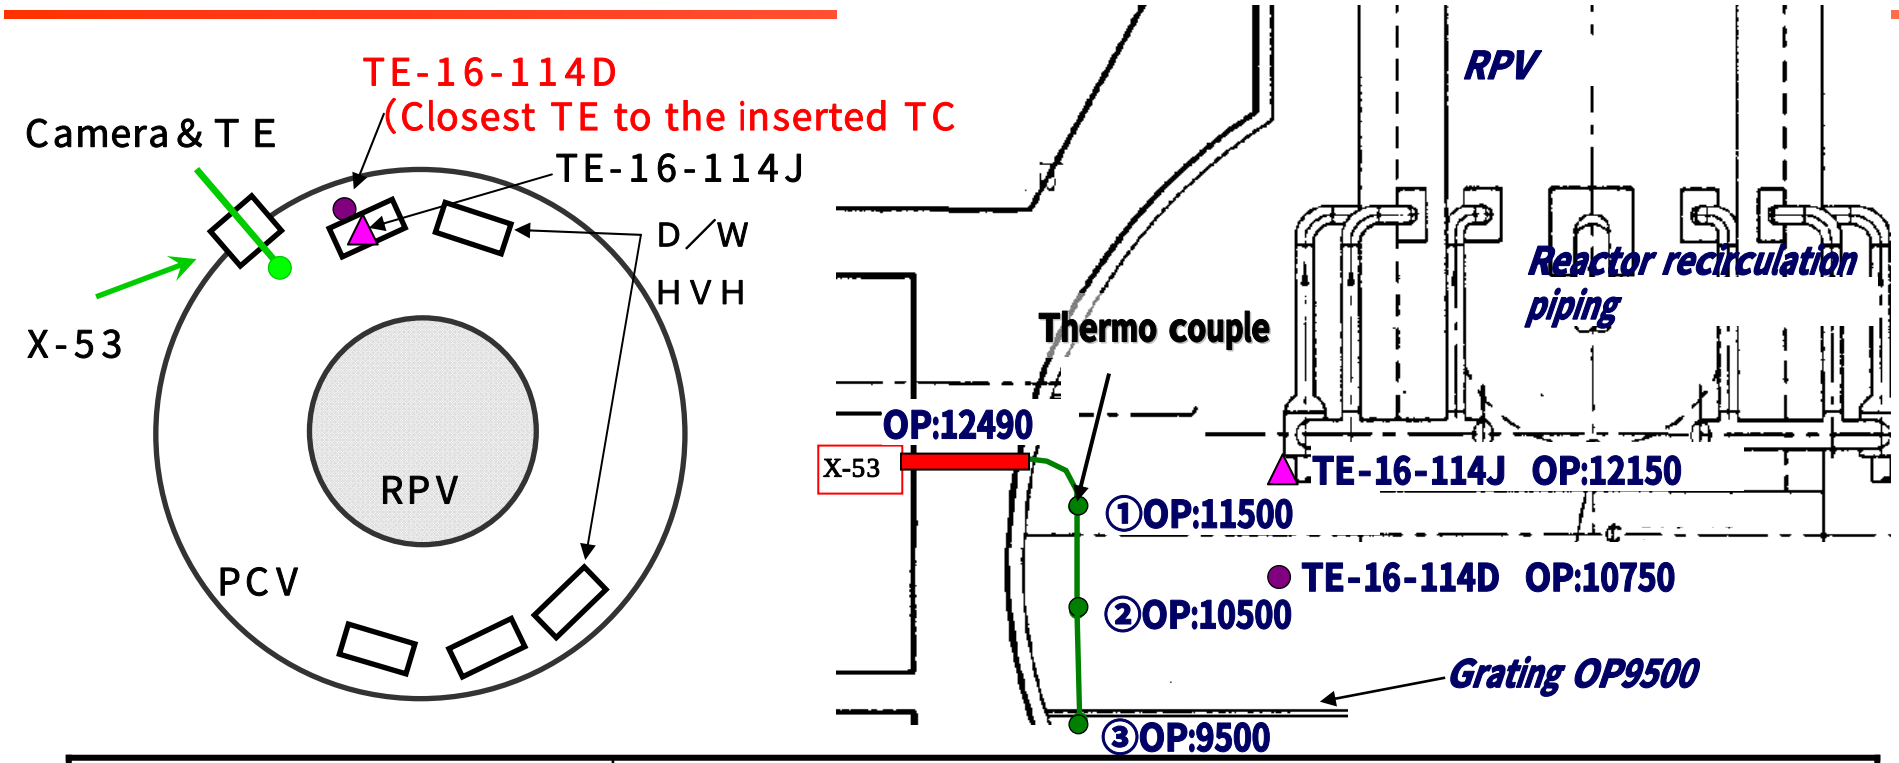
Temperature inside the PCV	Comparison with the main thermometer
① (OP11500) 44.7℃	We observed similar temperature with main thermometers nearby. TE-16-114D (return air D/W HVH cooler： OP10750 (72° direction) 42．6℃ (10:00 AM) TE-16-114J (supply air D/W HVH cooler：OP12150 (73° direction) 45．1℃ (10:00 AM)
② (OP10500) 44.7℃	
③ (OP9500) 45.7℃
