Increases in the Concentration of Radioactive Materials in Seawater and Groundwater on the Ocean Side of the Site: Current Situation and Countermeasures

1. Analysis of Current Situation

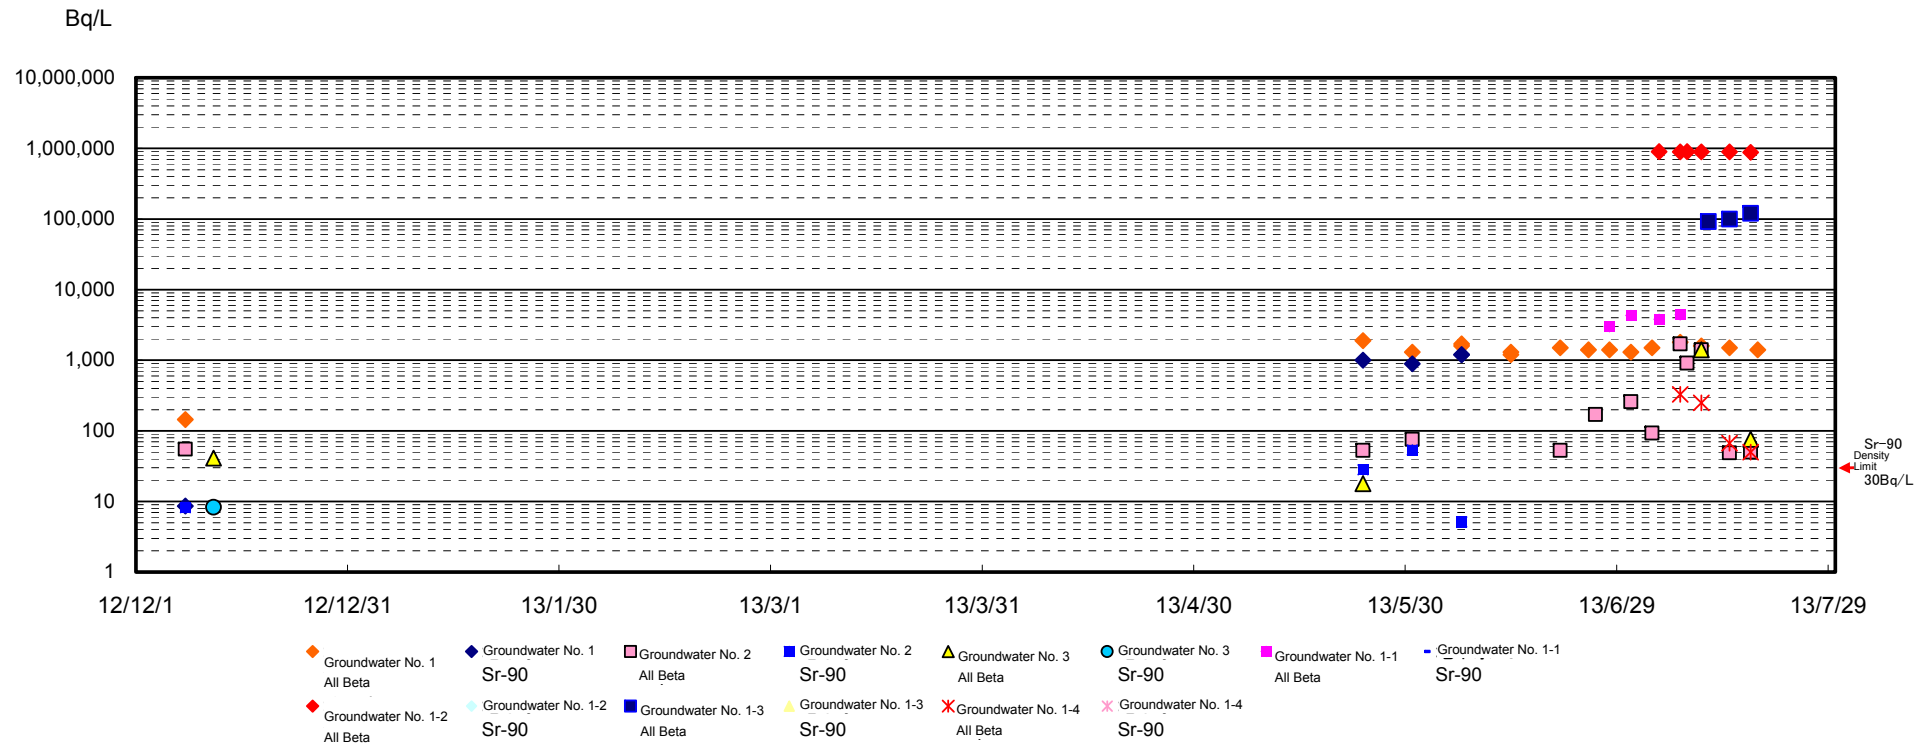
- 400,000 to 500,000Bq/L of tritium and 1,600Bq/L of all beta radiation were detected from the No.1 groundwater observation hole between Unit 1 and 2. **(Reference B)**

Trends in All Beta and Strontium concentrations in Groundwater

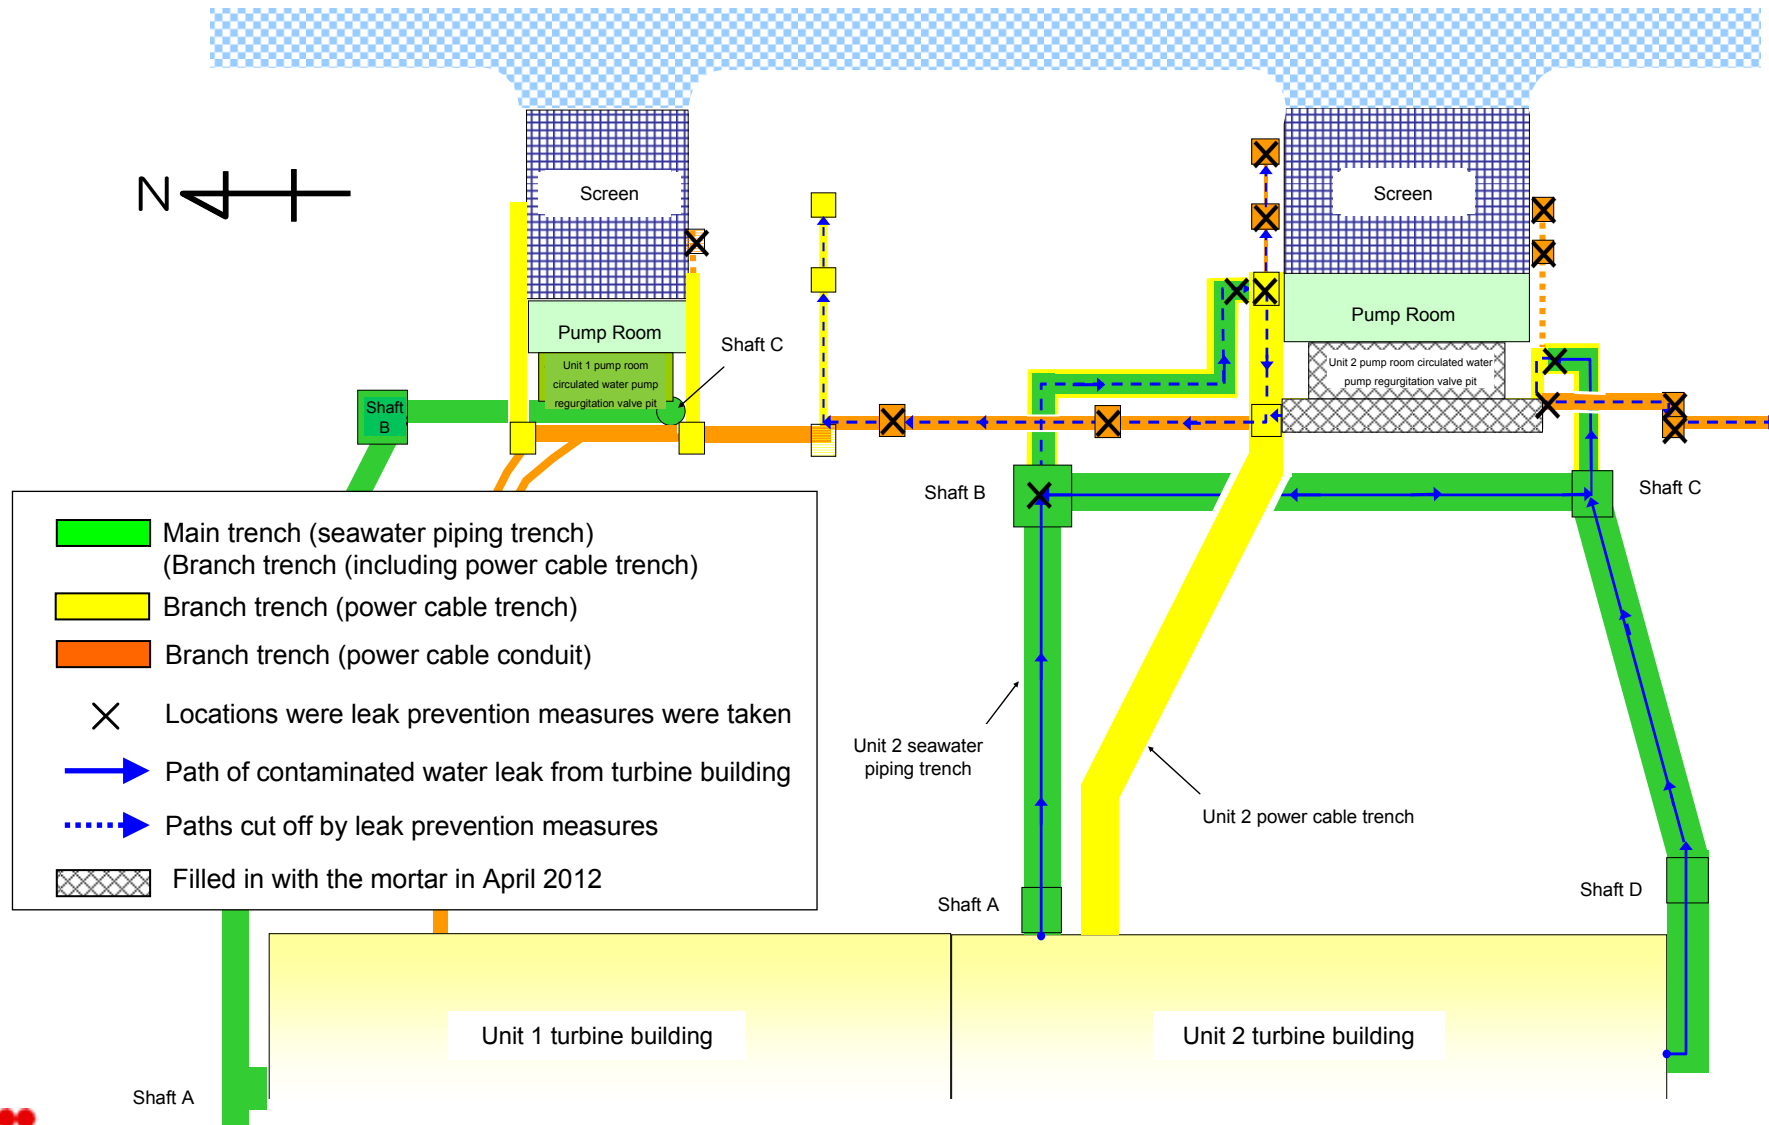
Condition of trenches in area 4m above sea level (Unit 1/2)

- The pits are basically sealed

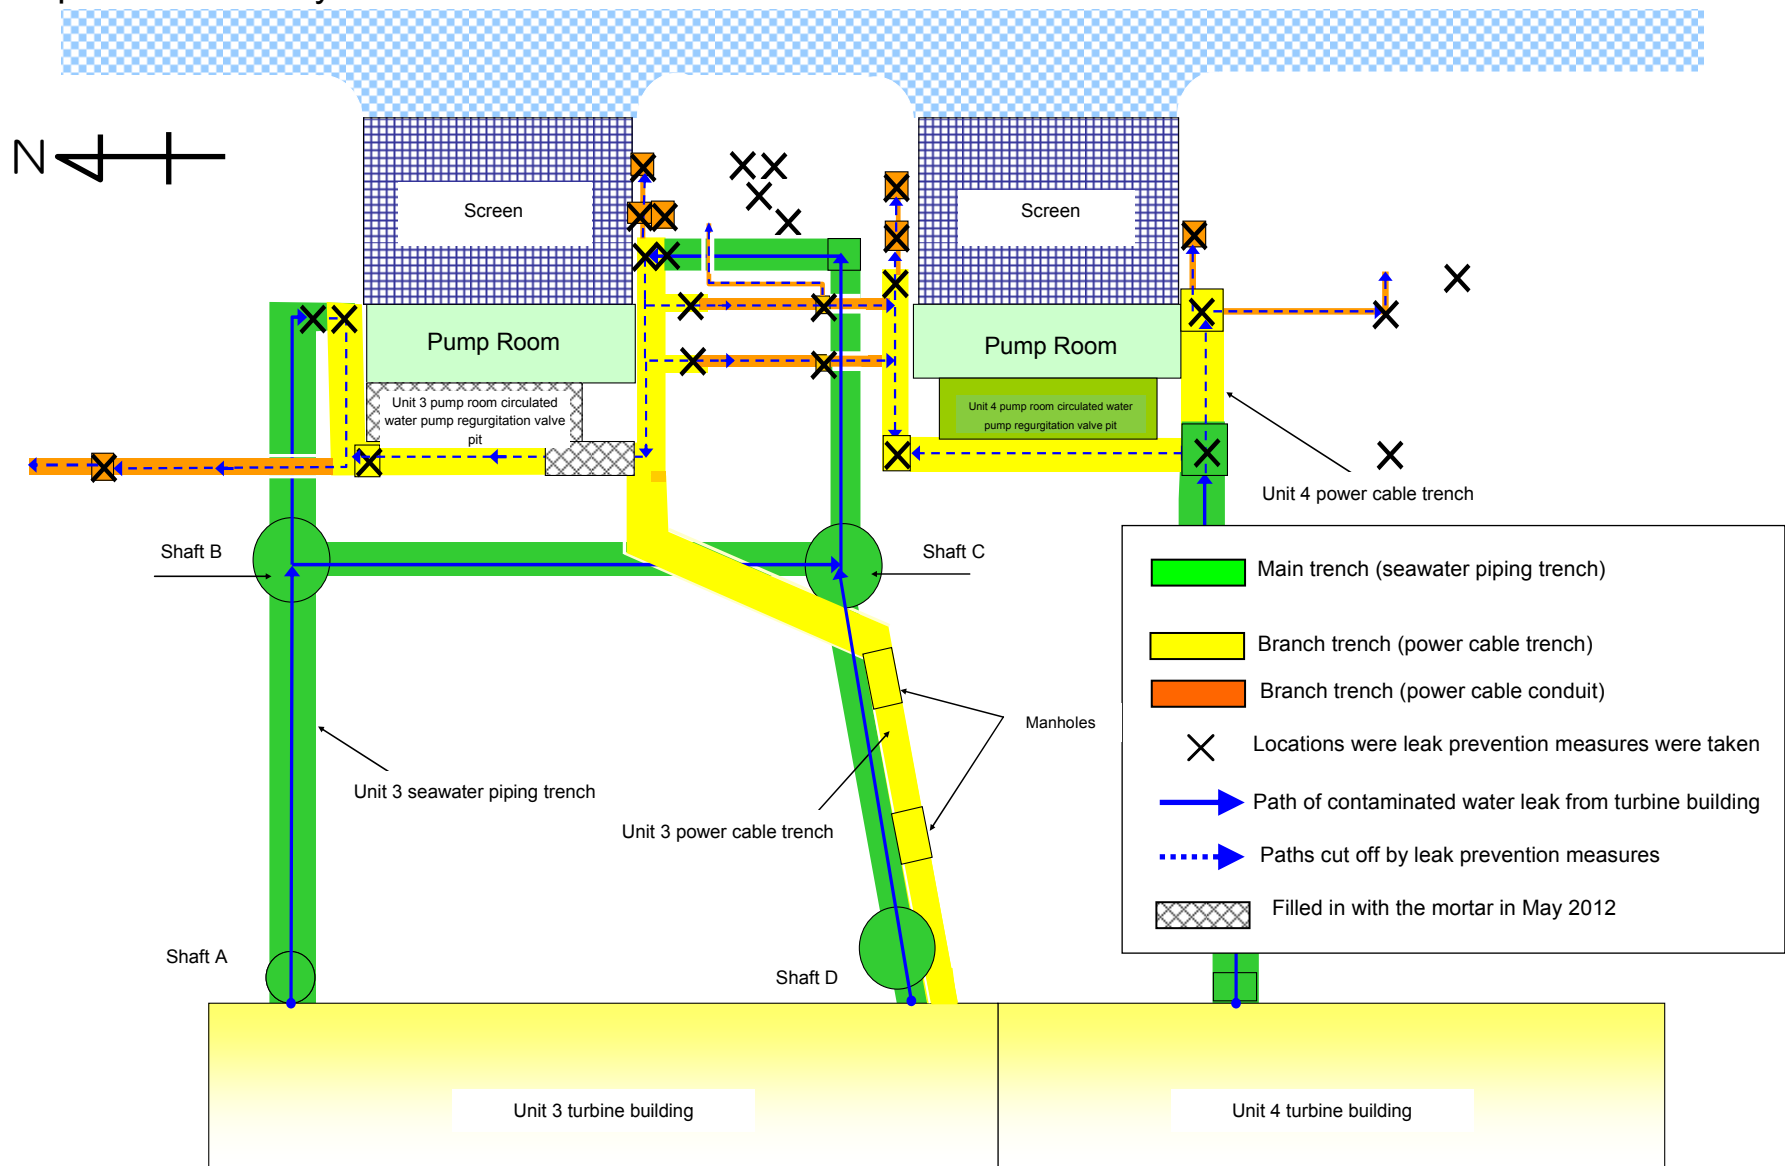
Condition of trenches in area 4m above sea level (Unit 3/4)

■ The pits are basically sealed

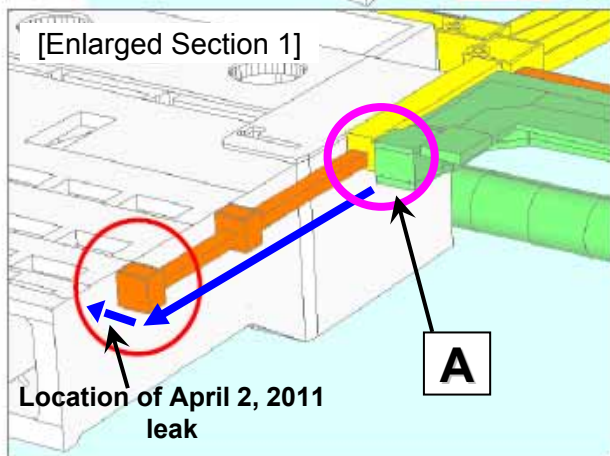
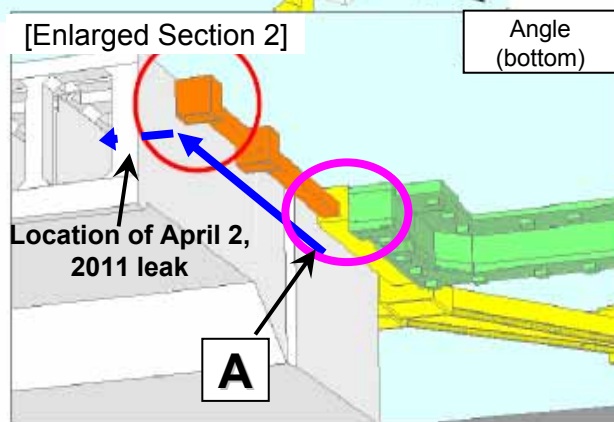
A Cross-section

Leak locations/Estimated leak paths (Unit 2 ocean side trench location diagram)

- Main trench (seawater piping trench)
(some parts include power cable trench)
- Branch trench (power cable trench)
- Branch trench (power cable conduit)

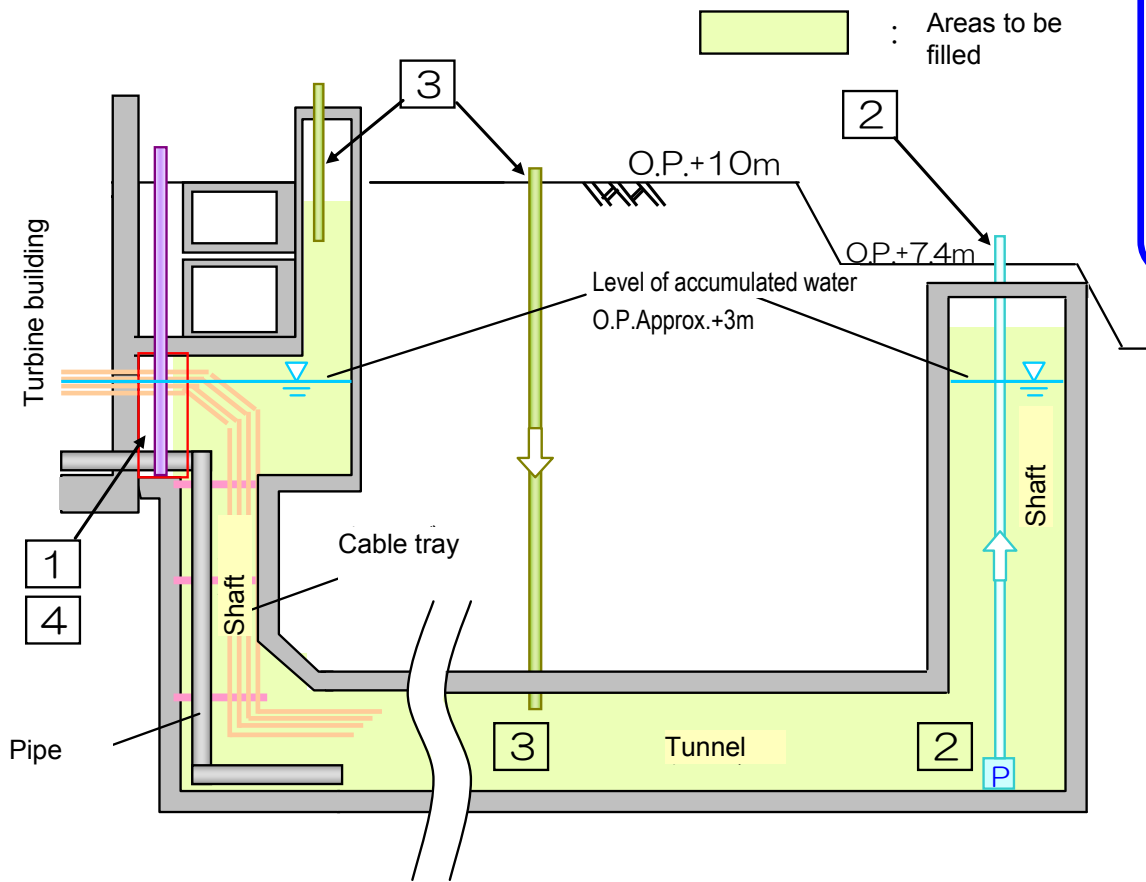
Unit 2 work proposal

※ Freezing water in gaps in the earth is accepted practice, but since this water has never been directly frozen...

Waterproofing the connection to the building through freezing

Contaminated water in the trench will be transferred

The trench and the shaft will be filled

The connection with the building will be thawed and then filled

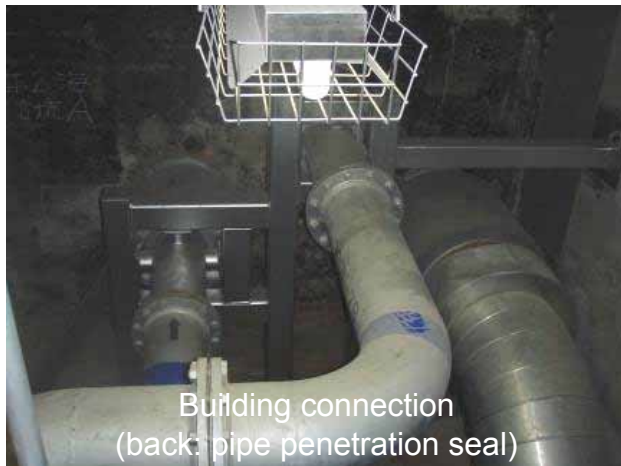
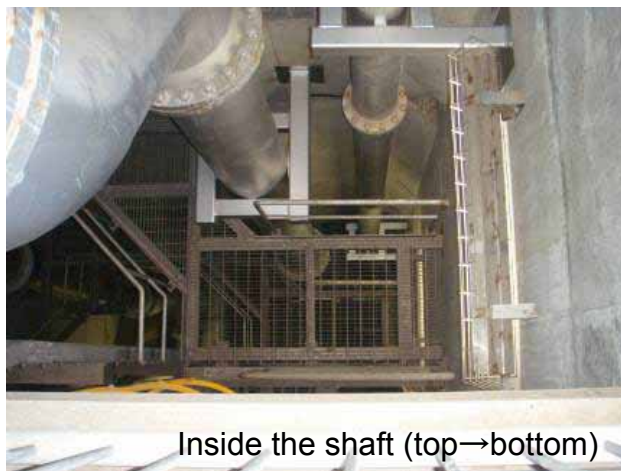
- **Freezing test objective: To confirm the validity of waterproofing connections through freezing**

- Whether or not waterproofing is possible by direct freezing of water and waterproofing performance
- The impact of equipment (the pipes/cable trays) on waterproofing performance
- The impact of water inside pipes on waterproofing performance
- The impact of cooling from outside the trench on waterproofing performance
- The impact of the number of rows of frozen pipes on waterproof performance
