Simulated Images of the Spent Fuel Pool and the Duct at Unit 1 of Fukushima Daiichi Nuclear Power Station

< Reference >
 February 18, 2013
 Tokyo Electric Power Company

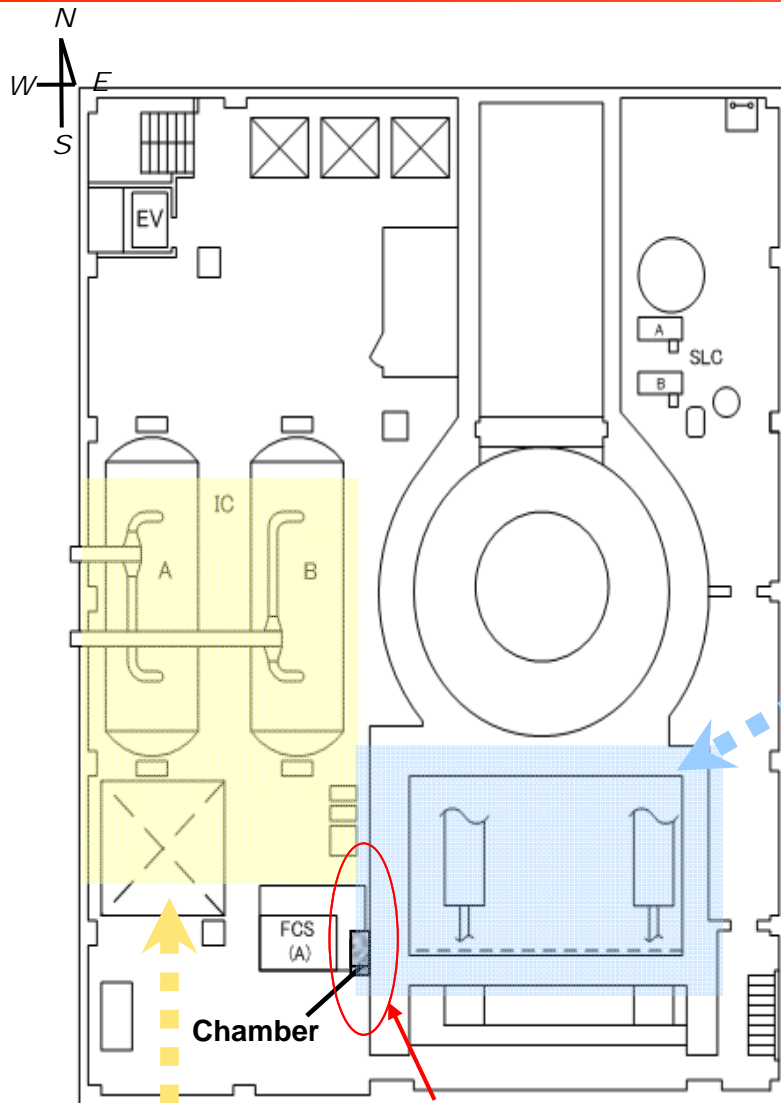
Water leakage location witnessed by the investigative panel appointed by the parliament

- The duct installation location and the water leakage location witnessed were found to be about the same.
- The water leakage on the fourth floor is assumed to have been caused by pool water generated by sloshing going through the air conditioning duct and overflowing from the chamber for overflow prevention.
