< Reference > March 13, 2013
Tokyo Electric Power Company

Outline

SARRY will be suspended in order to perform the following for reliability improvement.

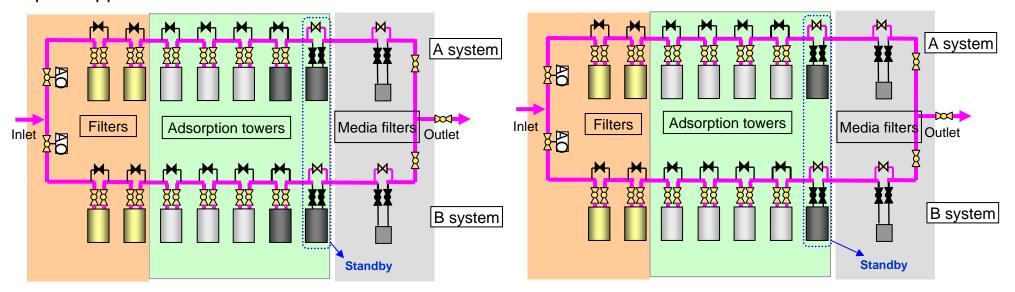
Overview of SARRY (Current adsorption tower arrangement)

Overview of SARRY (New adsorption tower arrangement)

(Supplement) The adsorption towers indicated in black have higher adsorption capability compared to those indicated in white, even in the case of high chloride ion concentration.

Considering that the water quality conditions have changed since SARRY started operation (decreased radioactivity density and chloride ion concentration), the arrangement of adsorption towers will be changed when restarting SARRY (see below).
