1. Finding of the tank from which water has leaked

Survey Results Related to Leak from the RO Tank

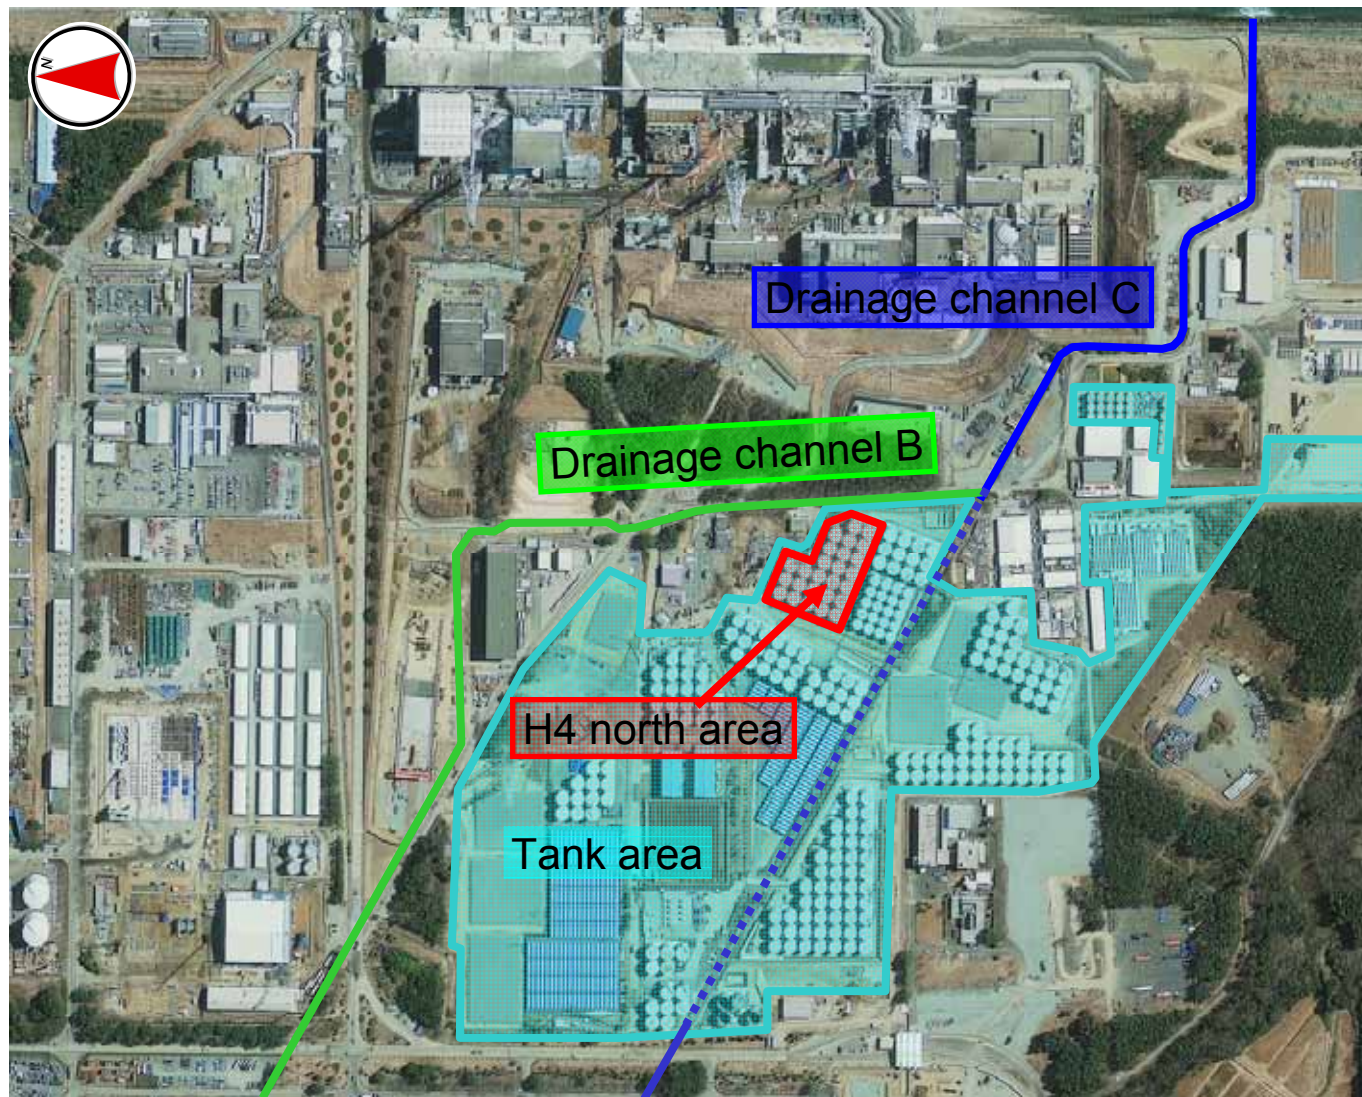
Locations of Tank Area and Drainage Channels

- We found water spread at the bottom part of the area near the No.5 (H4-I-5) tank in the area. Therefore, we checked the water level of this tank, and found out that the water level has fallen to approximately 3m 40cm from the top of the tank.

- With regards to water considered to have leaked, we are collecting the water remaining inside the dike and have already collected some. However, since the water seems to have flowed out from the dike through the drain valve, we will collect soil in the surrounding area on August 20 and continue to conduct an investigation to find out the range reached by the water.

- Removing contaminated soil found outside the dike. (Started at 6:30 AM on August 20)
- In locations near the leakage location that have no earth-fill dams (with large-sized sandbags), building sandbag-reinforced embankments after removing the contaminated soil as above, for the purpose of preventing the leaked contaminated water from flowing into drainage channels.
