**Causes and Countermeasures for  
Dust Concentration Increases and  
Bodily Contamination in front of the  
Fukushima  
Daiichi Nuclear Power Station's  
Seismic Isolated Building**

**September 12, 2013  
Tokyo Electric Power Company**

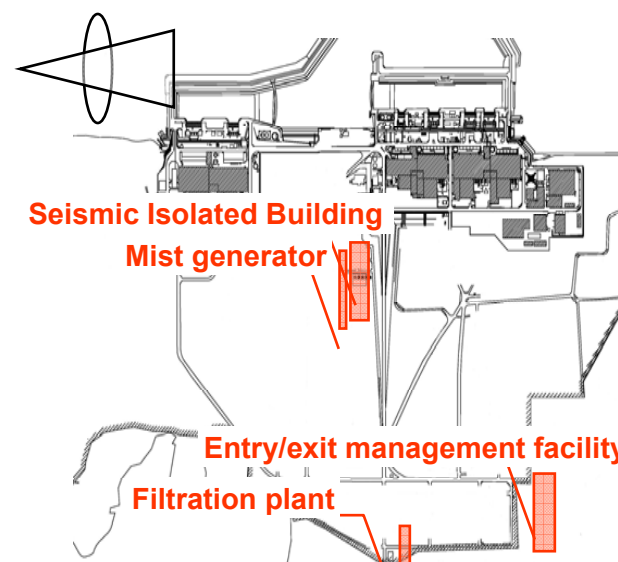
Site Diagram (Sampling Locations)

Around 1:05 PM to 1:25 PM:  $1.4 \times 10^{-5} \text{Bq/cm}^3$

Gamma: ND (Cesium 134: Less than approx.  $3 \text{Bq/l}$ ,  
Cesium 137: Less than approx.  $3 \text{Bq/l}$ )

All Beta: ND (Less than approx.  $13 \text{Bq/l}$ )

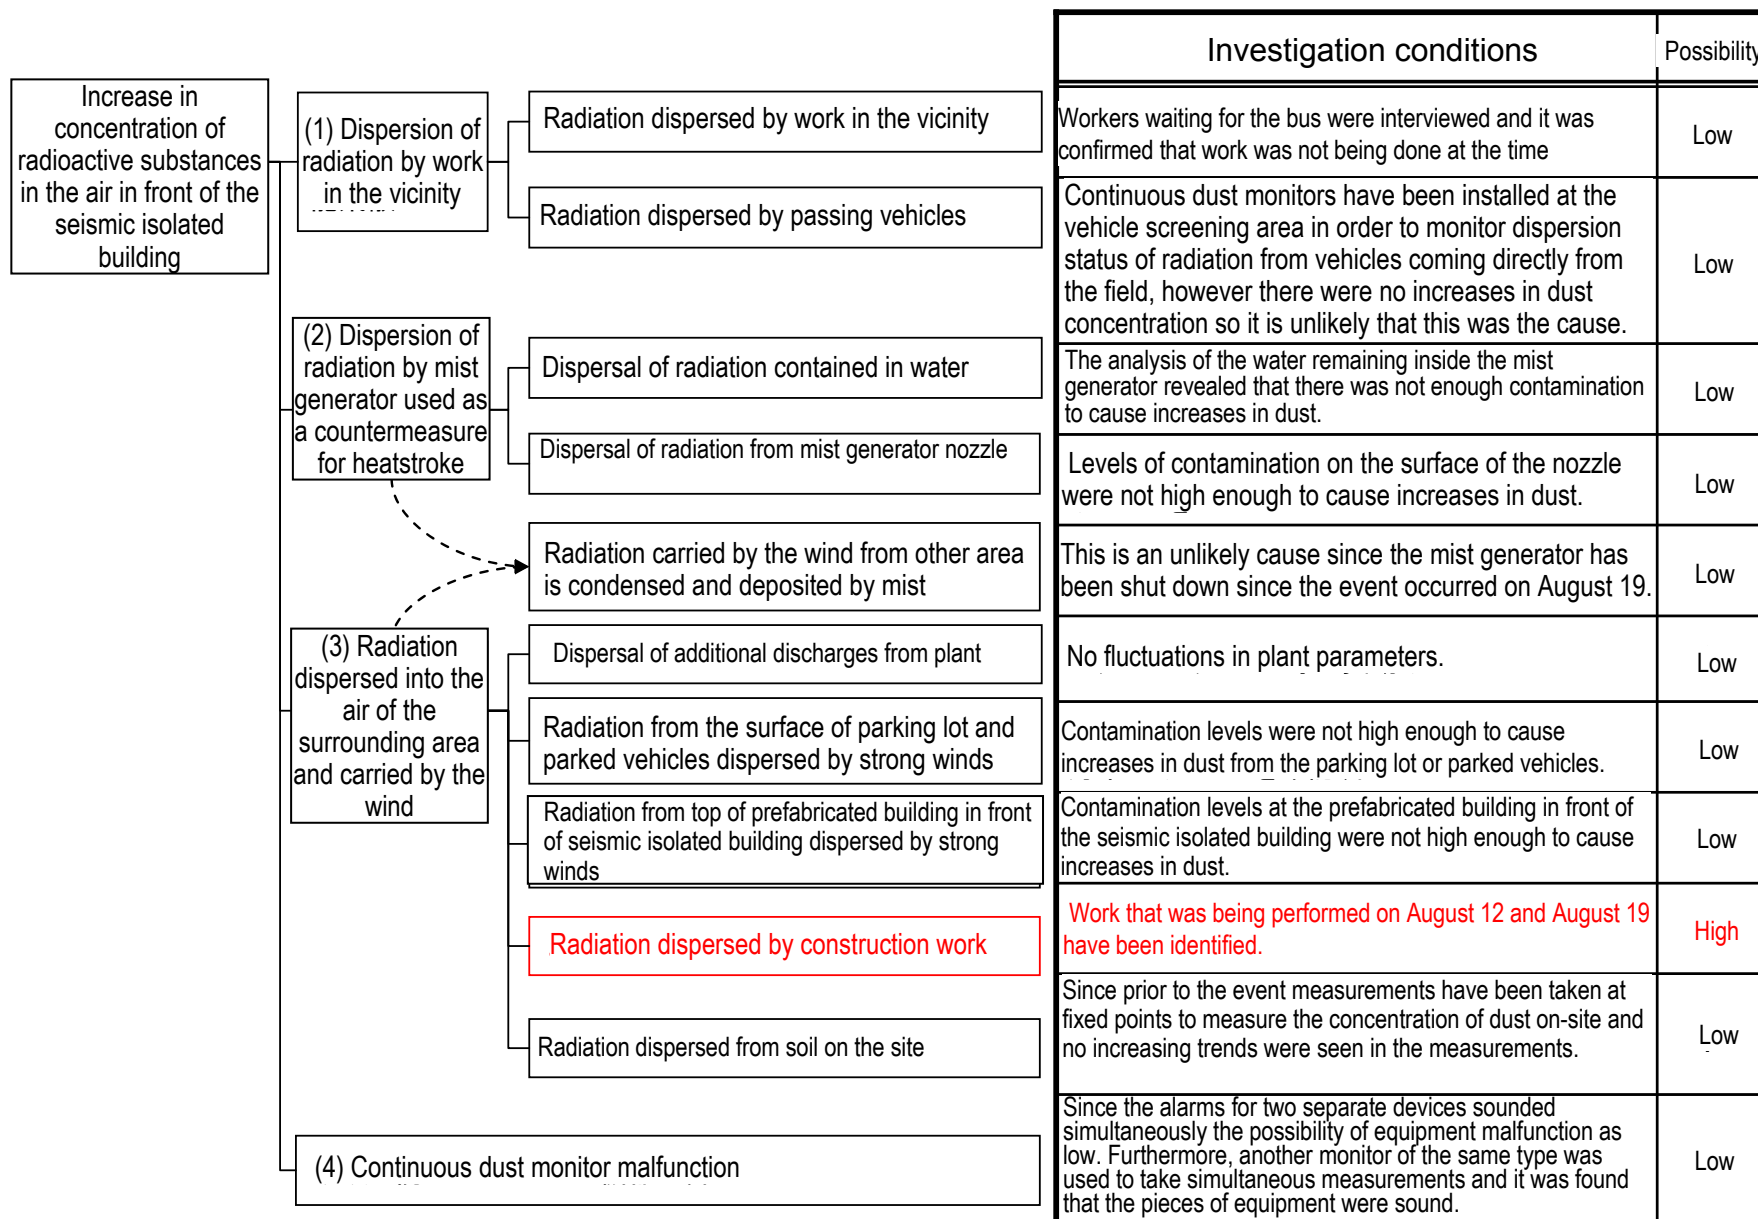
### 3. Cause analysis and status of investigation (1/3)

On August 12 and 19 “work to remove debris from the top of the Unit 3 reactor building” was conducted. During this work dust has the potential to be turned up and on these two days the wind was blowing in the direction of the front of the Seismic Isolated Building (southeast/south-southeast)

On both August 12 and August 19 work to remove debris from the top of the Unit 3 reactor building was conducted and on these days this work was upwind of the continuous dust monitors so there is a connection. Furthermore, since the 20<sup>th</sup> when work to remove debris from the top of the Unit 3 reactor building was suspended, there have been no fluctuations with the continuous dust monitors, therefore it has been deemed highly likely that the aforementioned work was the cause of the increase in dust.

Assessment	<p>The amount of dust increased on the top of the reactor building during work</p> <p>→Work to remove Unit 3 debris has been deemed the cause of the increase in dust in front of the Seismic Isolated Building</p>	<p>Whereas radiation on the same order as detection limit concentrations was detected in the dust downwind of the work no significant increase was found (standard levels that require the wearing of full face masks is 2.0E-4Bq/cm<sup>3</sup>)</p> <p>→the spreading of agents to prevent dispersion has been effective at preventing impact on locations downwind of the Unit 3 reactor building. Furthermore, no fluctuations have been seen at the monitoring posts (MP) downwind of the reactor building.</p>

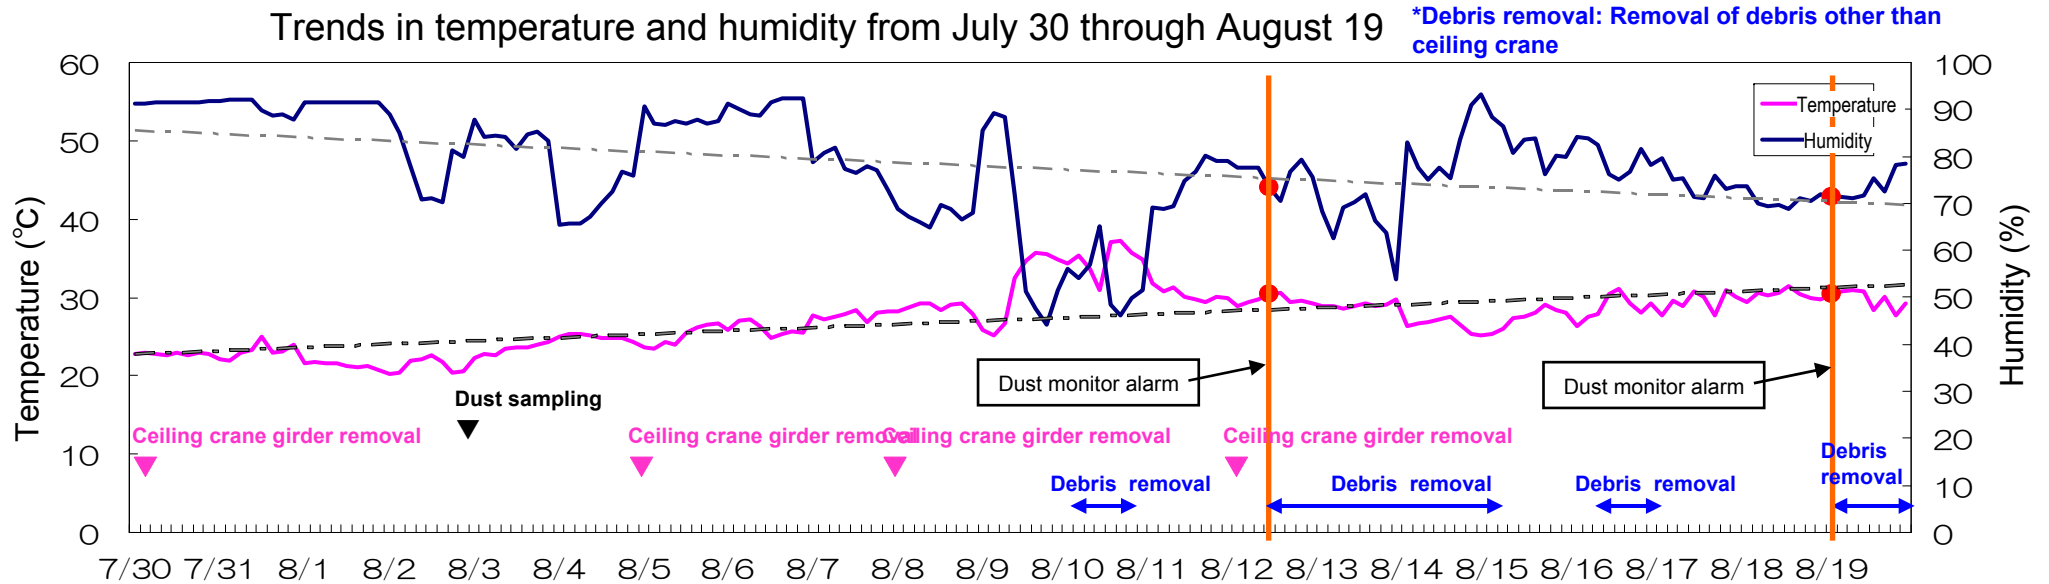
# [Reference] Weather around dates when dust monitor alarms sounded

- There were no alarms during debris removal work exposed to outside air until July
- On July 30 debris that had been under the ceiling crane girders was exposed to the outside air for the first time during removal work. (the debris was under the ceiling crane girders making it impossible to spread with dispersion prevention agents)
- During July the air was quite humid but at the beginning of August sunny days allowed the debris to dry.

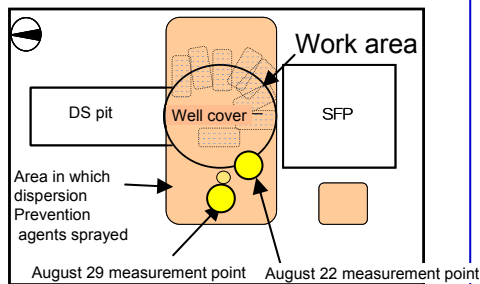
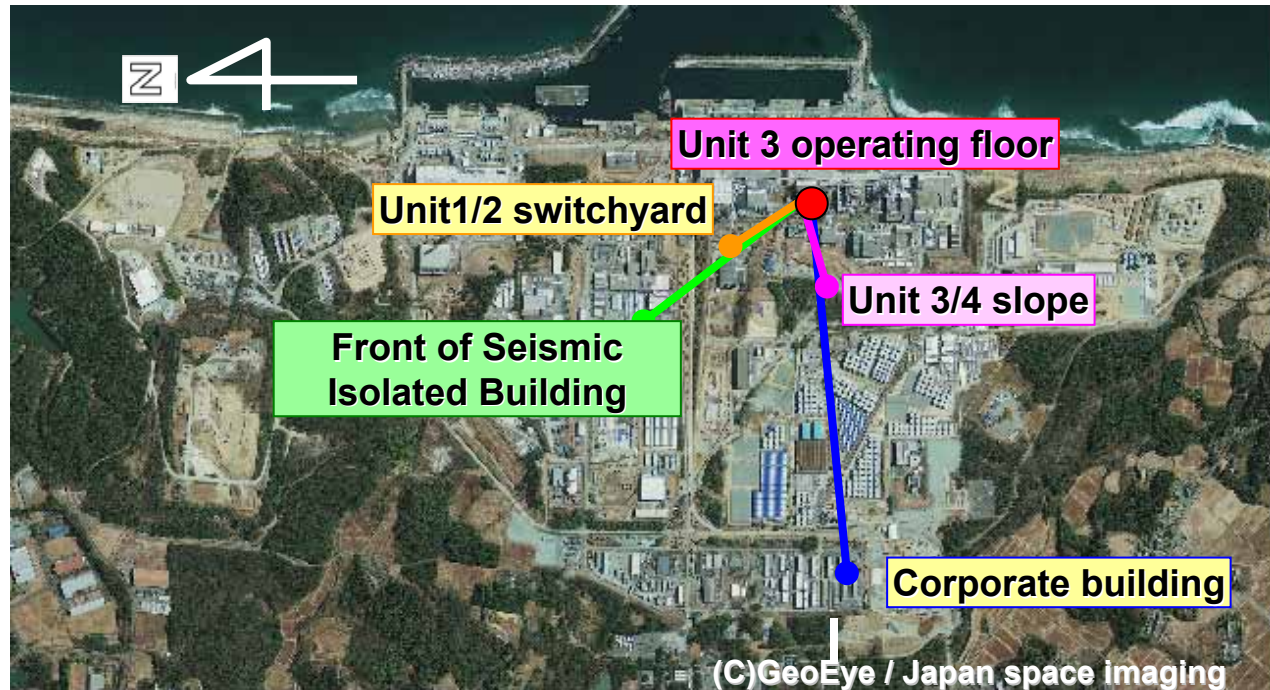
- Work times: 1:15 PM-4:03 PM
- Relationship between work area and measurement points

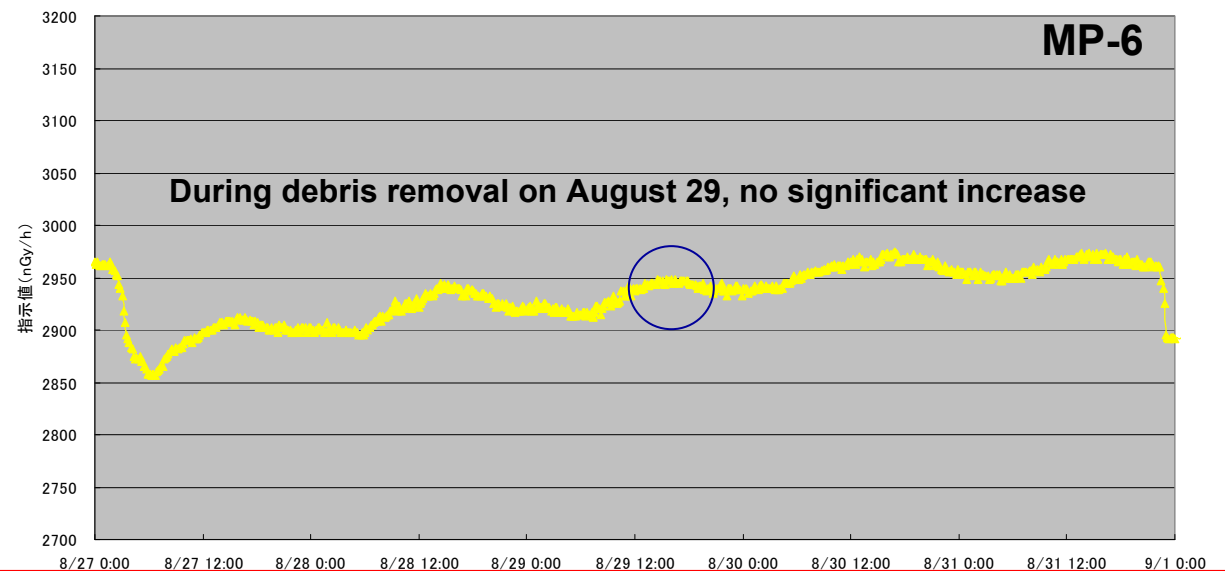
Monitoring post indicator (MP-6)

MP indicator values fluctuate with the daily environment with levels high during the day and low at night. Furthermore, indicator values drop when rain falls and increase little by little while fluctuating up and down between evening and night when sunny days continue.

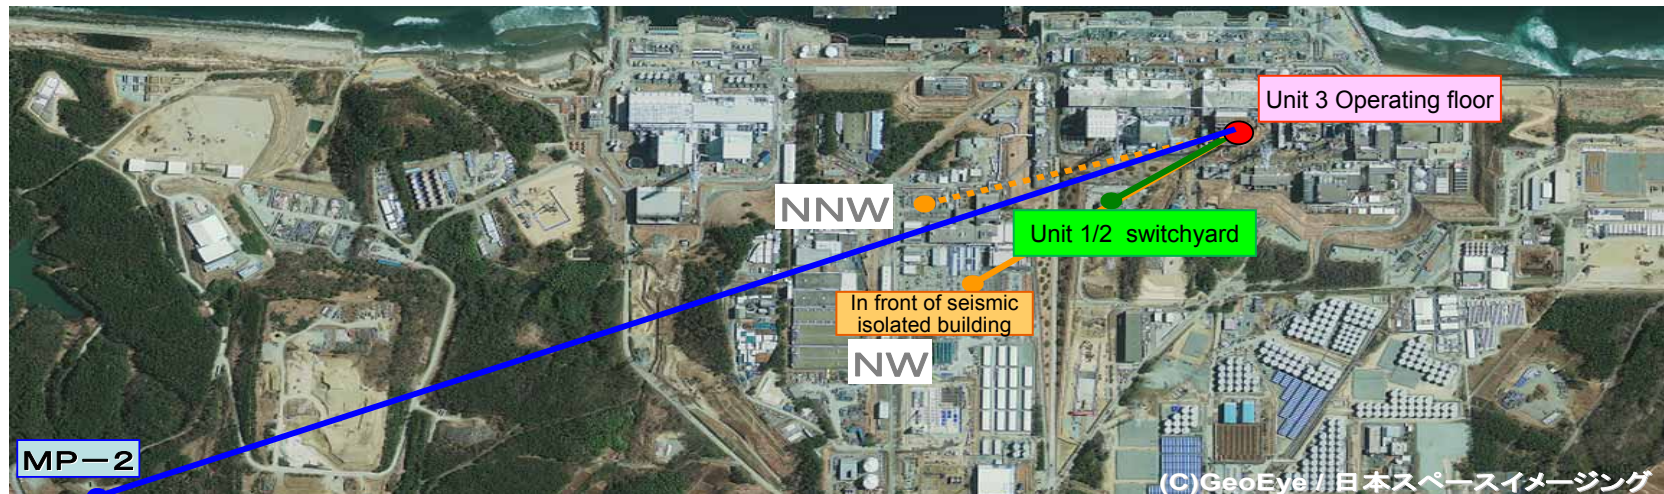
Date/Time	Wind direction (10m)	East side of Unit 1/2 switchyard	Front of Seismic Isolated Building	Near MP-2
8/12 Around 12:33	SE	—	(Continuous dust monitor alarm sounded)	—
8/12 13:05-13:25	ESE	—	$2.0 \times 10^{-6}$	—
8/12 14:10-14:30	SSE	—	$2.3 \times 10^{-6}$	—
8/19 Around 9:29	SE	—	(Continuous dust monitor alarm sounded)	—
8/19 9:50-10:10	SSE	—	$8.4 \times 10^{-4}$	—
8/19 11:10-11:30	SSE	—	$4.2 \times 10^{-5}$	—
8/19 12:48-13:08	SSE	$1.0 \times 10^{-4}$	—	—
8/19 13:50-14:10	SSE	$2.9 \times 10^{-5}$	—	—
8/19 16:09-16:29	SSE	—	$8.9 \times 10^{-6}$	—
8/19 19:55-20:25	SSW	—	—	$7.7 \times 10^{-7}$
8/20 11:30-11:50	NE	$1.3 \times 10^{-5}$	—	—
8/20 11:40-12:00	NE	—	$< 4.7 \times 10^{-6}$ [Cs-137]	—
8/20 11:58-12:58	NE	—	—	$7.4 \times 10^{-7}$

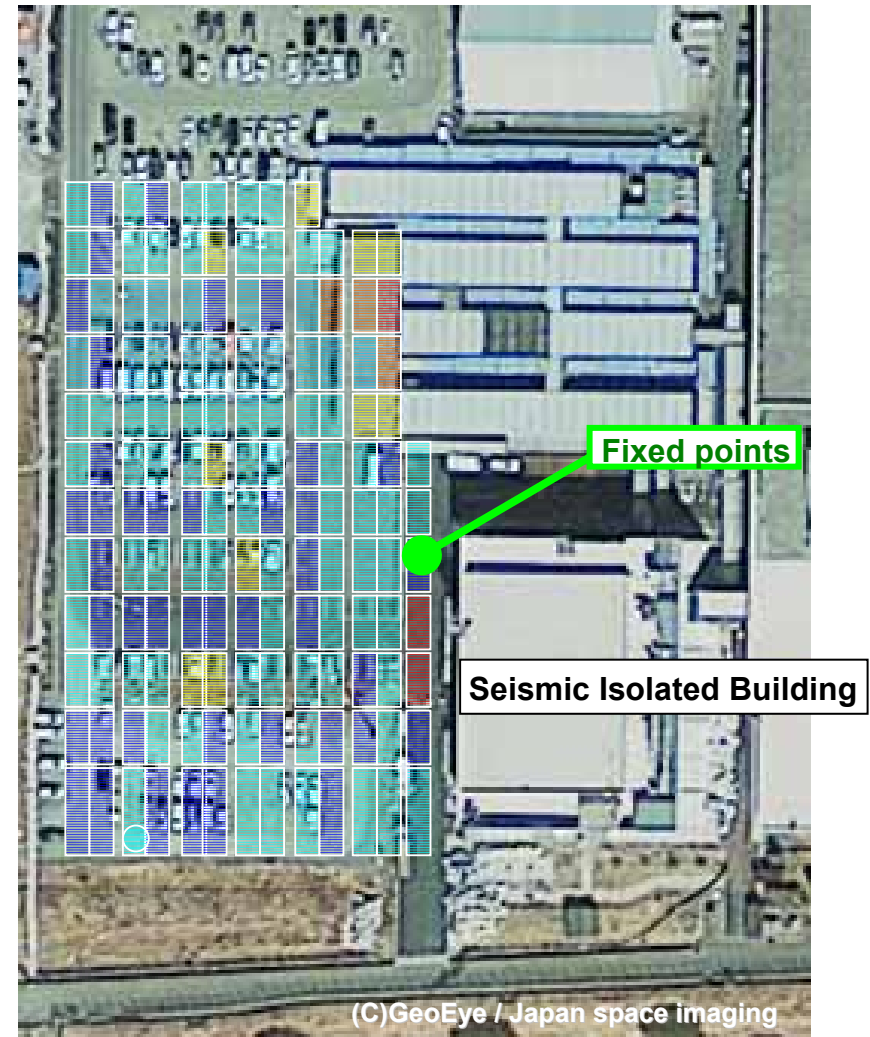
Surface contamination density[Bq/cm<sup>2</sup>]

Geometric mean *	Maximum
2.2E+00	3.7E+01

➔ About the same as the surface contamination density of the parking lot

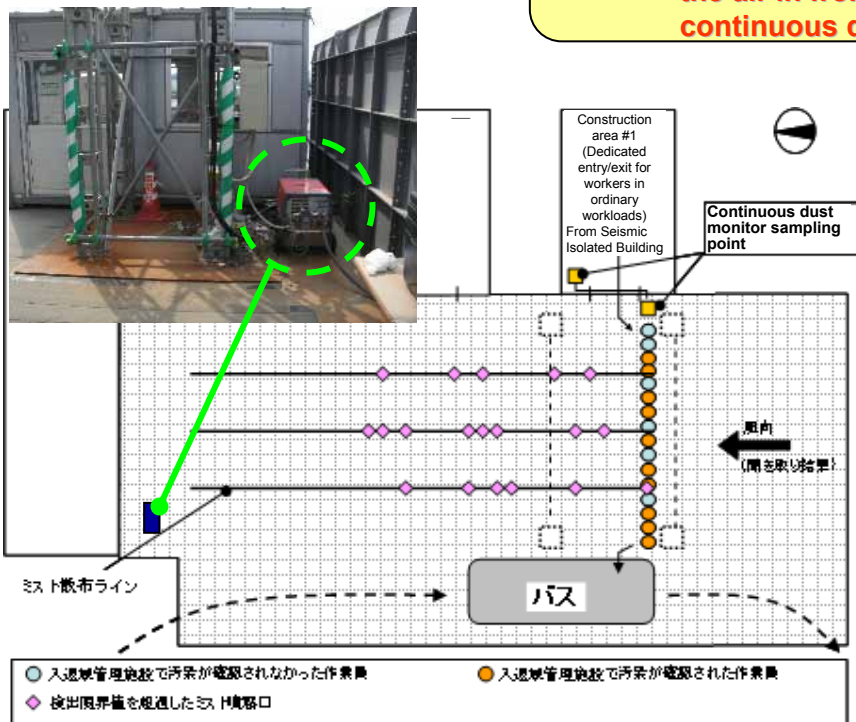
Radiation concentration of tank water (Cs-134 + Cs-137)

➡ Contamination levels are not high enough to increase the concentration of radioactive material in the air in front of the #1 construction area (bus stop) to  $1 \times 10^{-4}$  [Bq/cm<sup>3</sup>] (level at which continuous dust monitor high-high alarm sounds)

$$9.8 \times 10^{-2} \text{ [Bq/cm}^3\text{]}$$

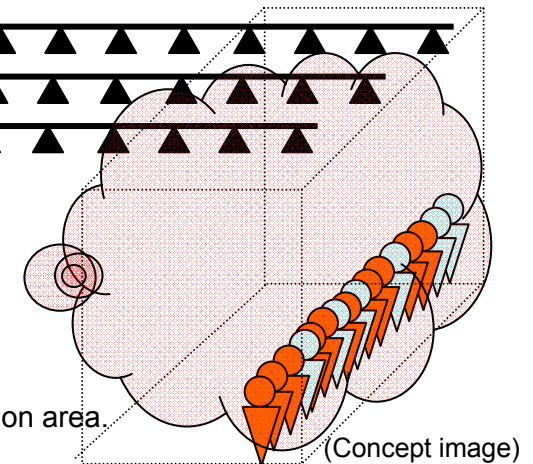
Air in front of #1 construction area  
Approx. 150m<sup>3</sup> (5 × 10 × 3)

Assumption: It is assumed that the mist fell locally in front of the #1 construction area (excessive condition)

$$9.8 \times 10^{-2} \text{ [Bq/cm}^3\text{]} \times 100 \text{ [mL]} \div 1.5 \times 10^8 \text{ [cm}^3\text{]} = 6.5 \times 10^{-8} \text{ [Bq/cm}^3\text{]}$$
