Cracks Found during Inspection on Fuel Assembly Having Deformation in Fukushima Daiichi NPS Unit 4 Spent Fuel Pool

< Reference >
December 27, 2013
Tokyo Electric Power Company

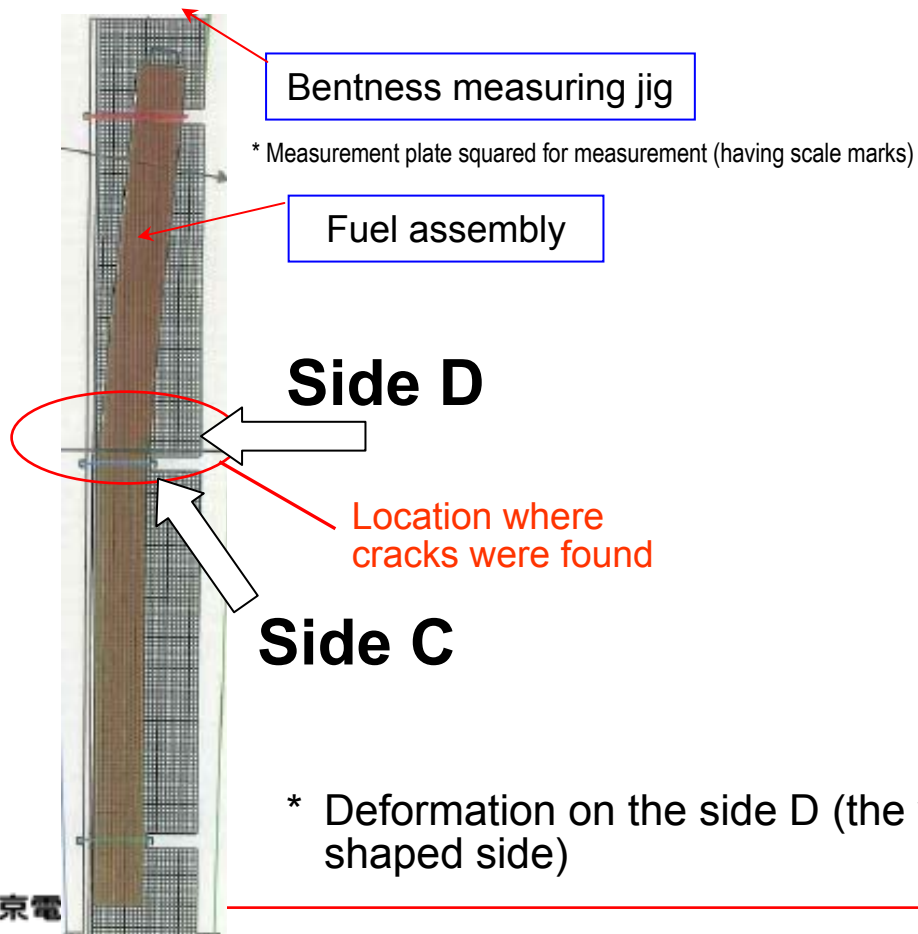
- Regarding a fuel assembly having its handle/channel box deformed (*) due to mishandling in the past, an inspection of the shape was conducted to know the degree of deformation. During the inspection, cracks were found in the channel box of the fuel assembly. We consider these cracks were caused when the channel box was deformed in the past. During this inspection, there was no change in the radioactive material concentrations in water of the spent fuel pool and the doses obtained by area monitoring.
