Results of Building Frame Inspection on Fukushima Daiichi NPS Unit 3 Reactor Building after Debris Removal at Upper Part

February 14, 2014

Tokyo Electric Power Company

Attachment 1. Inspection results on the operating floor (5th floor)

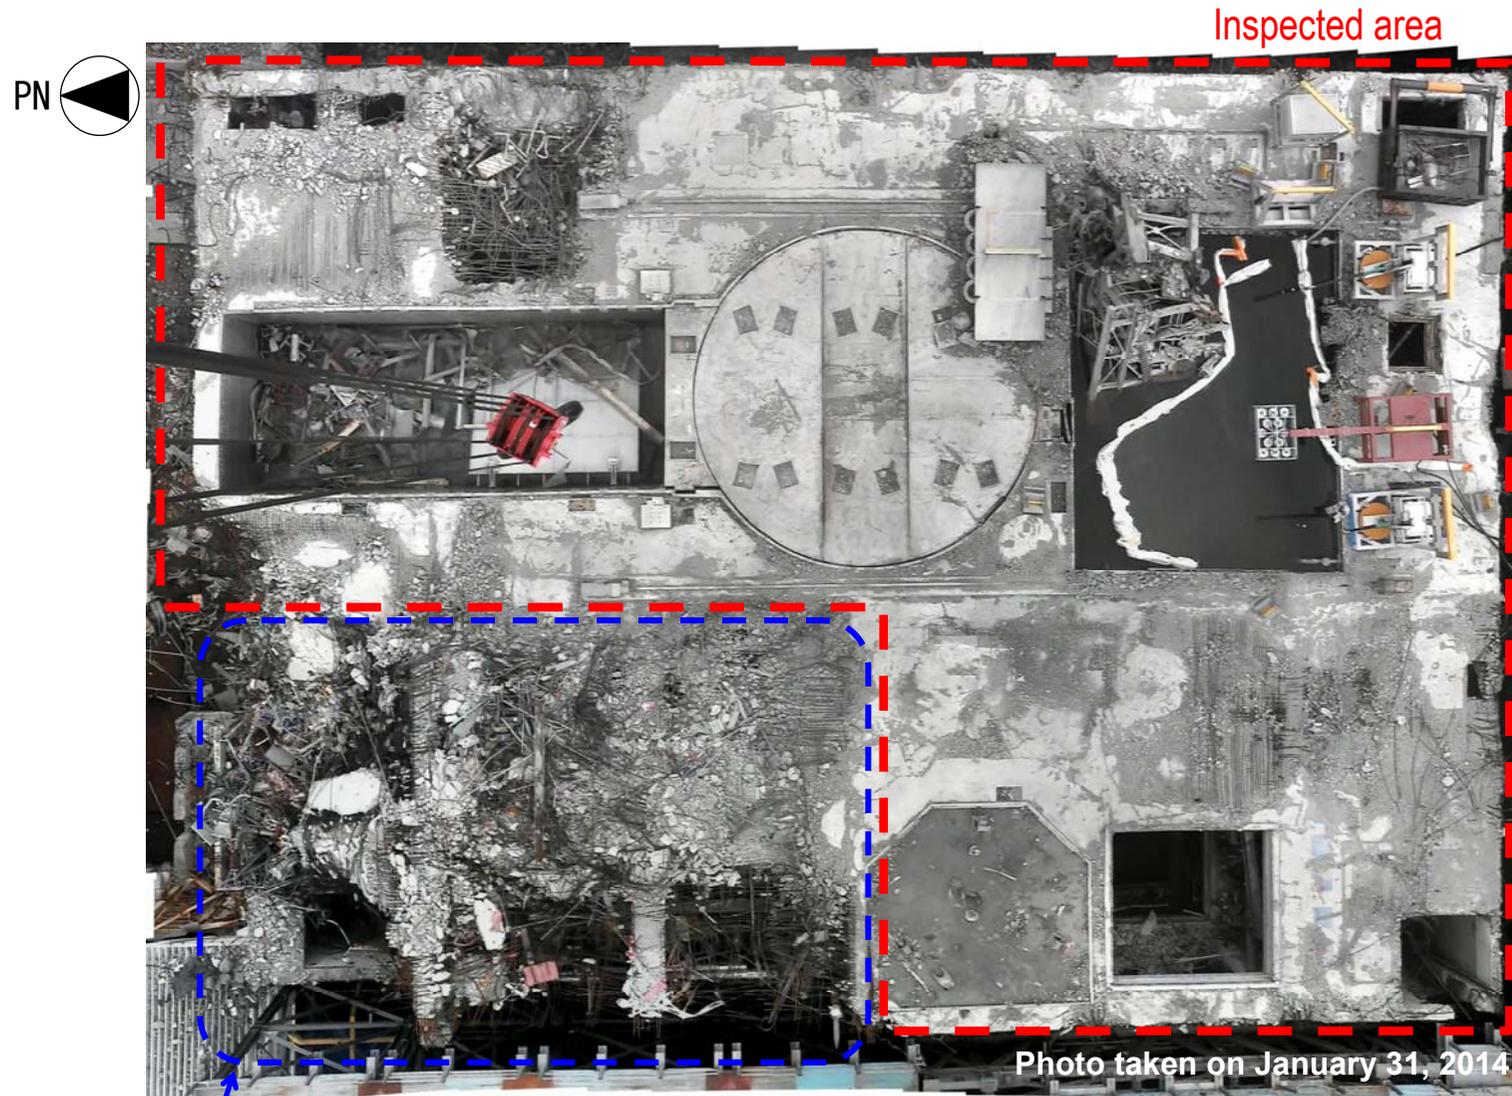
- ・ With respect to the floor of the operating floor, no severe damage was observed, although damages were found in some parts. [\[Attachment 1\]](#)
- ・ The building interior was found to have no remarkable damages. [\[Reference\]](#)

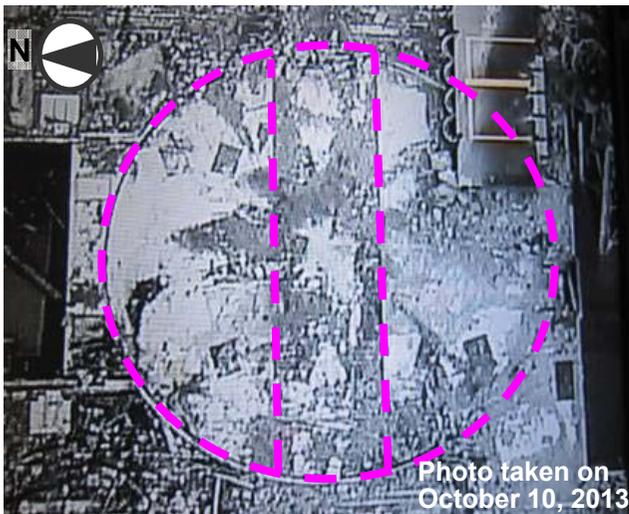
- Before the debris removal work, there were small pieces of debris piled up on the shield plug, and the detailed conditions were unavailable.
- The conditions on the shield plug surface were inspected after the small pieces of debris were collected and removed. Then, the deformation (approx. 300mm) was found in the central part of the shield plug.

Before decontamination was started
