Measures for Leakage from the Top Plate of the Upper Part of H6 Area Tank

February 28, 2014

Tokyo Electricity Power Company

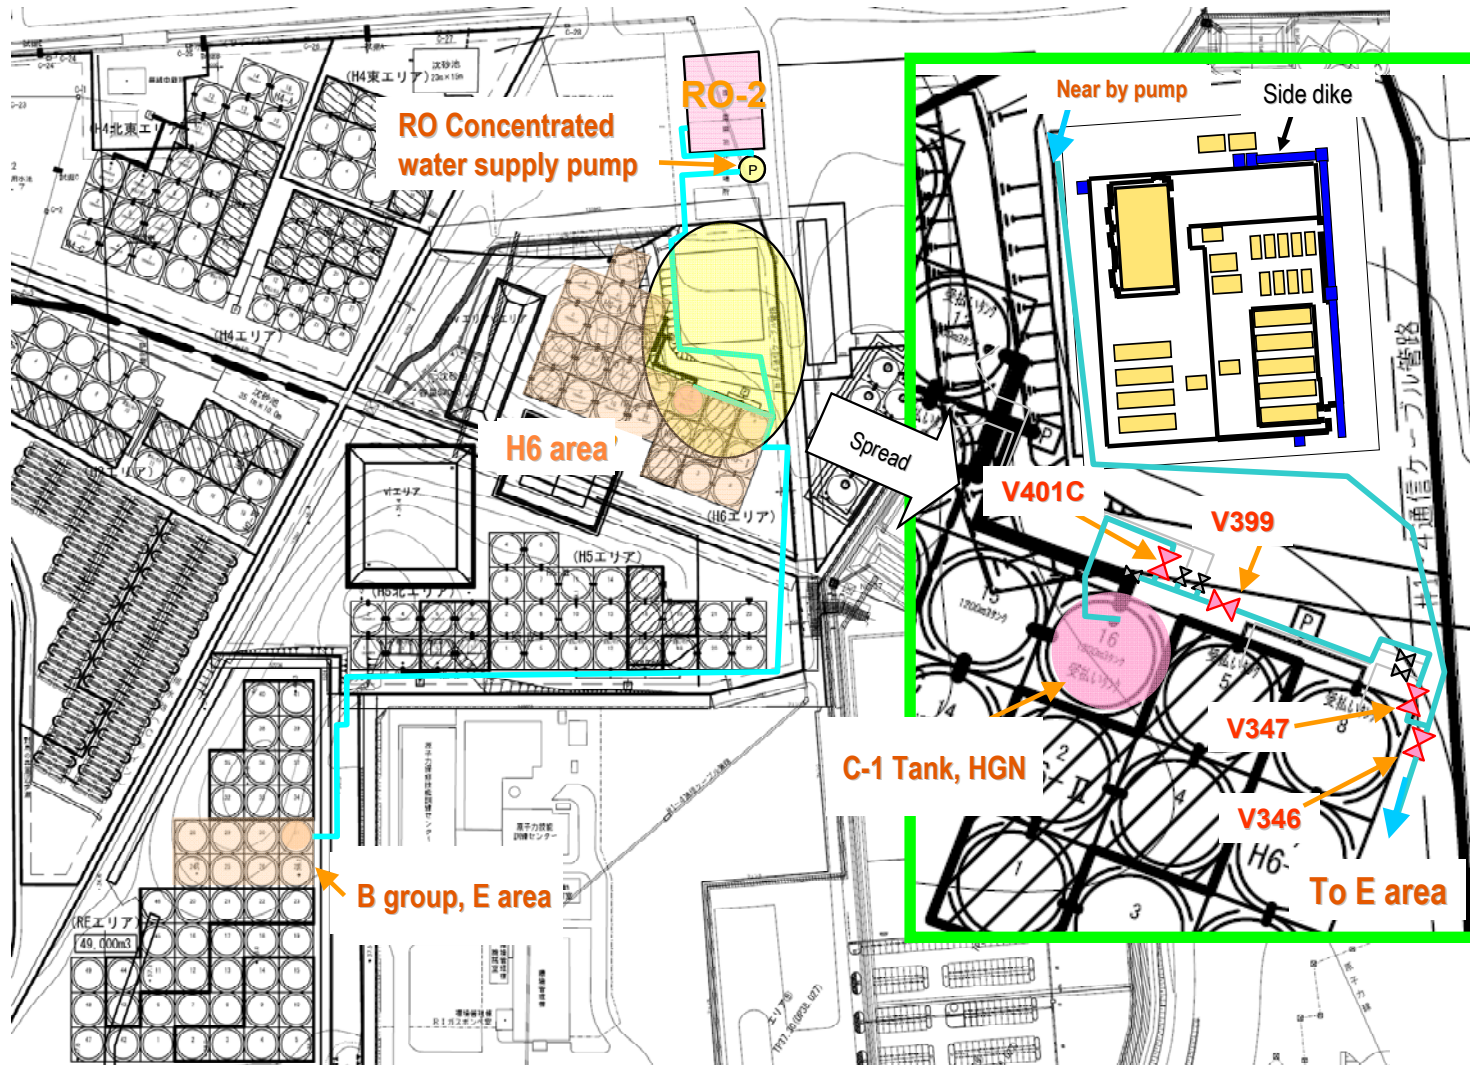
Pipe Route Layout (RO concentrated water supply pump – H6 Area Tank)

◆ Contaminated water was originally designed to be transferred to the tank in E area. But at the time the leakage occurred, the system was switched to the design the water to be transferred to the first tank of H6 area, that is, the valve for E area (V346) was “closed” while the valves for H6 (V347) were “opened”.

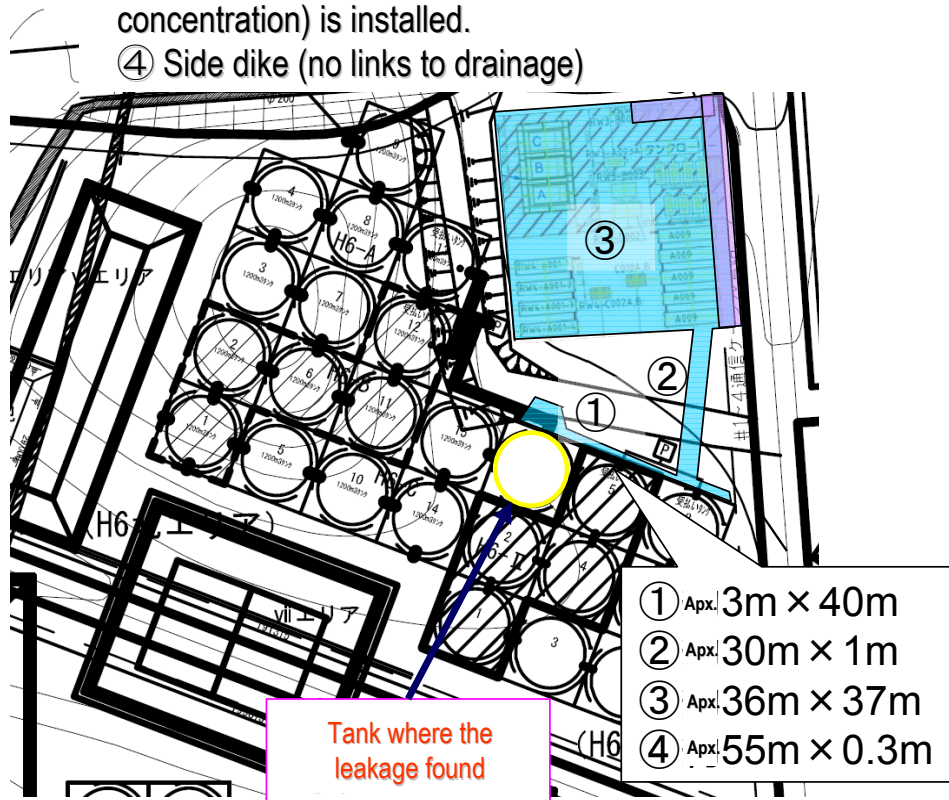
Leakage status (① area)

- Water overflowed outside the dike (Approx. 100m³)
 - ① Around the H6 tank area dike.
 - ② U-shaped gutter where electric cables are stored.
 - ③ Area where the desalination system (evaporative concentration) is installed.
 - ④ Side dike (no links to drainage)

- By February 21, of approx. 100m³ of the contaminated water leaked to outside the dike, approx. 42m³ have been collected.
- In future, since seeping out of neighboring soil, etc. attributed to the contaminated water may cause accumulation of water in the side dike of the leakage area, routine check will be conducted to collect the water as necessary.
