Survey on torus room wall in Unit 1 of Fukushima Daiichi Nuclear Power Station

June 13, 2014

Tokyo Electric Power Company

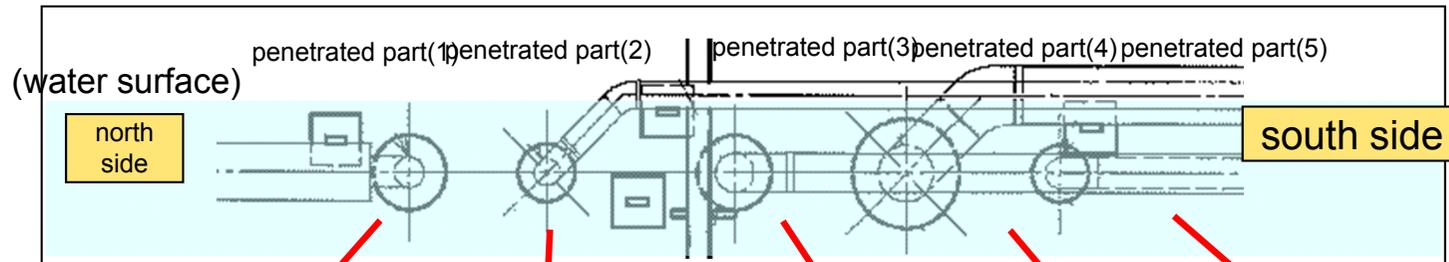
east wall penetrated part of torus room

- On images taken from the air, movement of surface floating matters were not found.

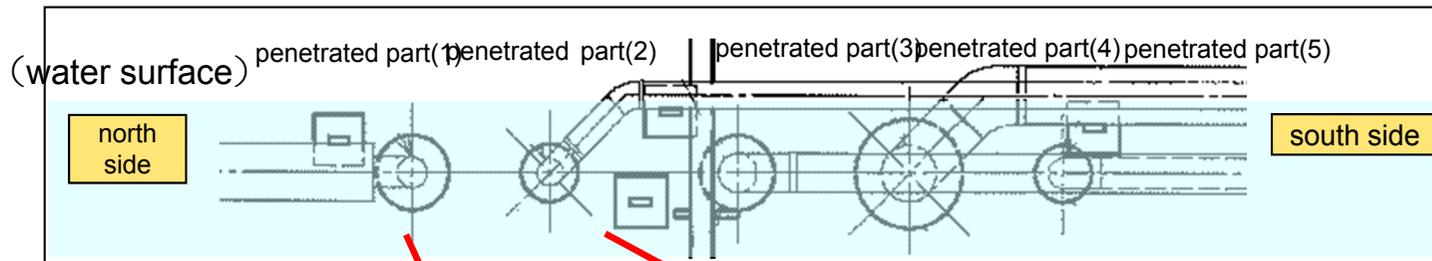
penetrated part (1) east wall penetrated part of torus room penetrated part (2)

- Surface of penetrated parts target: penetrated part (1) and (2)
 - On underwater imaging, serious damages on seal material of penetrated parts were not found.
 - For penetrated part (3) to (5), obstacle blocks underwater view.

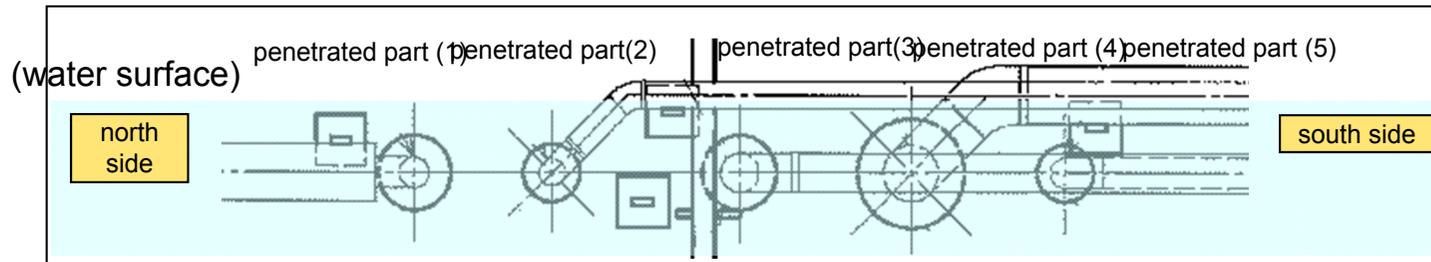
penetrated part(1)

- dispersing tracer* and tracked it, leak point around penetrated part **was not found.**
(*tracer: clay particles)

tracer

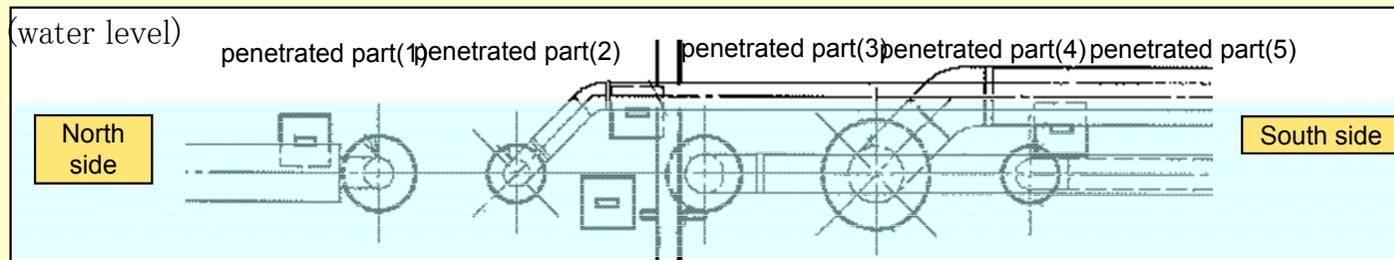
- Taking images of torus room wall with survey camera, we demonstrated **it can confirm whether there is any leakage or not on penetrated parts.**
- **For penetrated part (1) and (2)**
Throwing camera underwater and tracking tracer, **no leakage** on penetrated parts was found.
- **For penetrated part (3) to (5)**
 - Obstacle interfered from putting camera into water.
 - View from the air, **movement of surface floating matters were not found.**

- For penetrated part (3) to (5), using equipment for underwater wall survey (will be operated on unit 2), we will confirm whether any leakage is found or not, before water stopping construction between buildings.
- With sonar survey had been scheduled, we **review the requirement** of it for **no movement of tracer** and the **scope is small.**
