**Survey of wall of torus room
in Unit 2 in Fukushima Daiichi NPS
(Report for demonstration survey
in R & D project)**

July 28, 2014

Tokyo Electric Power Company

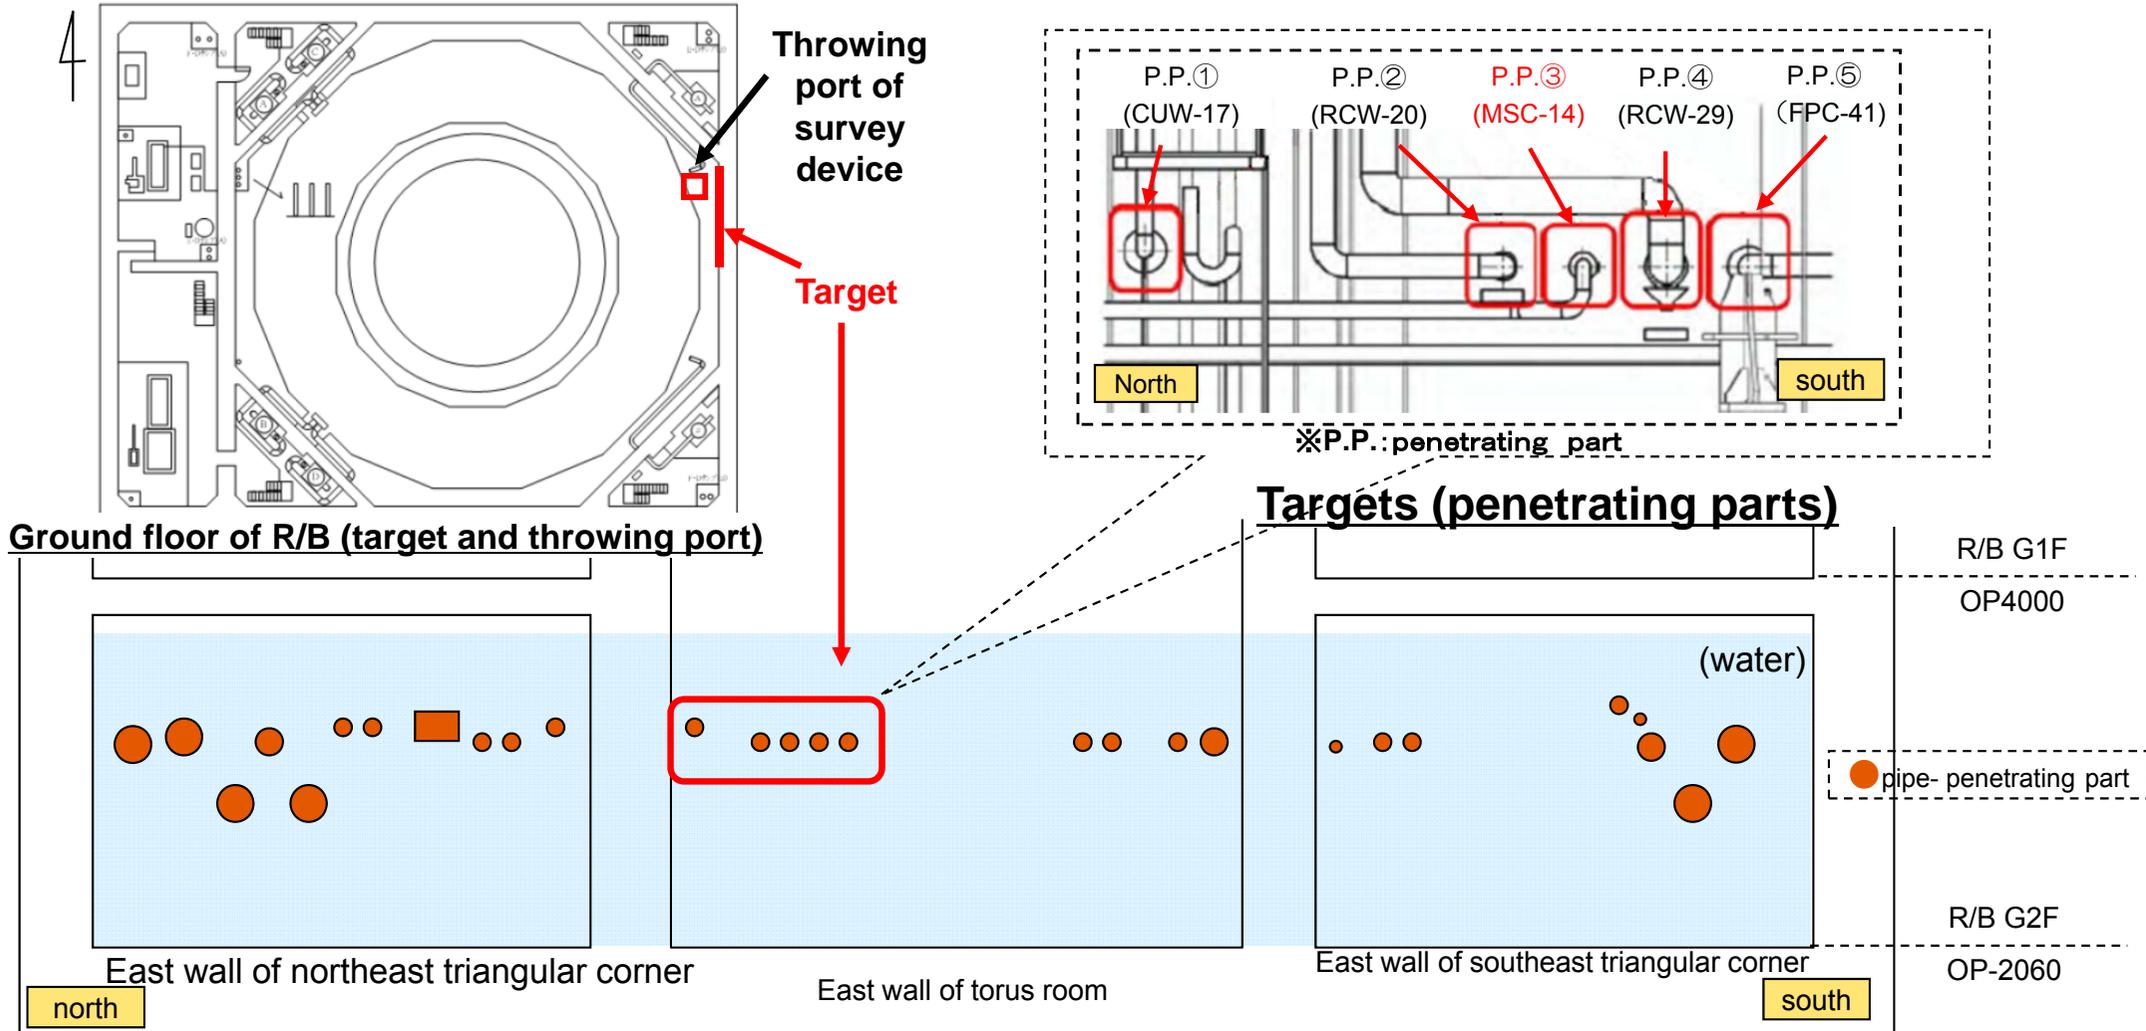
penetrating parts on East wall of Ground floor of R/B Targets

- no remarkable damage has been found around penetrating part ① to ⑤
- no flow has been found around penetrating part ① to ⑤ in sonar survey

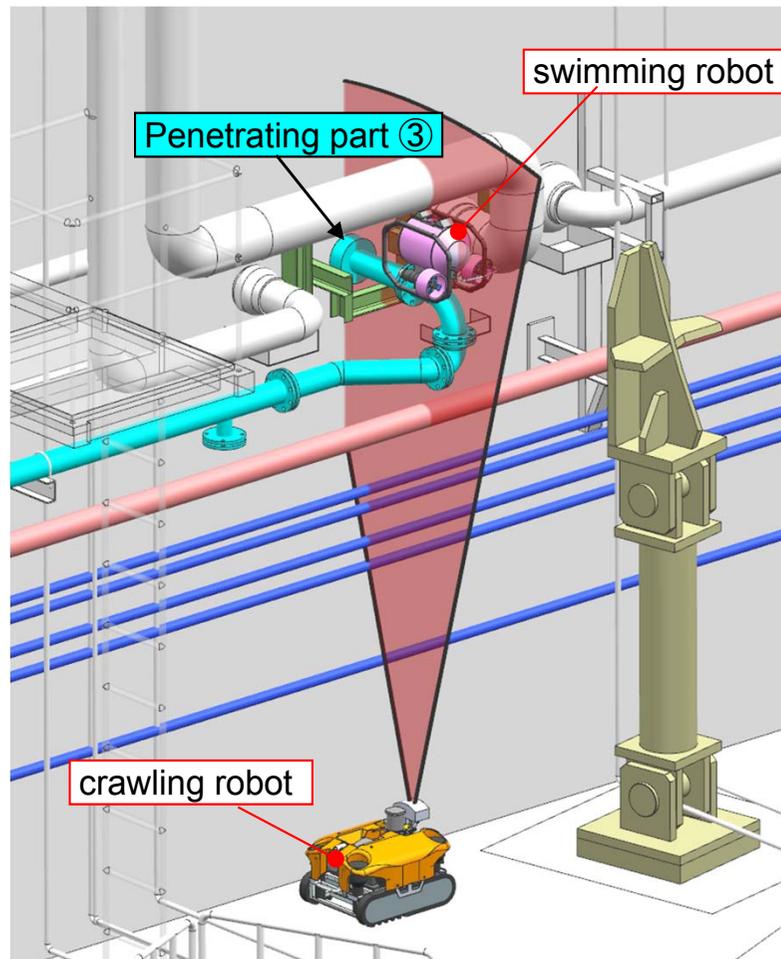
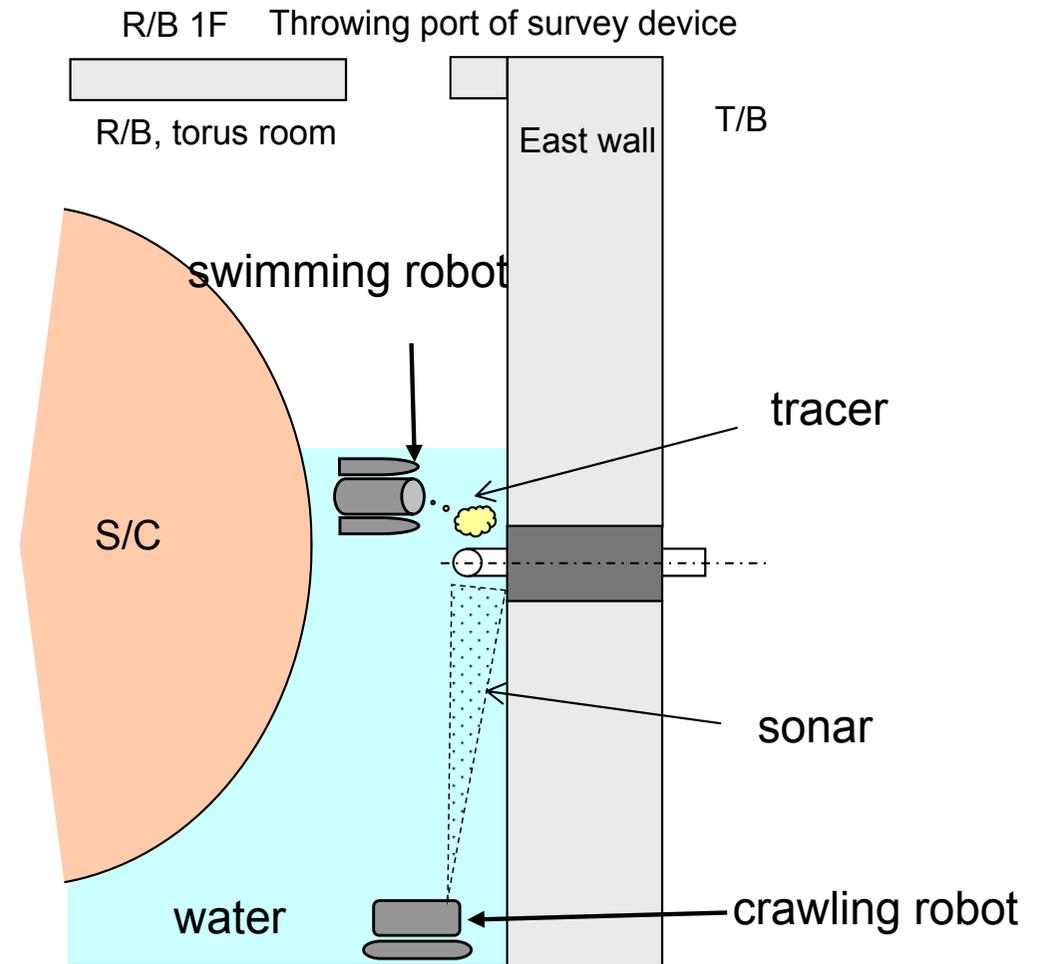
■ target: penetrating part ③

■ For penetrating part ③, inflow of tracer has not been found in Doppler measurement using sonar
