Results of Research Concerning Exterior Section under S/C (Suppression Chamber) at Unit 2

(Report on Verification Test Regarding a Device for Surveying Exteriors under S/C (Pressure Suppression Chamber) as a Part of “Developing Technologies for Surveying and Maintenance Involved in the Filling of the Primary Containment Vessel (Water Cutoff)”)

September 4, 2014

Tokyo Electric Power Company

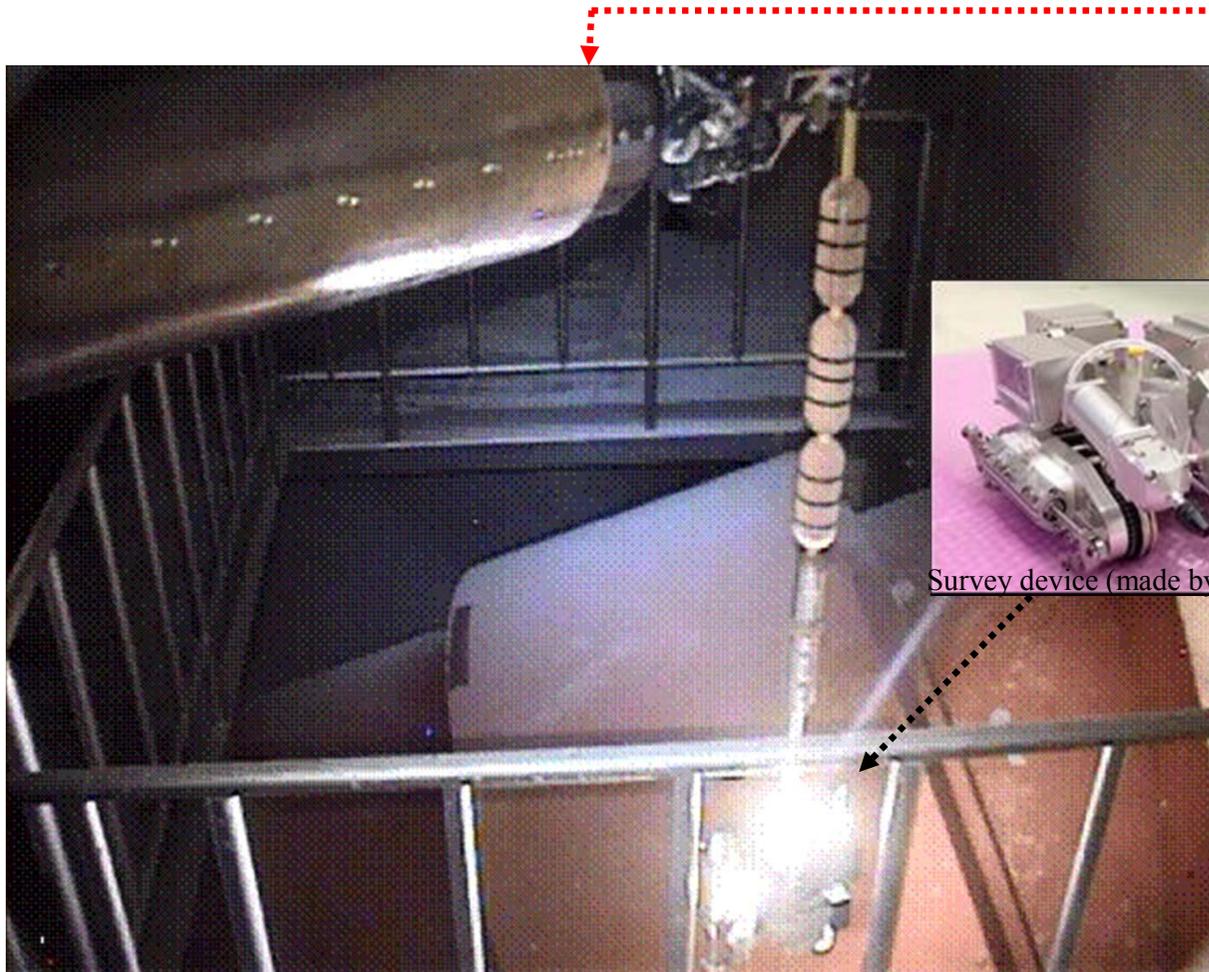
Survey using actual device at Unit 2
(Lowering the survey device)

- The survey consisted of using a support device to lower the survey device down onto the top of the S/C in the torus chamber from floor R/B1, and run the survey device along the top of the S/C while taking images of the S/C outer surface for the submerged section and checking whether there were openings.

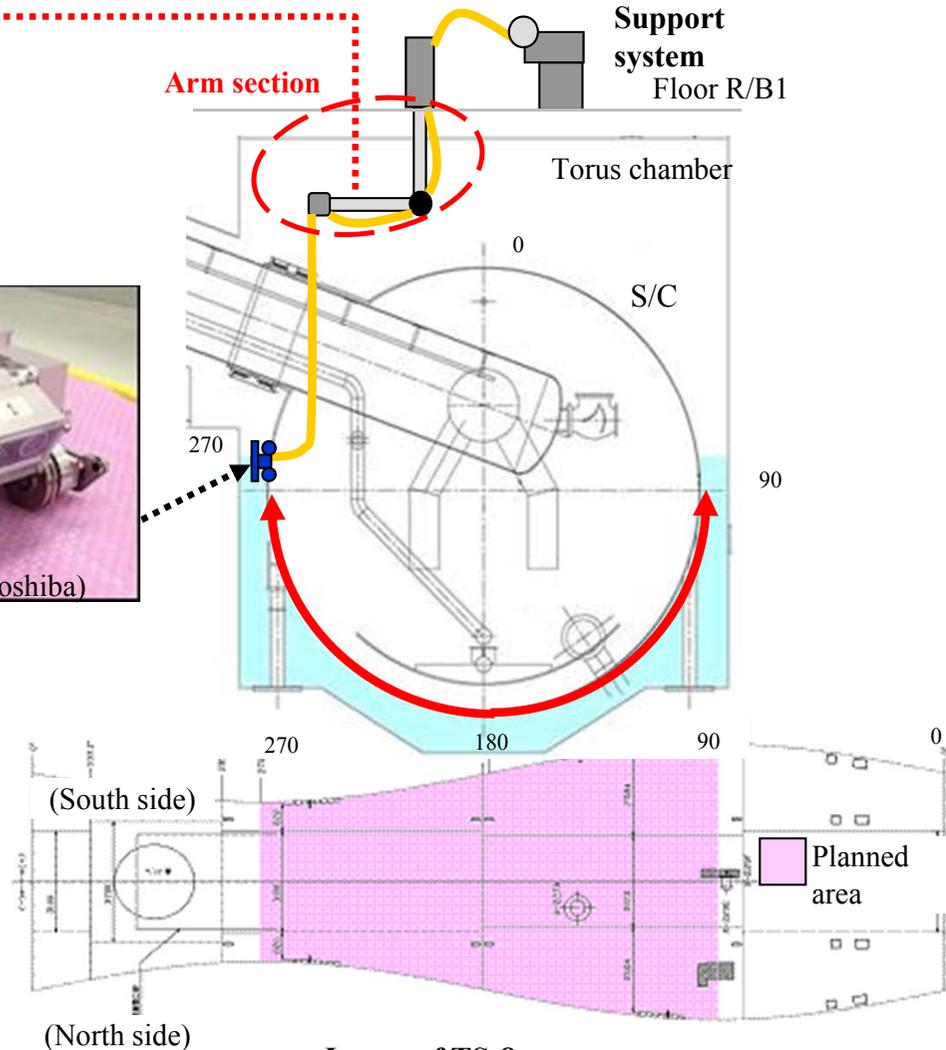
Image of TS-8 survey area

(Development diagram looking at the S/C from the bottom up)

- It was confirmed possible to use the support device to attach or remove the survey device from the outer surface of the S/C.
- No openings were found within the survey area.
