1. Progress of Unit 1 PCV internal investigation

(Preliminary report of March 18 investigation) 1/2

Tokyo Electric Power Company Holdings, Inc.

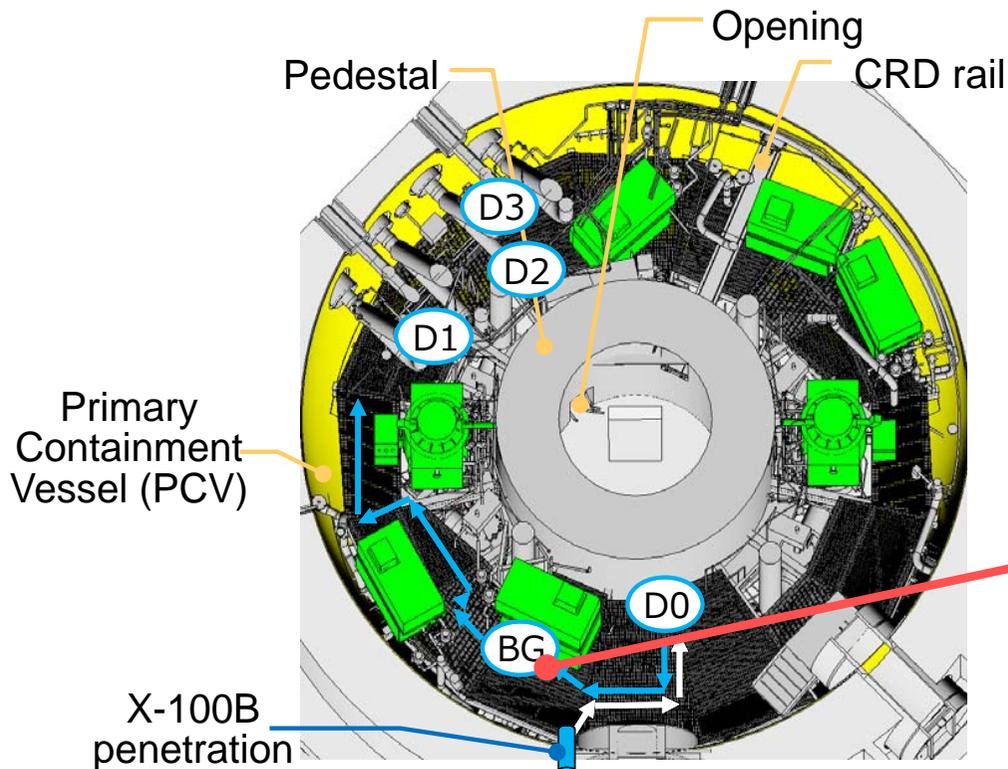
Cross section of 1st floor PCV

Radiation dose at measurement point D0

- (Provisional values)
- On metal gating: 7.8 Sv/h
 - The lowest point: 1.5 Sv/h (About 1m above the PCV basement floor*)

The conditions of PCV basement will be evaluated after organizing digital images and radiation data.

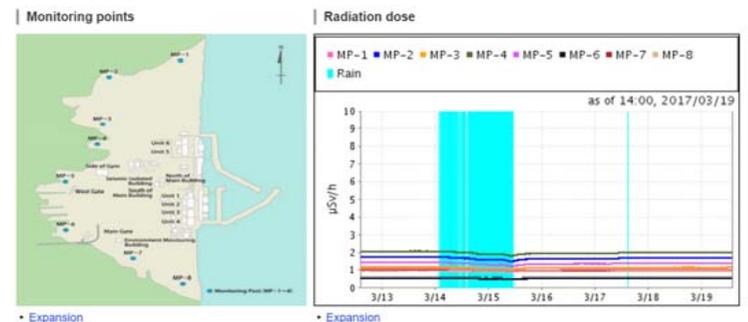
Monitoring post (MP1 - MP8)

MP-1	MP-2	MP-3	MP-4	MP-5	MP-6	MP-7	MP-8	Wind Direction	Wind Velocity	Rain
1.037	1.703	1.155	2.006	1.390	0.549	1.005	0.935	east-southeast	3.3	No

As of 11:40 a.m. on March 19, 2017: about 0.5-2.0 μSv/h
 *Radiation dose including the other influence than the PCV interior

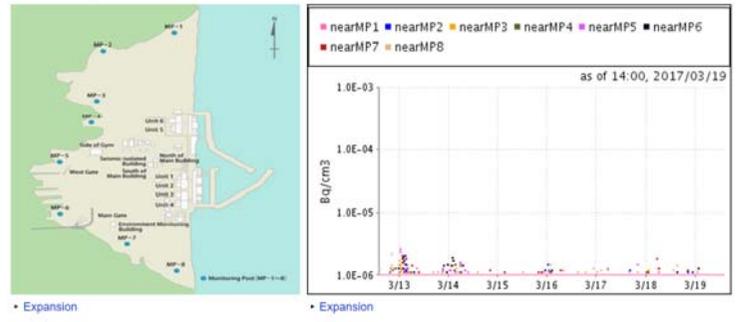
Monitoring points

nearMP1	nearMP2	nearMP3	nearMP4	nearMP5	nearMP6	nearMP7	nearMP8	Wind Direction	Wind Velocity
1.0E-06	east	1.9

As of 11:50 a.m. on March 19, 2017: 1.0E-06Bq/cm³
