Partial damage to temperature gauge cables for the
Reactor Pressure Vessel (RPV) found during the
Fukushima Daiichi NPS Unit 3 Primary Containment Vessel
(PCV) internal investigation

November 30, 2017

Tokyo Electric Power Company Holdings, Inc.

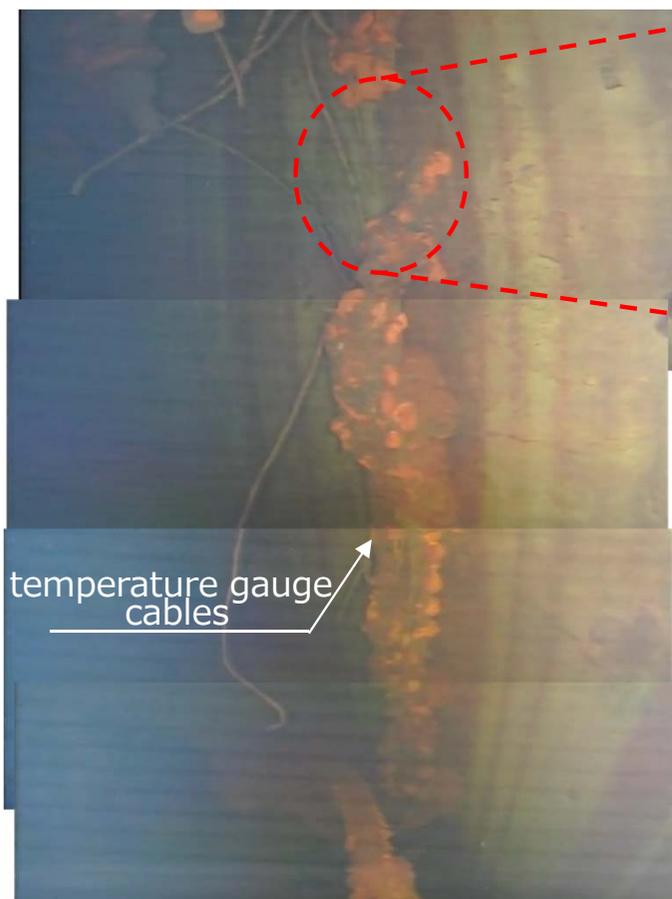
- There are two routes for temperature gauges at the bottom of the RPV, one inside the pedestal (12 temperature gauges*) and one outside the pedestal (6 temperature gauges*). * Three along the inside route and six along the outside route are used to monitor the limiting conditions of operation stipulated in the implementation plan.
- Damage to the inside pedestal route (12 temperature gauges)** was seen in images taken during the internal investigation.
- Damage was found on cables inside the PCV between the relay terminal platform and measuring points

- temperature gauge cables found damaged are made of a metallic sheath and wires that have a melting point of more than 1,000°C.
- It is assumed that the cables experienced thermal cutting by **high-temperature molten objects** that fell onto the cables from the RPV bottom.
- **The 12 temperature gauges along the route leading inside the pedestal are considered to be “broken”** because thermal cutting of the cables has rendered them unable to measure the temperatures at the bottom of the RPV.

- We will further confirm the state of cooling by measuring the resistance of temperature gauge circuits and looking at past temperature data for RPV and PCV temperature gauges.
- We will also deliberate how to check the state of cooling going forward based on the results of the PCV internal investigation etc.

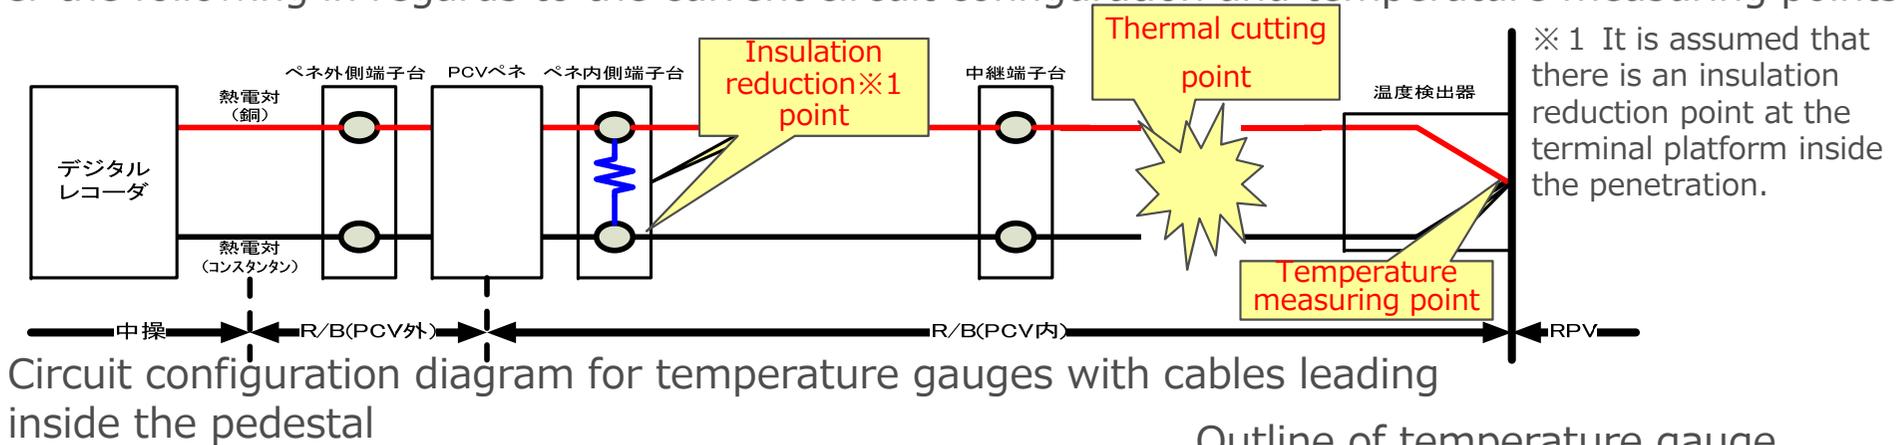
Outline of temperature gauge positions

- Temperature readings that have been obtained from the 12 temperature gauges along the route inside the pedestal infer the following in regards to the current circuit configuration and temperature measuring points.

- Thermocouple temperature gauges can measure temperatures only when the copper and constantan wires form a closed circuit. **The temperatures in the RPV (measuring points) cannot be measured** because the cables were severed by thermal cutting.
- Insulation reductions inside the PCV caused by the accident have been confirmed. Temperature readings can be taken at locations of insulation reductions because the insulation reductions form thermocouple circuits. **This means that temperatures in the PCV^{※2} are being measured.**
