Fukushima Daiichi Nuclear Power Station Unit 2 Primary Containment Vessel Internal Investigation Results

February 1, 2018

Tokyo Electric Power Company Holdings, Inc.

1. Primary Containment Vessel Internal Investigation Overview

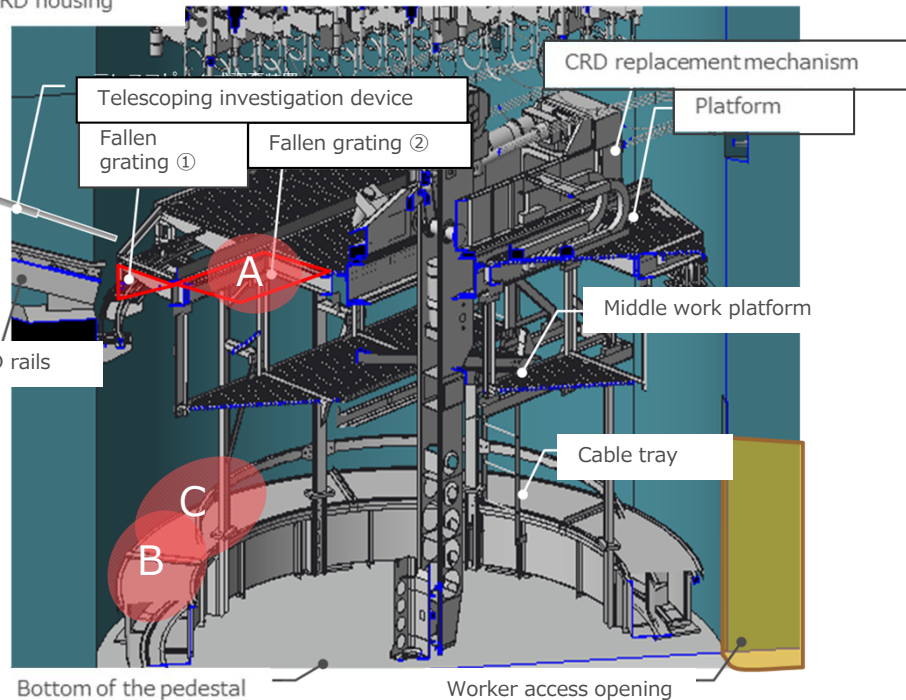
CRD housing

- The entire bottom of the pedestal was found to be covered with sandy and clay-like deposits.
- Some fuel assembly components (top tie-plate) have fallen to the bottom of the pedestal and deposits thought to be fuel debris were found in the vicinity of these fallen components.

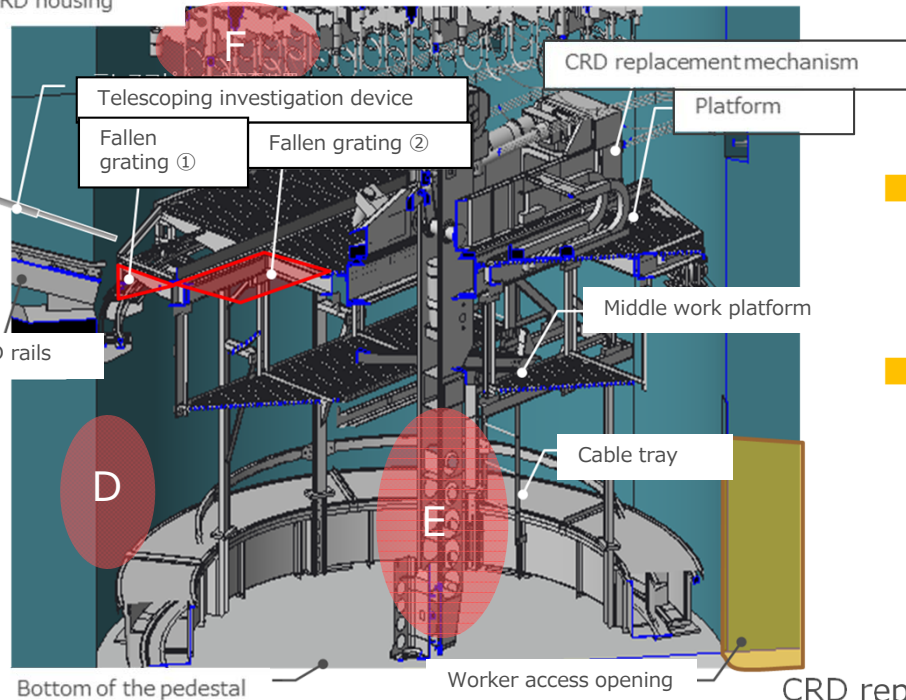
No significant damage was seen on the inner wall of pedestal

- No significant damage was seen to existing structures inside the pedestal (CRD replacement mechanism)
- The CRD housing supports were found to be in the same condition as was seen during the January~February 2017 investigations.
