3-D Rendering of Images obtained during the Fukushima Daiichi Nuclear Power Station Unit 3 Primary Containment Vessel (PCV) Internal Investigation

April 26, 2018

Tokyo Electric Power Company Holdings, Inc.

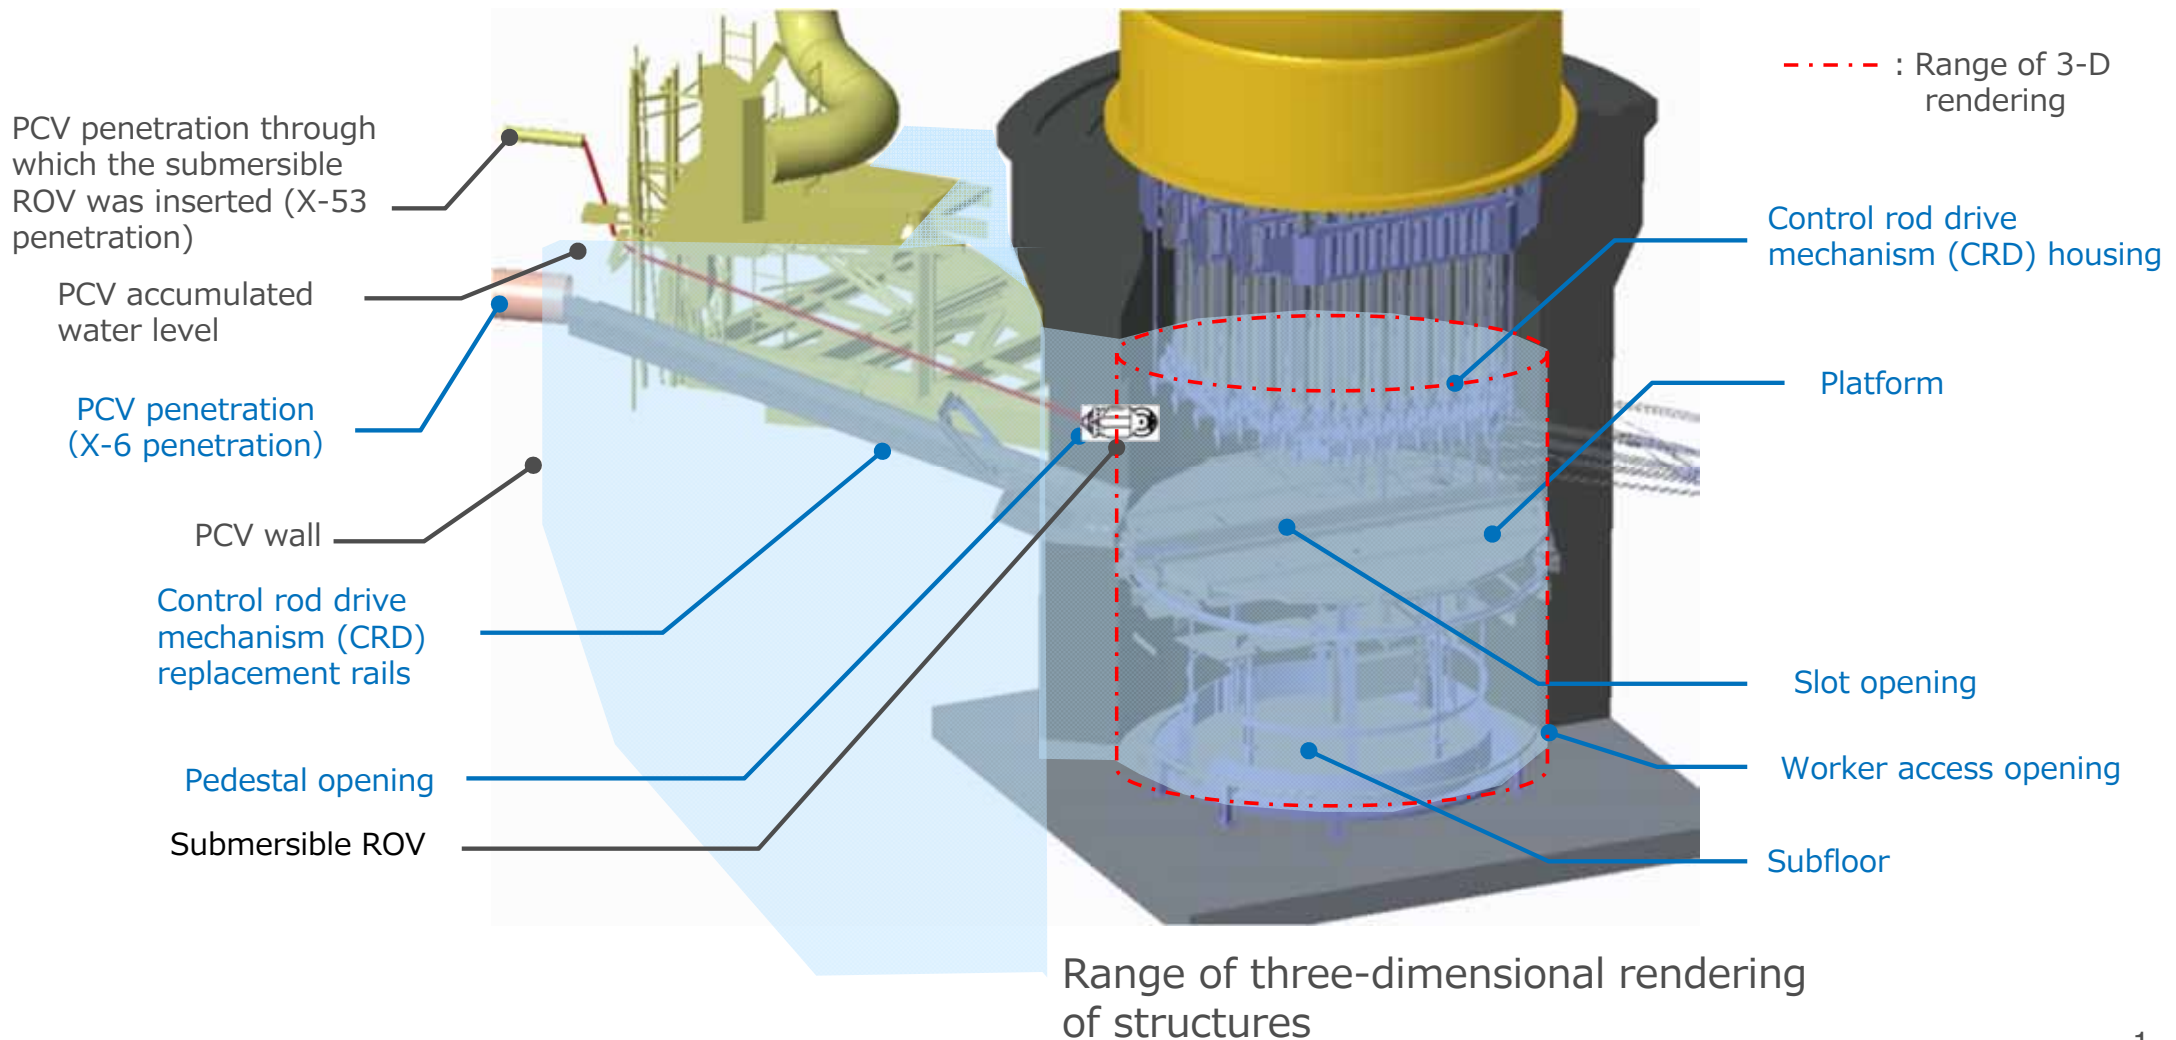
1. 3-D rendering from images taken

- Images obtained during the PCV internal investigation conducted in July 2017 were used to create a three-dimensional rendering of the entire pedestal using Structure from Motion (SfM).
- For areas where images were not taken during the internal investigation design data for structures was used to make estimates based upon which a three-dimensional image was rendered.
- Objects for which position could not be estimated and objects that could not be ascertained because they did not appear for long enough, were unclear, or were only partially visible in the videos, were not rendered.
