Workshop for technical catalog study regarding the development of equipment to remove fuel debris for decommissioning of Fukushima Daiichi Nuclear Power Station, Tokyo Electric Power Company 1

# Current Status and Needs for Technical Findings

February 24, 2012

Tokyo Electric Power Company

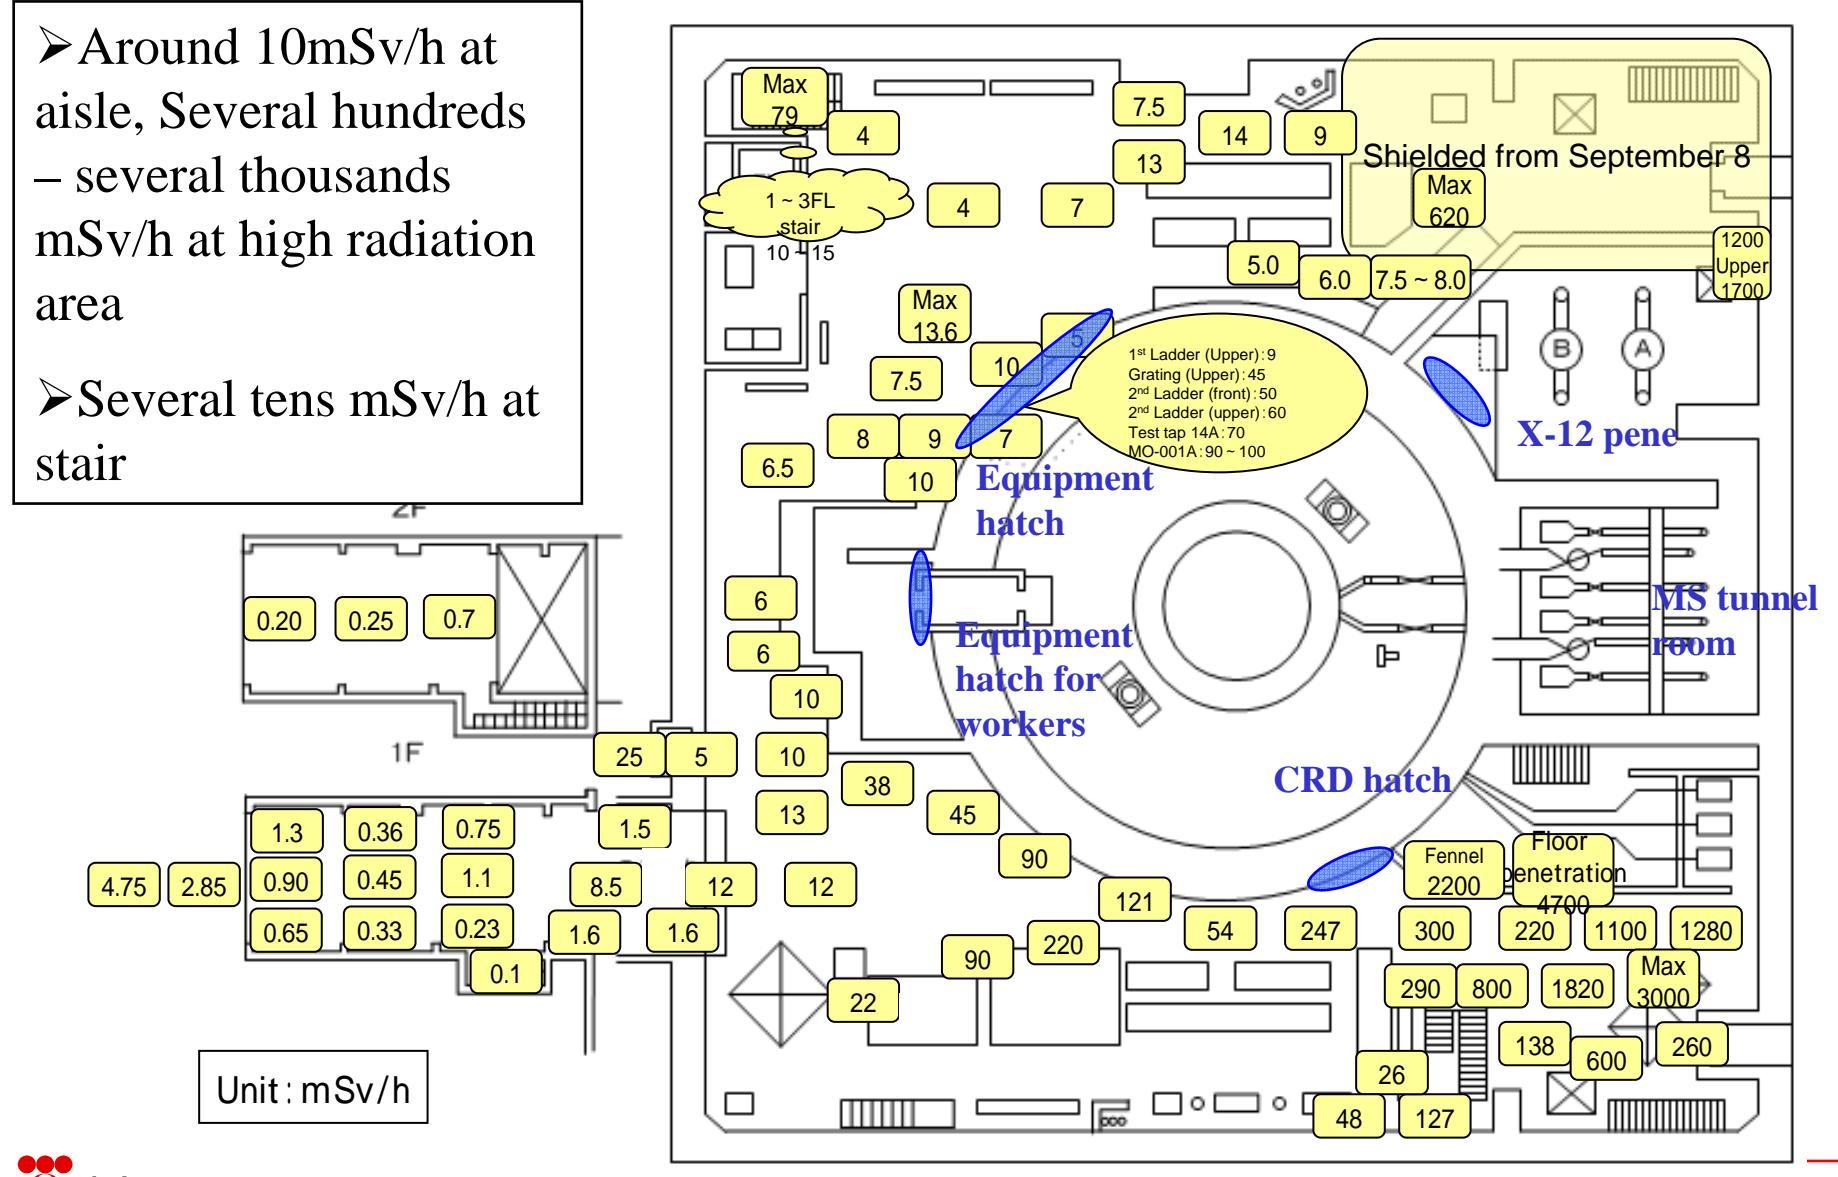
## Airborne radiation rate of reactor building (1<sup>st</sup> floor, Unit 1)

Data obtained from April to November 2011

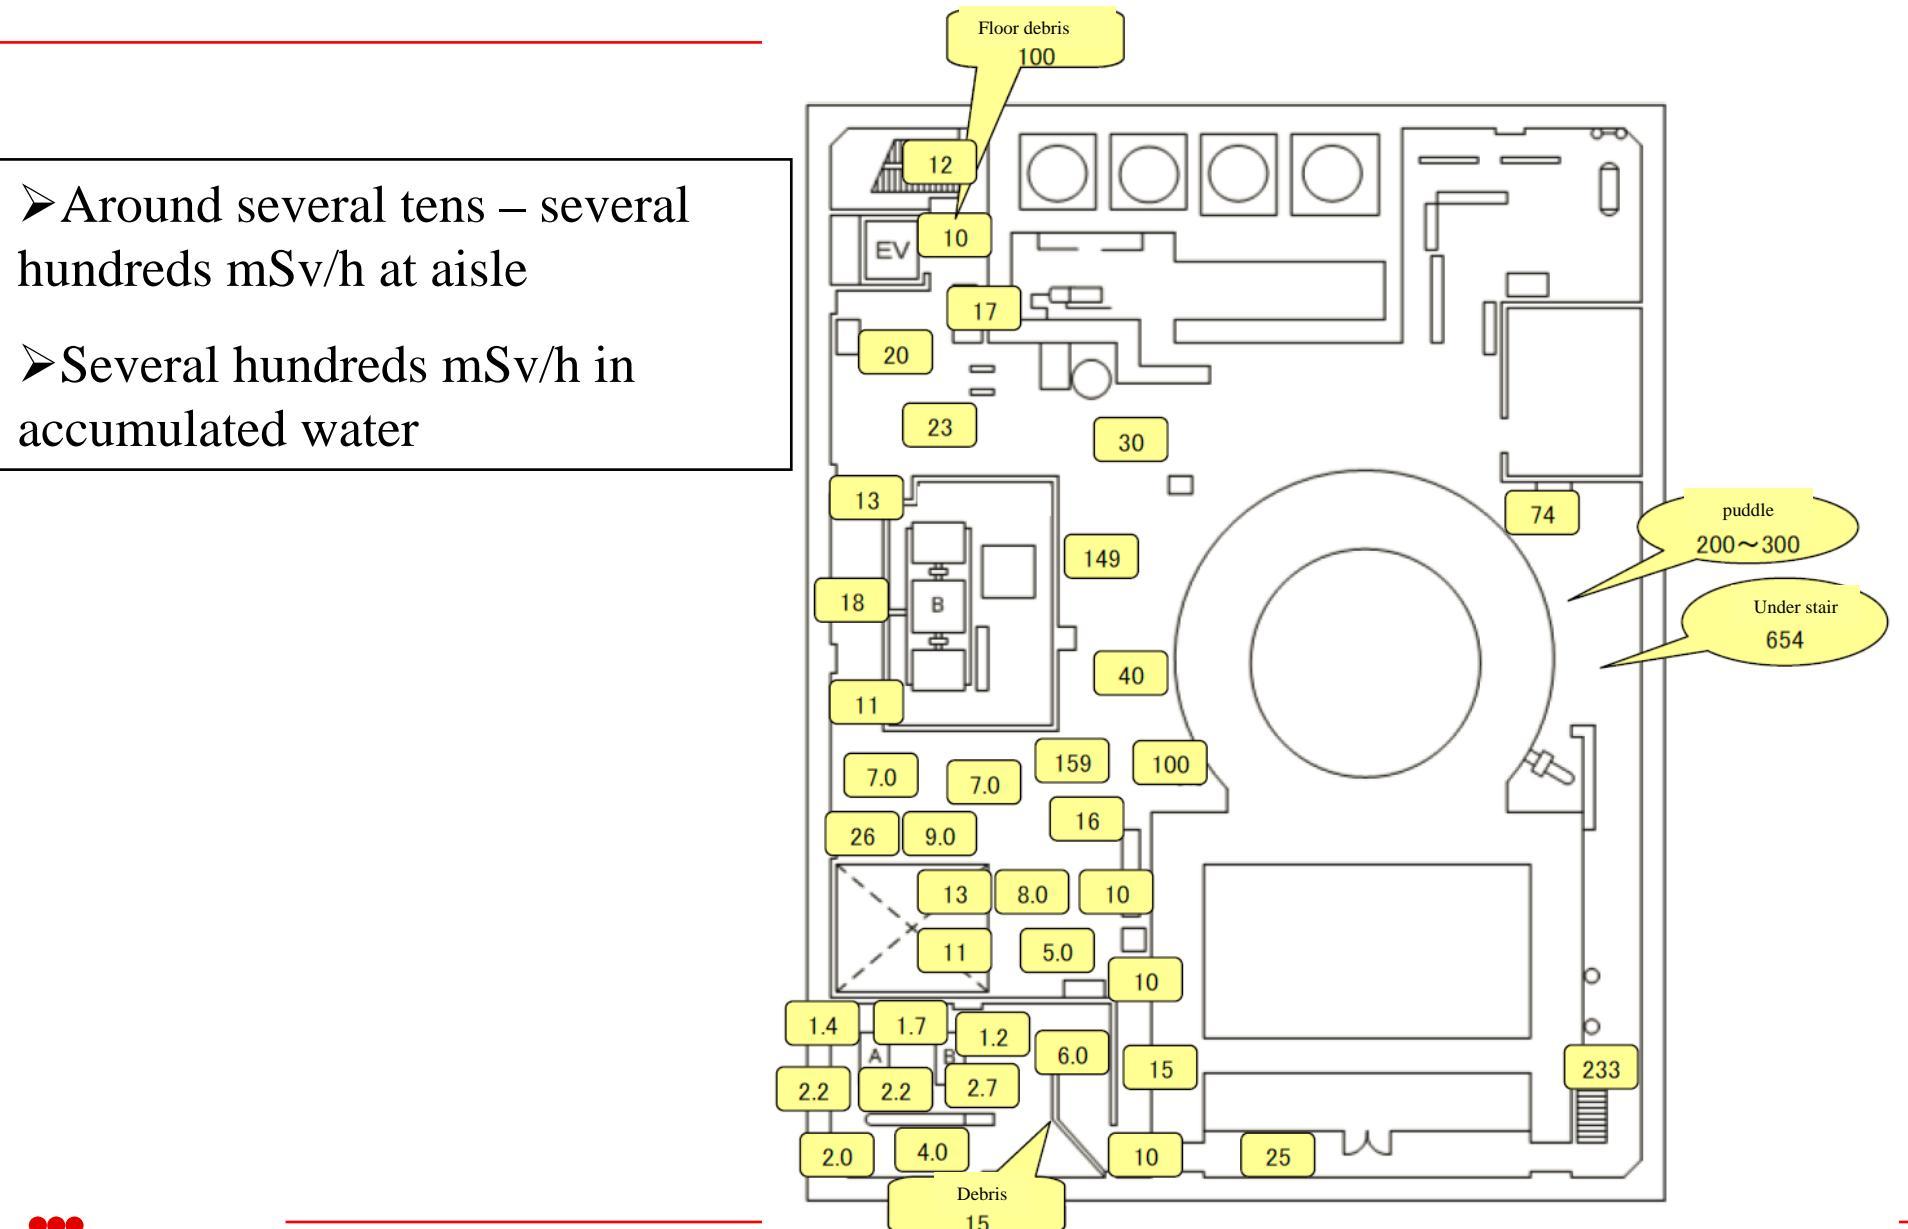
# Airborne radiation rate of reactor building (3<sup>rd</sup> floor, Unit 1)

Data obtained from April to November 2011

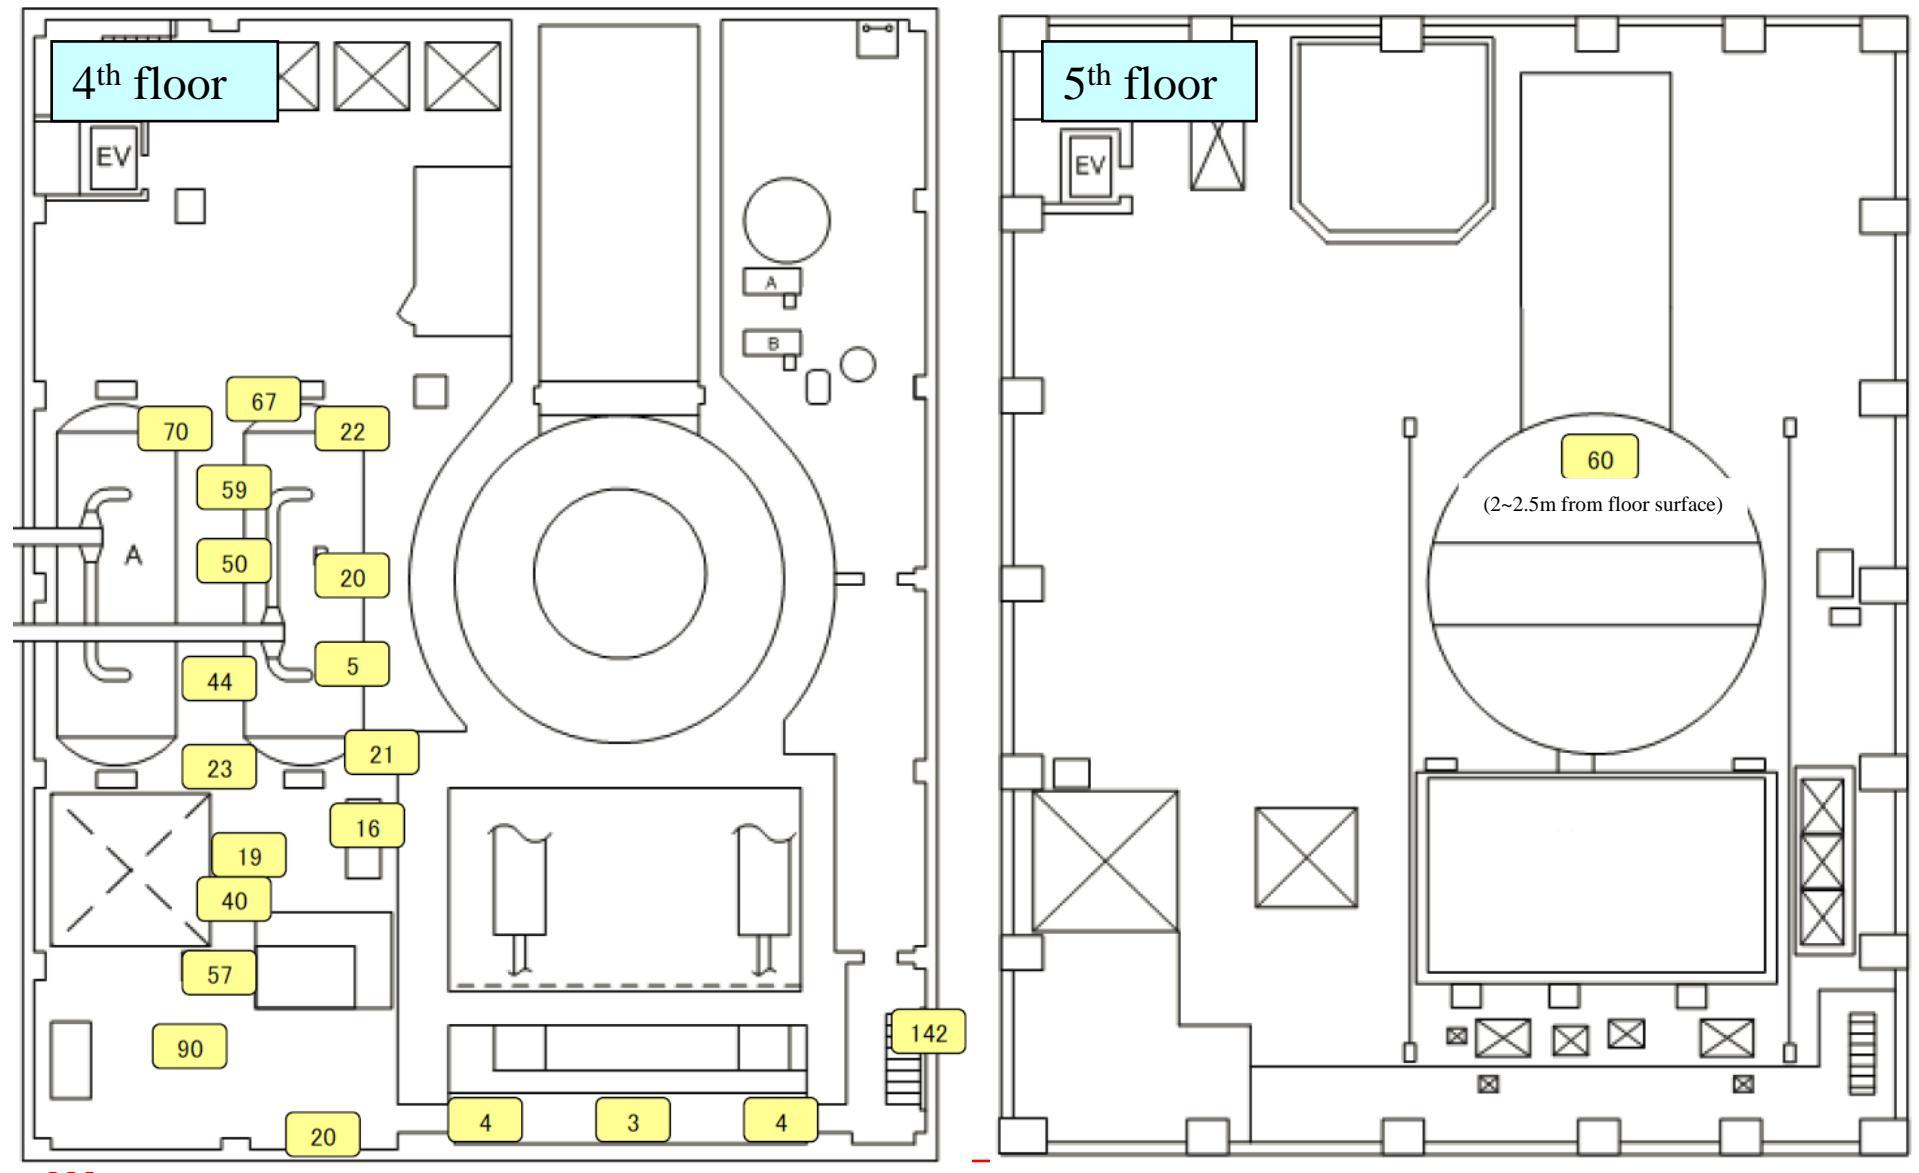
Data obtained from April to November 2011

- $\checkmark$  There are many area that has several tens several hundreds mSv/h
- $\checkmark$  Some high radiation area has several thousands mSv/h
- ✓ There is not much difference of airborne radiation rate regardless of whether or not reactor building exploded. (There is not clear difference among Unit 1, Unit 2, and Unit 3.)

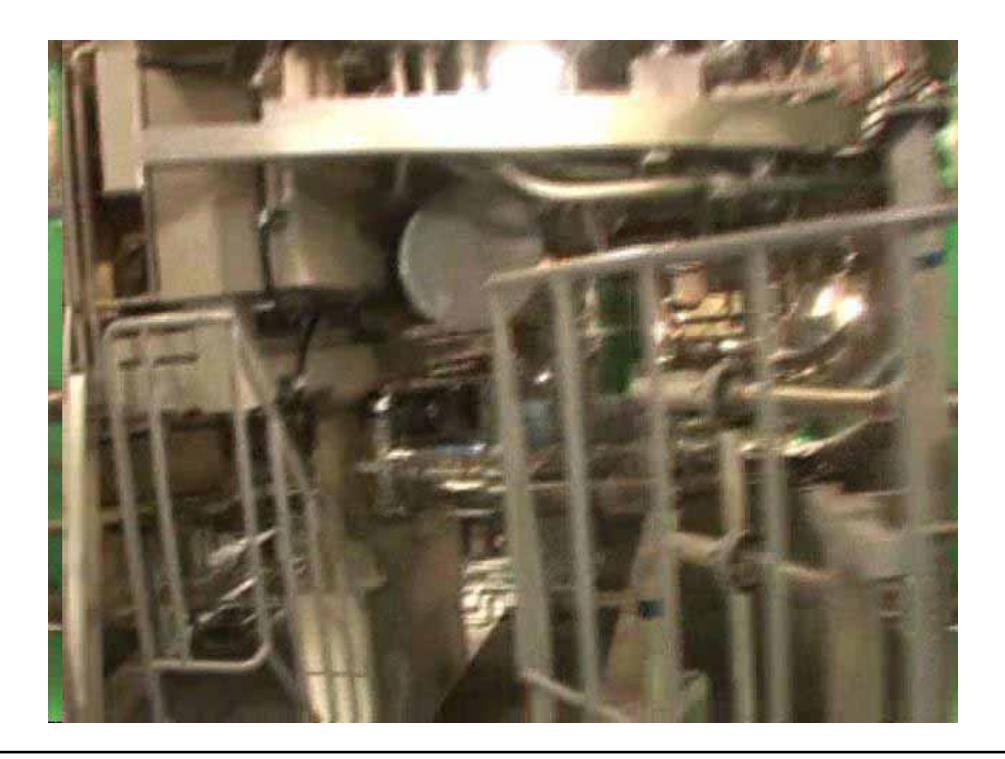
# [Reference] inside Primary Containment Vessel of Unit 4, Kashiwazaki-Kariwa

✓ Instruments are concentrated in primary containment vessel. Pluming roots are also complicated and so small.

$\checkmark$  It is not flat and has many ups and downs.
