# A One-year Review of Fukushima Daiichi Nuclear Power Station “Steps to Achieve Stabilization”

March 2012

# I. Accident Causes & Measures Taken

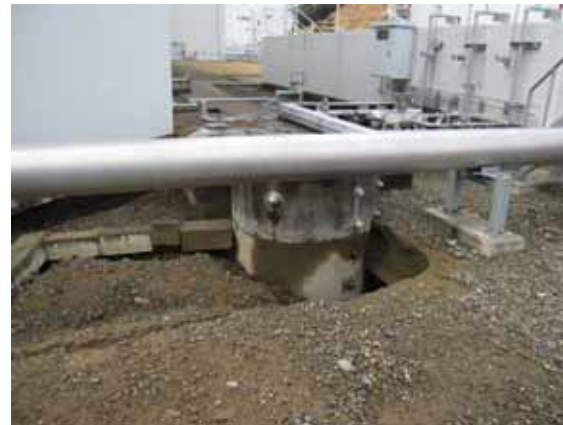
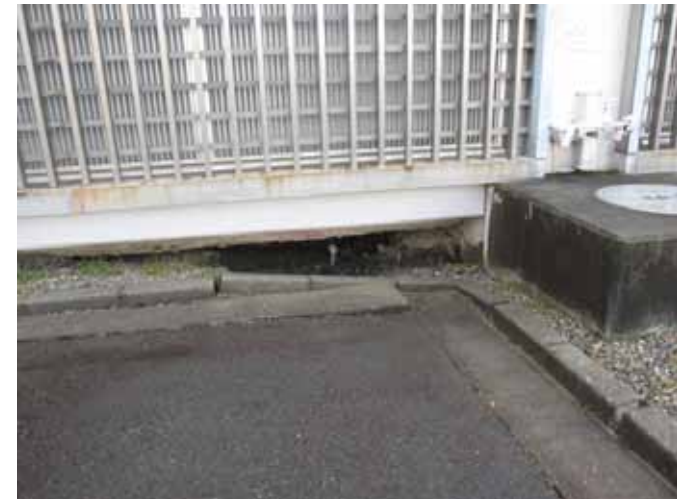
Ground subsidence partially occurred

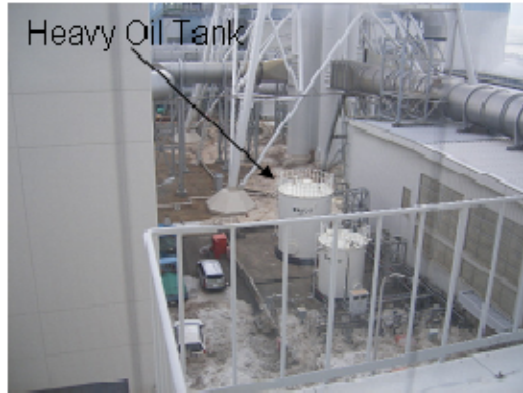
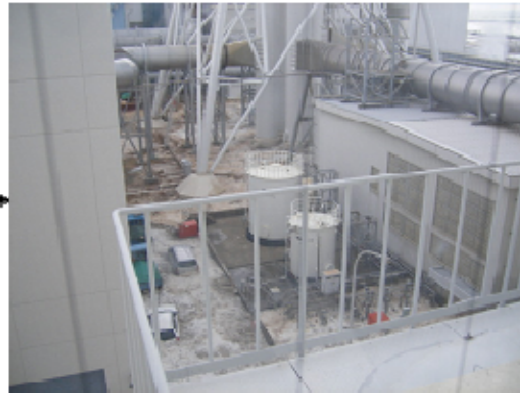
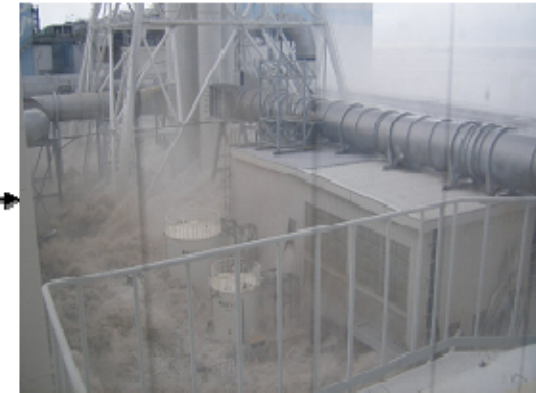
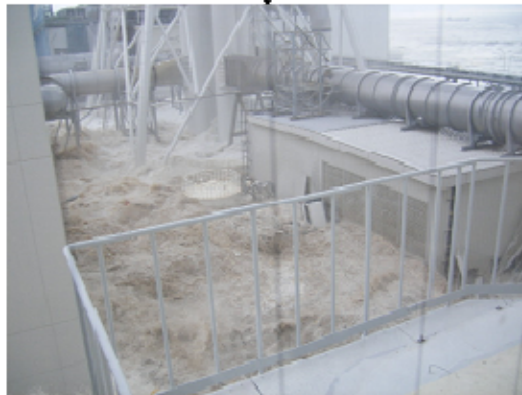
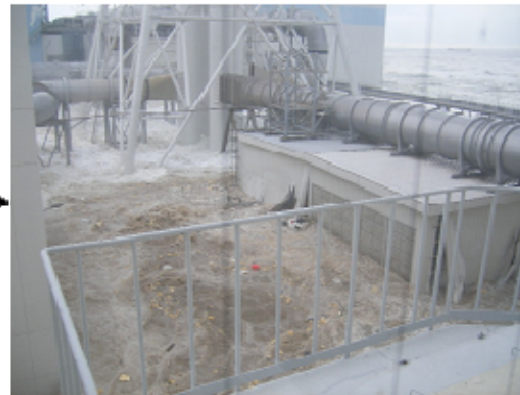
Heavy Oil Tank (about 5.5 m high) was submerged by the tsunami, which was located at the level of OP +10 m.

**Outdoor flooding conditions at Fukushima Daiichi Nuclear Power Station**

(Near the Unit 4 South-side Central Environmental Facility Process Main Building site height O.P.+10m, heavy oil tank height approximately 5.5m)

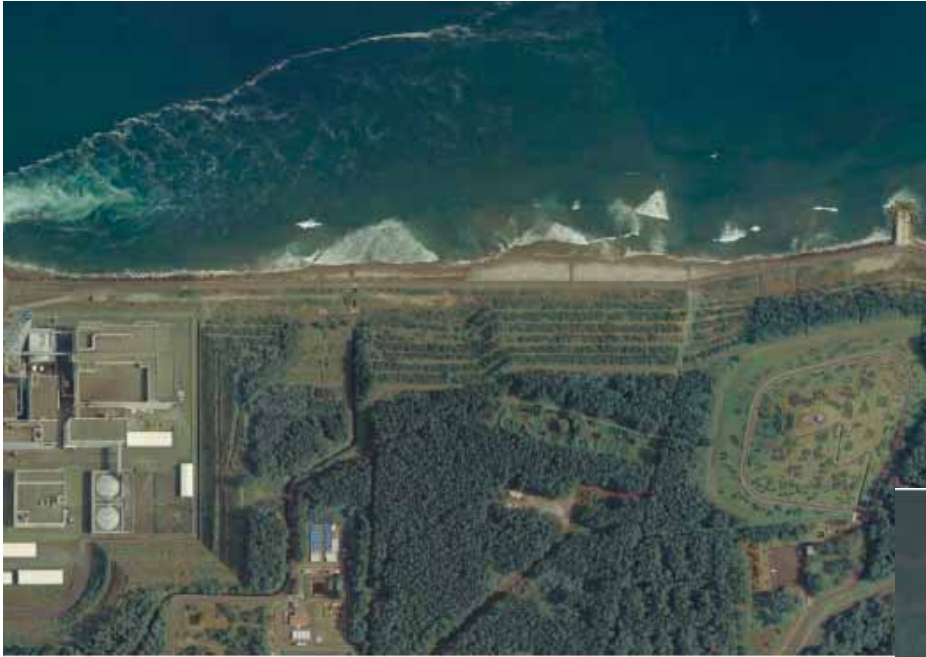
Before March 11th

Washed Away Trees

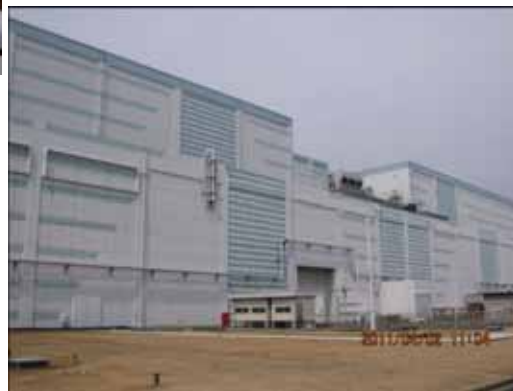
(3) No damage to Turbine Building of Units 3 and 4

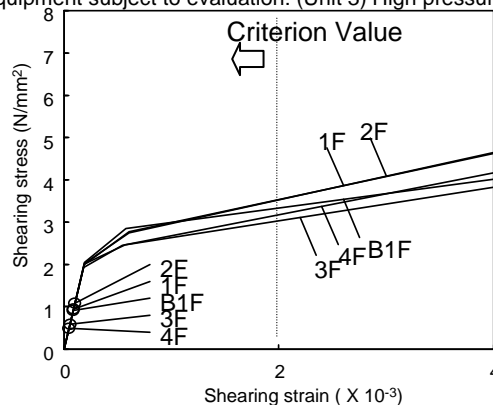
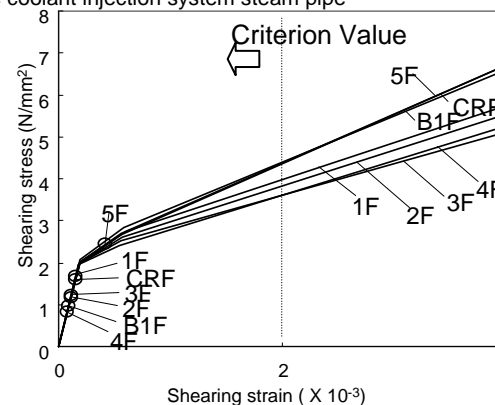
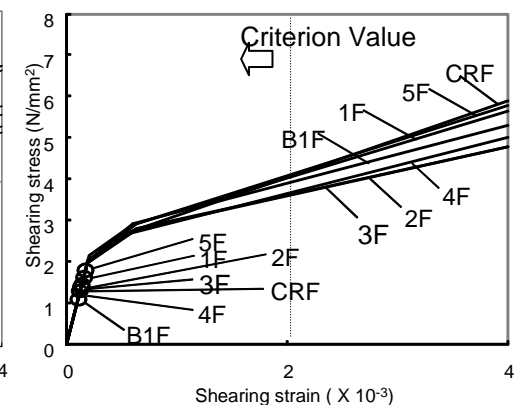
It is estimated that the safety functions of the important safety-related equipment had been secured after the earthquake because the stress strain analysis with actual seismic records resulted below the design basis in all equipments.

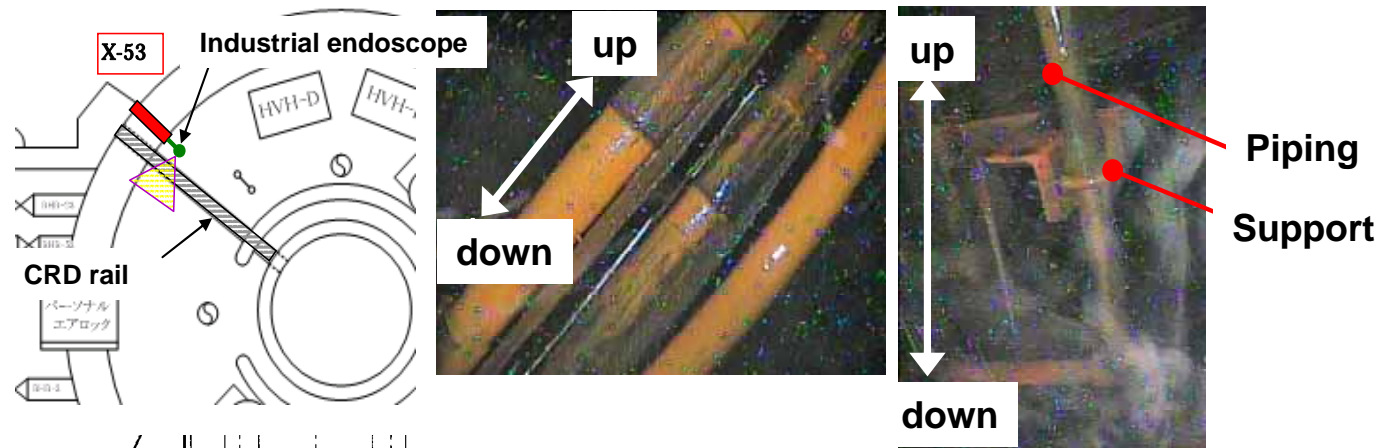
No damage was confirmed to the small-diameter piping inside the PCV according to the video observation in Unit 2 of Fukushima Daiichi

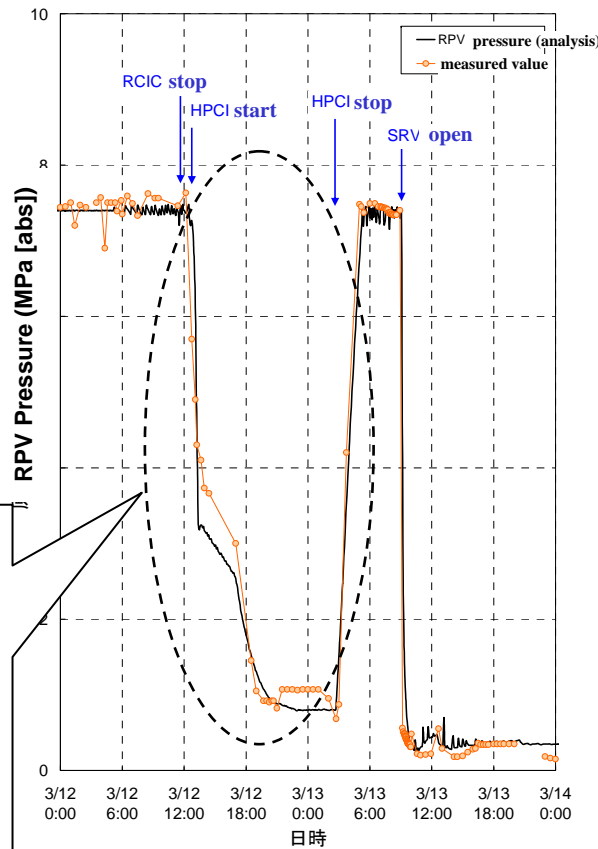
Although the piping rupture of HPCI in Unit 3 was a concern considering the reactor pressure decrease, no damage was confirmed by the operator who investigated in the field after HPCI had been brought to a stop. The reactor pressure decrease during HPCI operation is due to its continuous water injection.

- The reactor pressure decreased after HPCI start-up and maintained near 1MPa.
- After HPCI stopped, the reactor pressure increased.
- The decreased reactor pressure is simulated with operator's flow control by analysis.

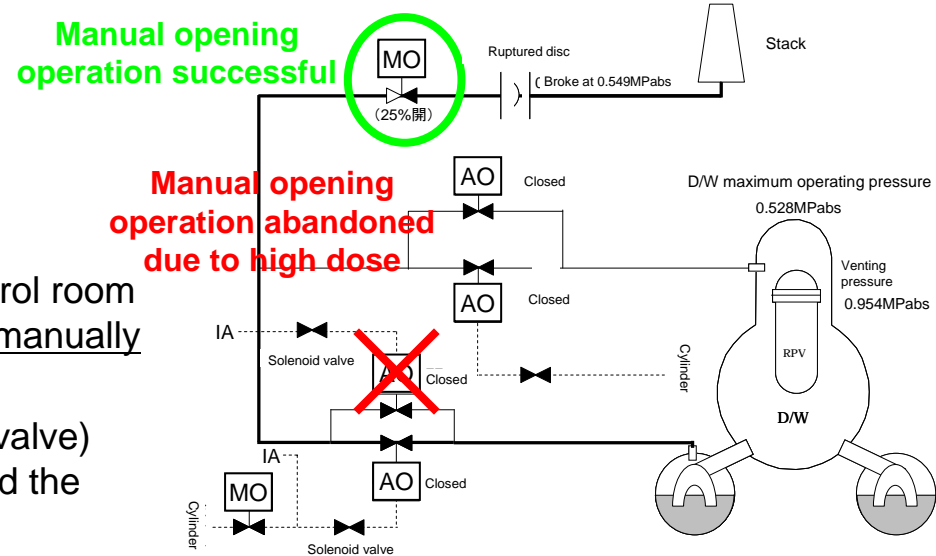
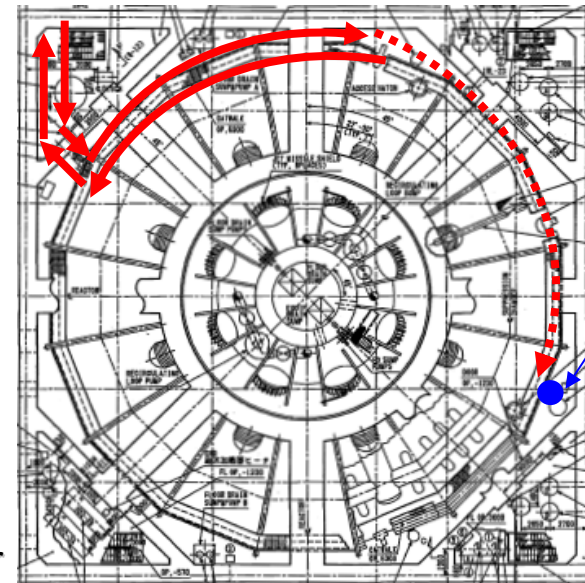
S/C vent valve (AO valve)

- The valve could not be operated from the main control room due to the loss of power supply and air pressure, thus it was decided to open it manually in the field.
- The second team entered the Torus room (R/B B1F), but the valve was located at the opposite side from the entrance.
- Since the radiation meter exceeded its measurable limit, the operators had to give up and return.

➡ Decided to give up the manual operation for venting and to choose another method ( to connect a portable compressor and generator etc. )

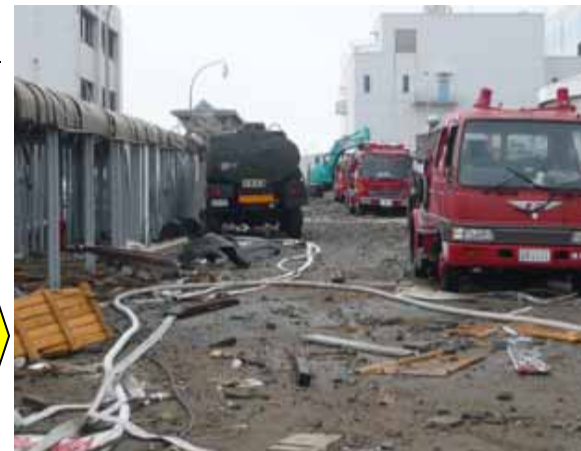
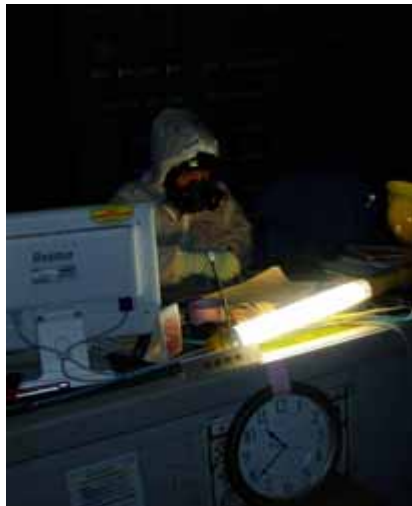
Subsidence of roads etc.  
Dangerous to walk in, especially at night

Obstacles  
Detours to avoid fire truck hoses etc. After the explosion, debris and damaged fire trucks became obstacles.

Vice operation manager during monitoring  
Monitoring with a full-face mask on in complete darkness.

Temporary battery for instruments  
Utilized temporary battery etc. for the power source of the instruments

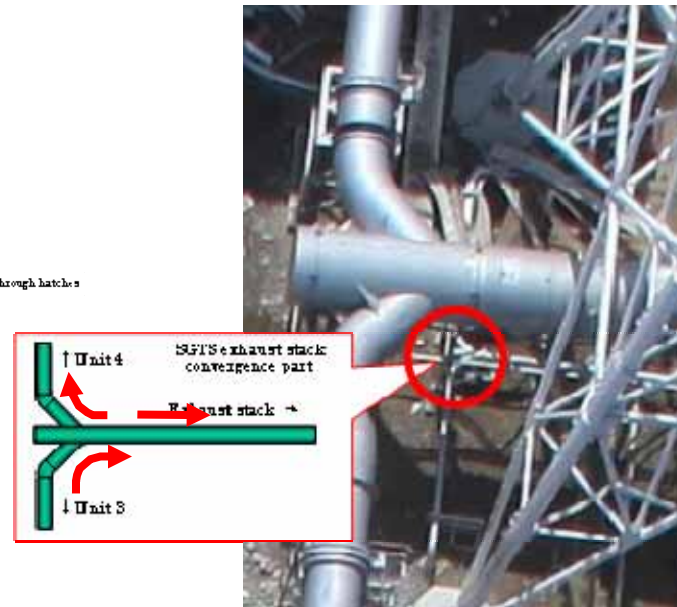
Units 1 & 3 Image of leakage path

- Unit 1 & 3: Hydrogen generated from the damaged reactor fuels without cooling function accumulated in the PCV, leaked into the Reactor Building and then exploded.  
(It is estimated that inert gas (nitrogen) was properly inserted and thus the explosion inside the PCV was able to be avoided.)
- Unit 4: Hydrogen leaked and accumulated from the neighboring Unit 3 through the Standby Gas Treatment System (SGTS) piping while it was venting and then it exploded.
- Unit 2: It is estimated that the air ventilation inside the building was stimulated when the blow-out panel on the top floor burst open due to the explosion of Unit 1 and thus an explosion was avoided.

There are possibilities that the inferred leakage flow paths differ between Unit 1 and 3 according to system configuration

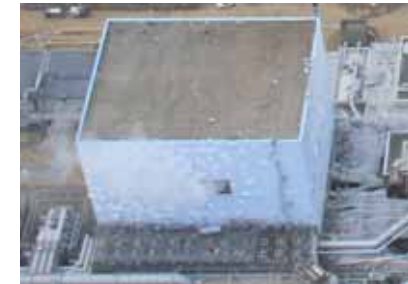
Opening the Unit 2 blowout panel

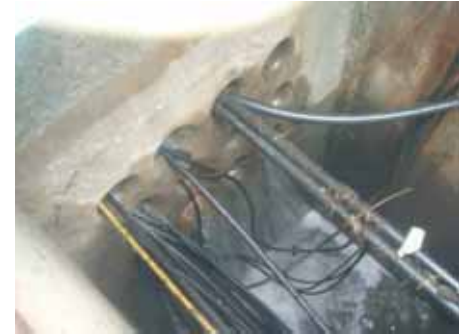
- High-level contaminated water spilled out to the Unit 2 intake. (2011.4.2)
- Contaminated water accumulated in the Central Radioactive Waste Treatment Building and was released into the ocean.(2011.4.4)
- Contaminated water spilled out through a pit near the Unit 3 intake.(2011.5.11)

Situation in the pit near Unit 3 intake

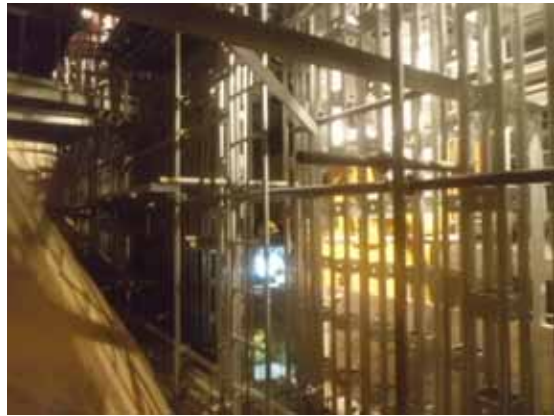
Steel support structure (2011.6.20)

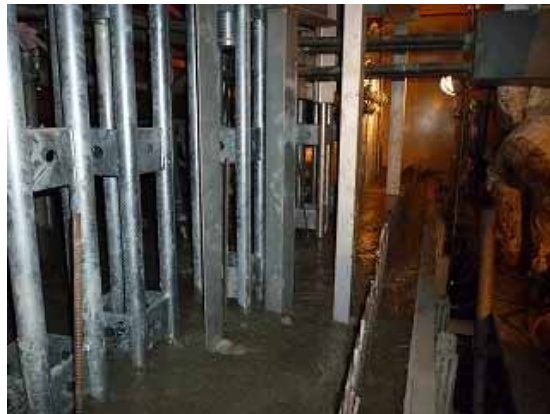
Concrete placement (2011.7.21)

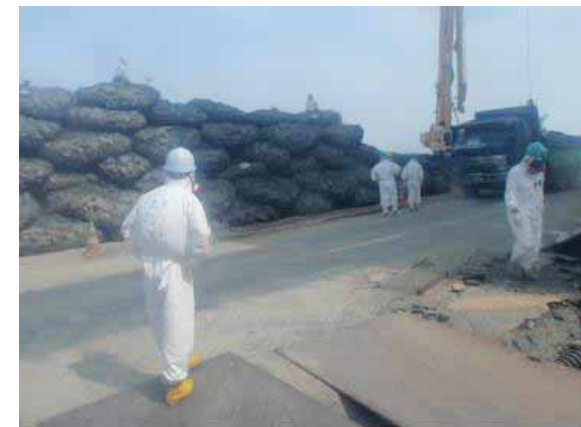
Temporary coastal barrier was installed as a countermeasure against tsunamis in case of a large aftershock of a magnitude 8 level.  
(completed in June 30th 2011)

Installation work of temporary coastal barrier

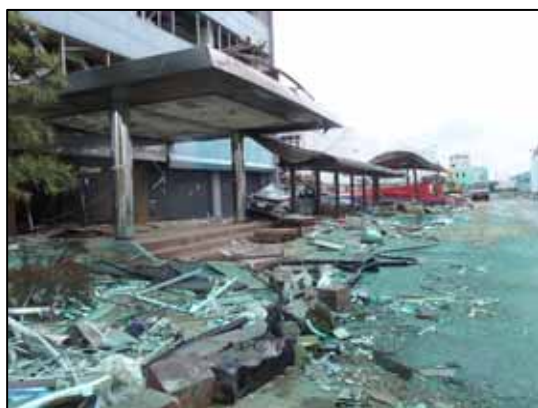
[Date] 2011.5.27

[before] (1) In front of the Main Office (2) Road between Units 2 and 3

Trying to improve the working environment and reduce the radiation dose exposure of workers by removing and storing the rubble. The removed rubble are stored separately according to its radiation dose.

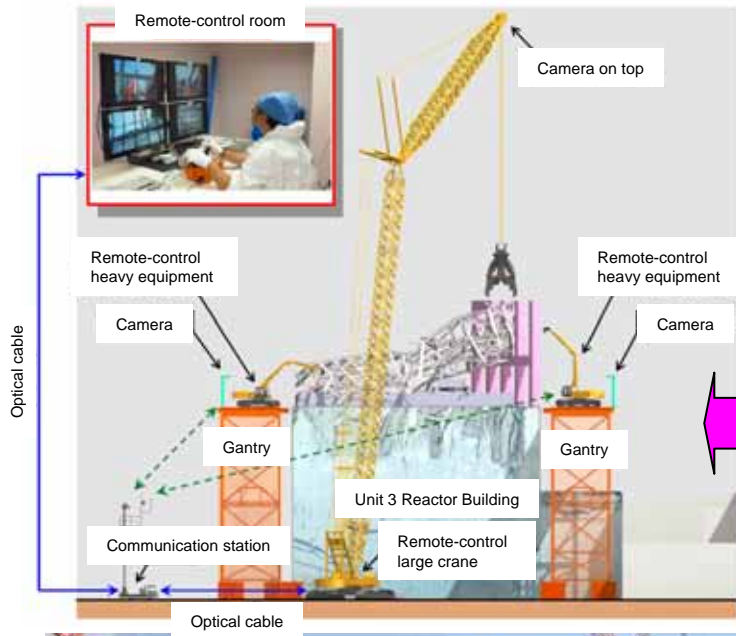
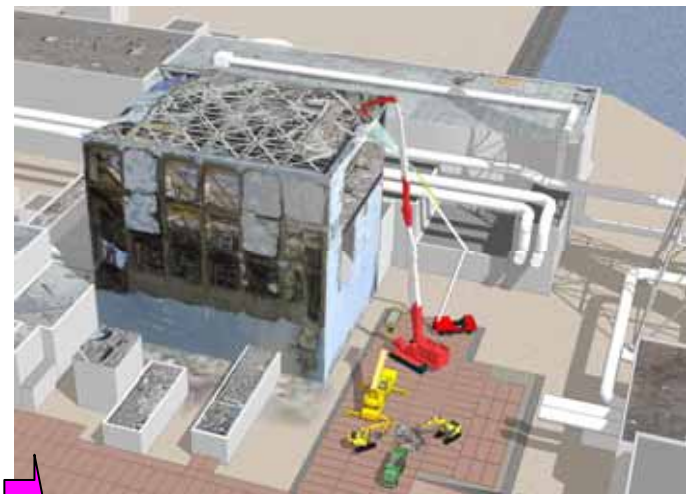
Unit 3 2012.2.21

To prepare for fuel removal from the Spent Fuel Pools, the scattered debris above the Units 3 & 4 reactor buildings are now being removed.

**Unit 3** Rubble removal work above the reactor building is being carried out by the remote-control heavy equipment on the surrounding gantry or the ground to reduce the radiation dose of workers.
