# Soundness Verification Results of Unit 4 Reactor Building at Fukushima Daiichi Nuclear Power Station

May 25, 2012

Tokyo Electric Power Company

# Inspection Overview

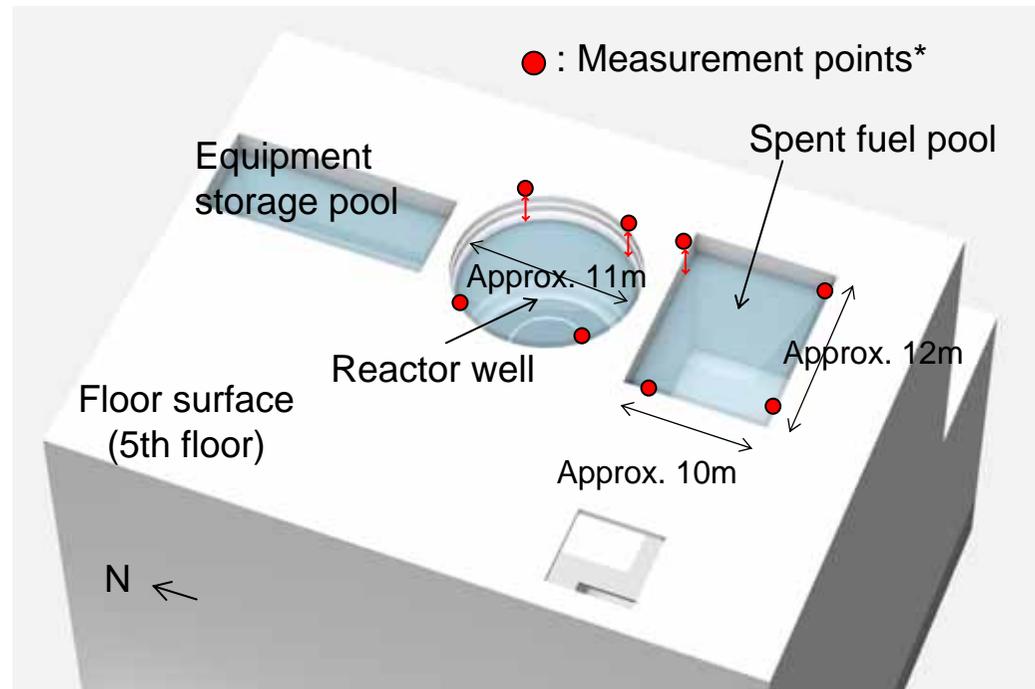
### Measurement Points (Floor surface of the 5th floor)

As the measurement values on the four corners are about the same, it can be concluded that the 5th floor surface and the water levels of the spent fuel pool and the reactor well are parallel. (It has already been confirmed that the building is not tilted based on the measurement results acquired on February 7, 2012 and April 12, 2012.)

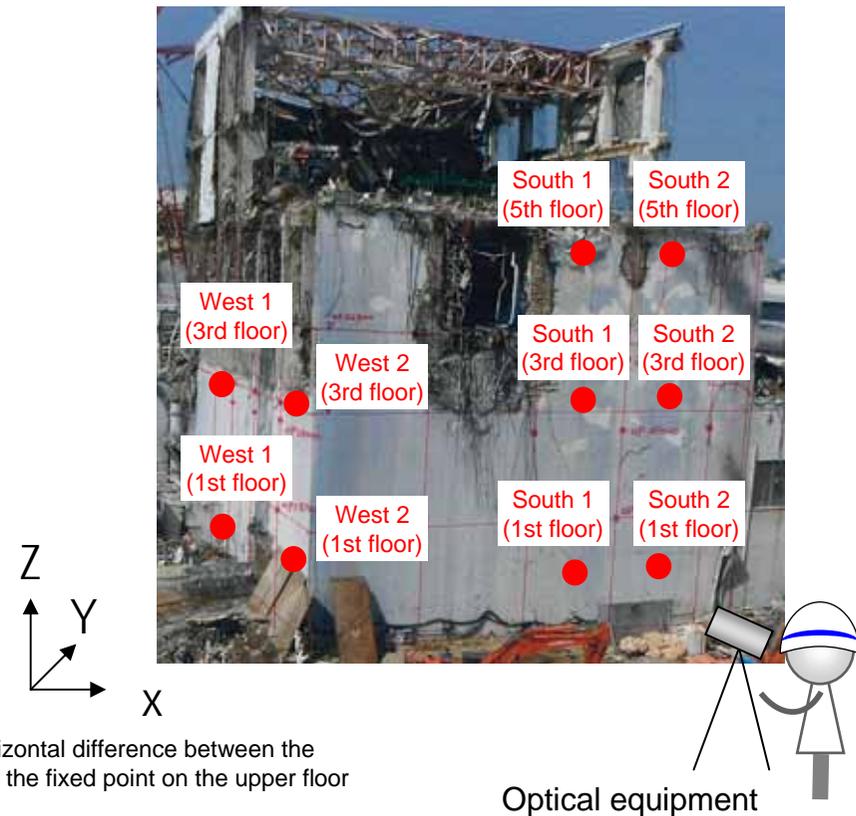
\* Measurement points were set on the locations near the spent fuel pool (South 1 & 2), the central part of the west surface (West 1) and a location near the vaulted floor which is assumed to have been largely effected by explosion (West 2).

The results of the exterior wall perpendicularity were all below the limits given in the Building Standard Act\*. It can be concluded that the building itself is not tilted and the structure safety is secured.

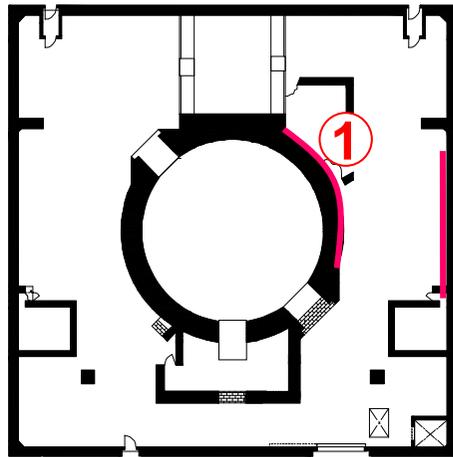
1st Floor Plan

As a result of visual inspection, cracks of which the width exceed 1mm or which have the possibility of rebar corrosion were not confirmed.

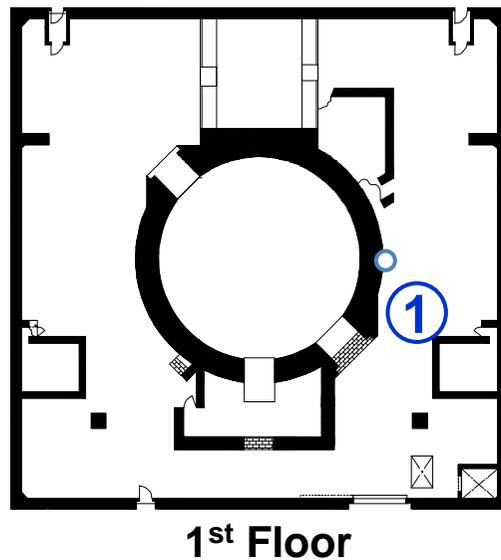
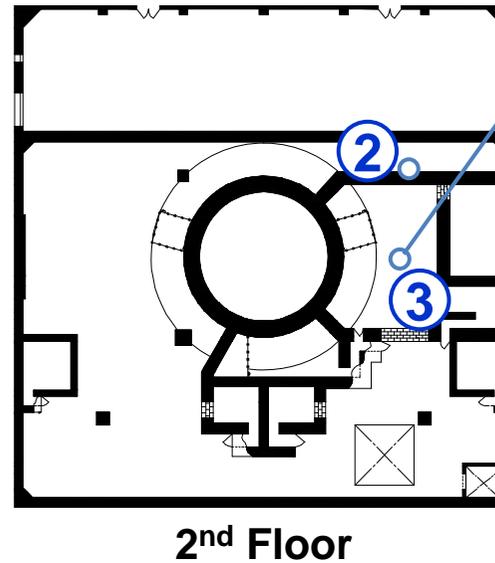
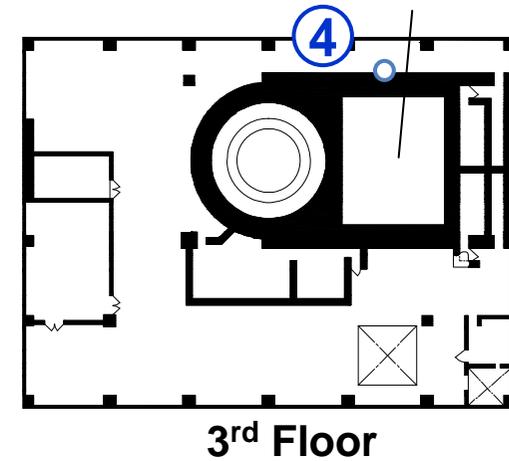
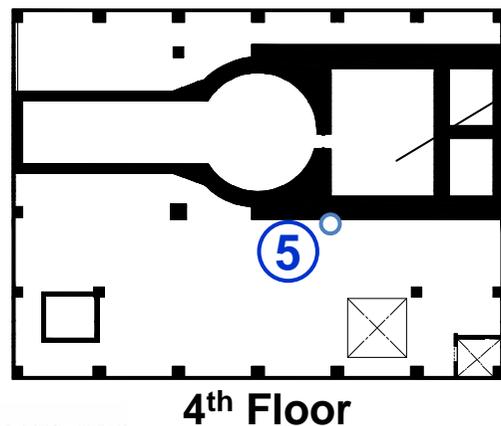
➤ At all points, we confirmed enough structural strength since the concrete strength was above the design standard (22.1N/mm<sup>2</sup>).

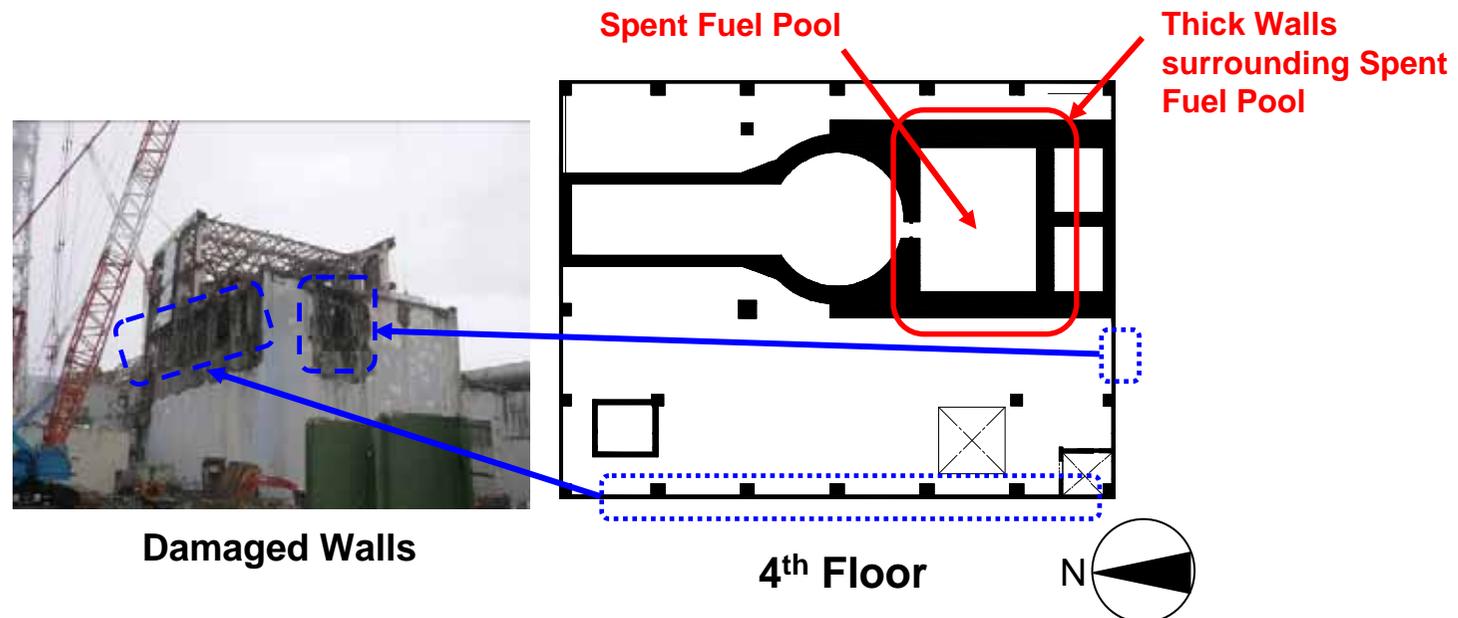
- According to the investigation this time, we confirmed that the spent fuel pool can safely hold spent fuels since the strength of the concrete walls is maintained, there was no cracks or slants, the thickness of the important walls of the spent fuel pool is 140cm ~ 185cm, even though some parts of upper layer of the exterior walls are damaged.
- Additionally, we confirmed that the building is not tilted from the measurements this time, even though it looks like being tilted depending on the viewpoint of pictures.

We will investigate changes over time in future inspections.
