# The Soundness of Unit 4 Reactor Building and Spent Fuel Pool at Fukushima Daiichi Nuclear Power Station

August 30, 2012

Tokyo Electric Power Company

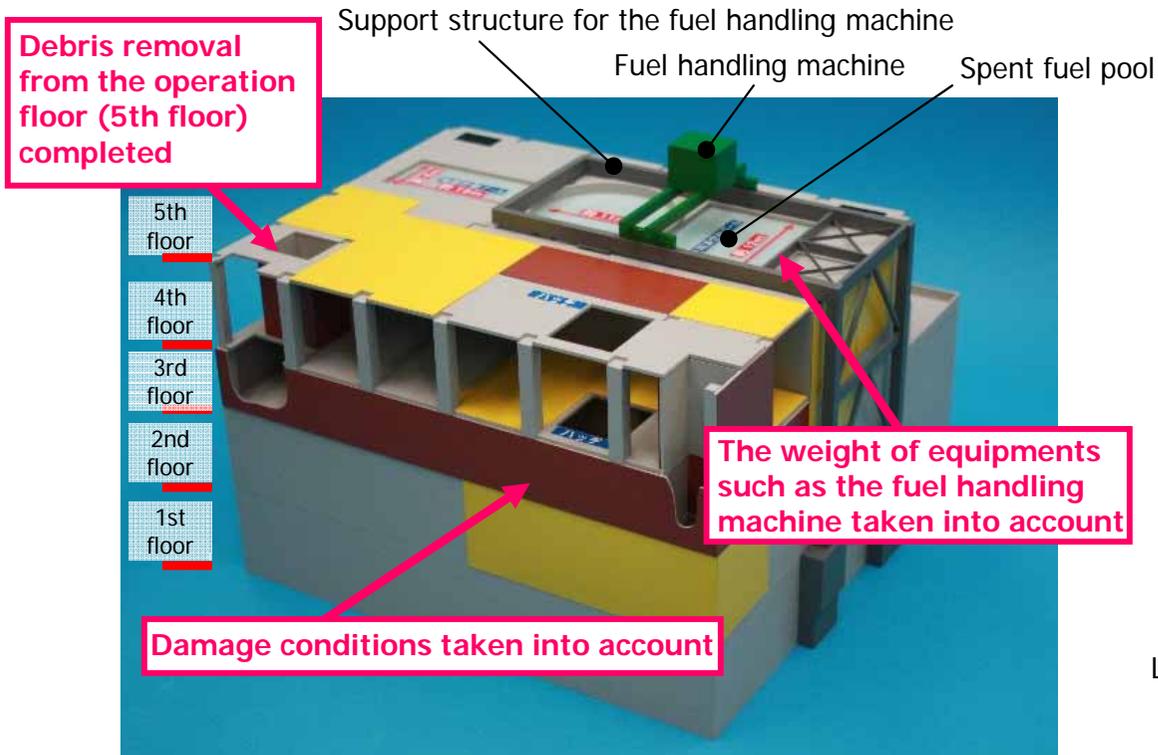
## Assumed conditions of the reactor building

Legend (Damage conditions)

: Completely destroyed
  : Partially destroyed\* (Including the bulge)
  : No damage

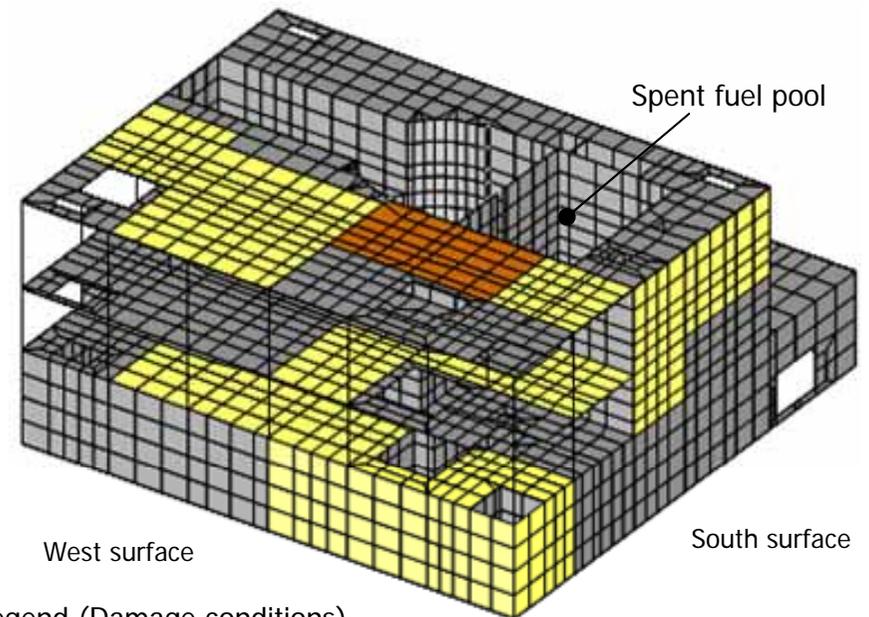
## Computer analysis model (in consideration of damage conditions)

: Completely destroyed
  : Partially destroyed\* (Including the bulge)
  : No damage

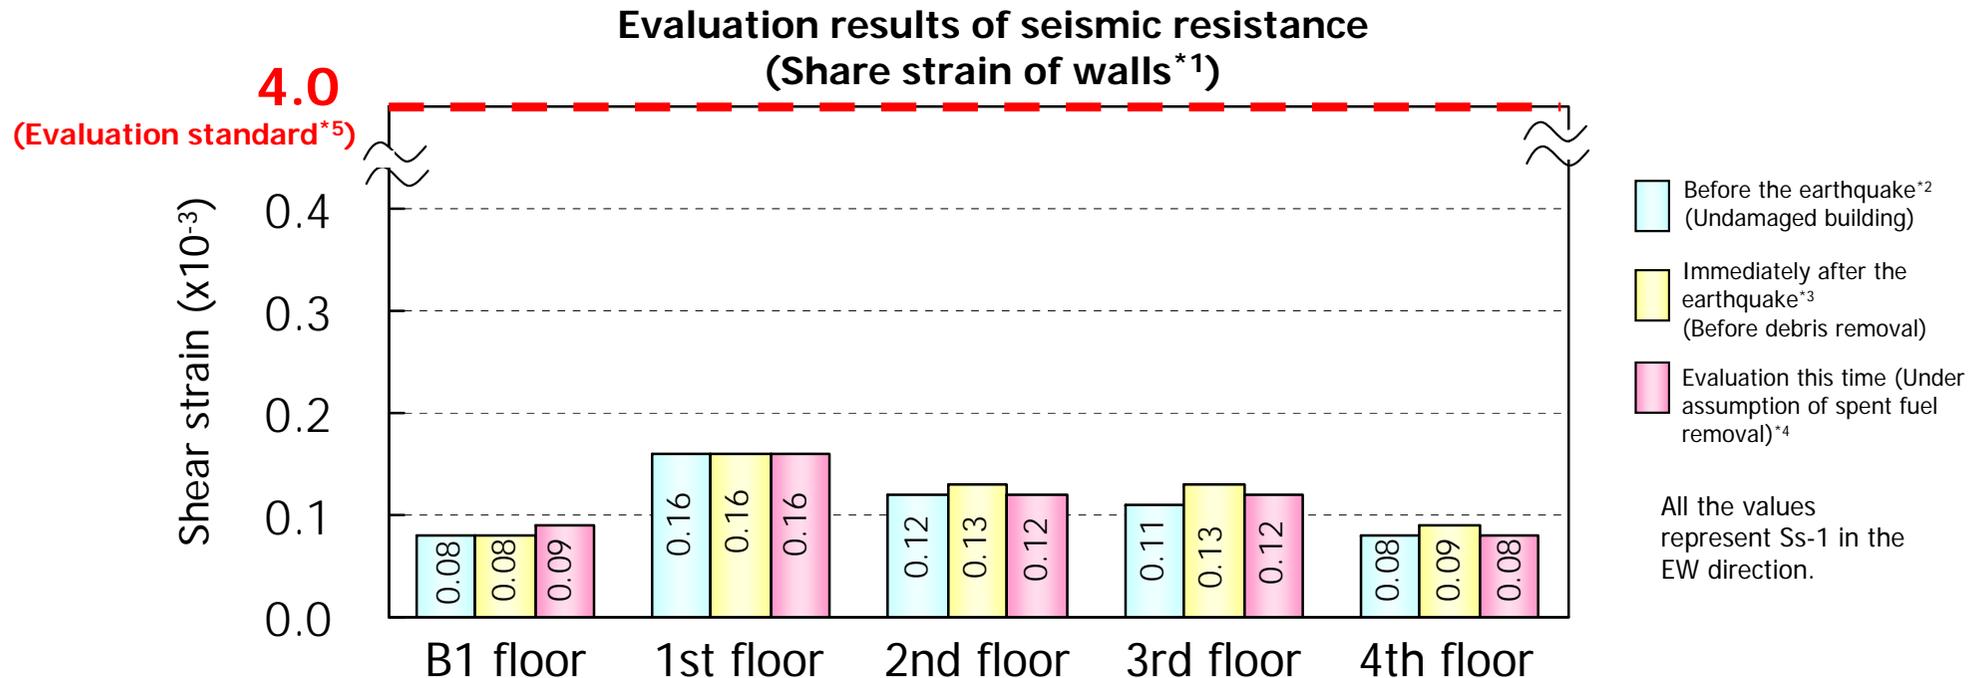
- The reactor building has seismic resistance equivalent to that of before the earthquake.
- The reasons supporting this result are as follows.
  - Debris removal will substantially reduce the weight of the upper part of the building which in turn will reduce the seismic force.
  - The spent fuel pool walls and the thick walls around the PCV remained intact even after the earthquake.

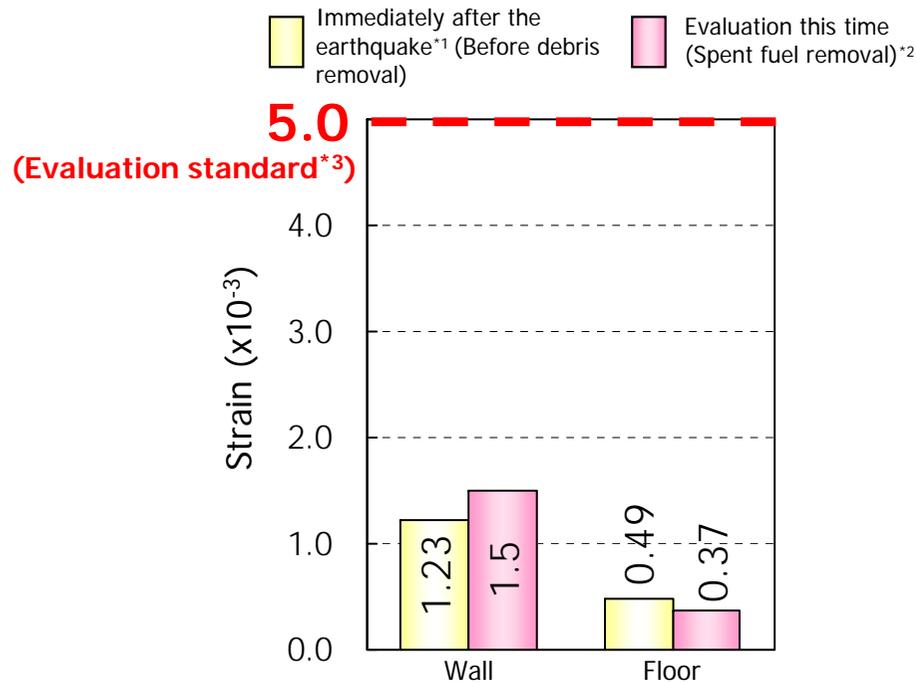
- The strains and stresses generated in the spent fuel pool structure are lower than the evaluation standards, and thus, the pool has sufficient seismic resistance.
- Since the strains and stresses generated in the pool structure are sufficiently low, it has been judged that there is no possibility of the stainless-steel lining (of about 6mm thick) on the inner surface of the pool being damaged and water leaking from the pool. (See Reference 2 for details.)

Evaluation results of rebar tensile strain

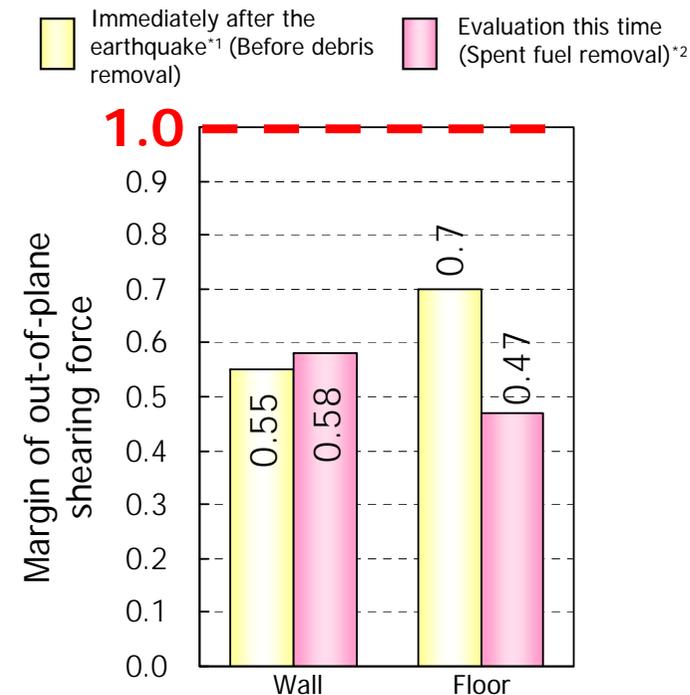
Evaluation result of out-of-plane shearing force\*4 (margin\*5)

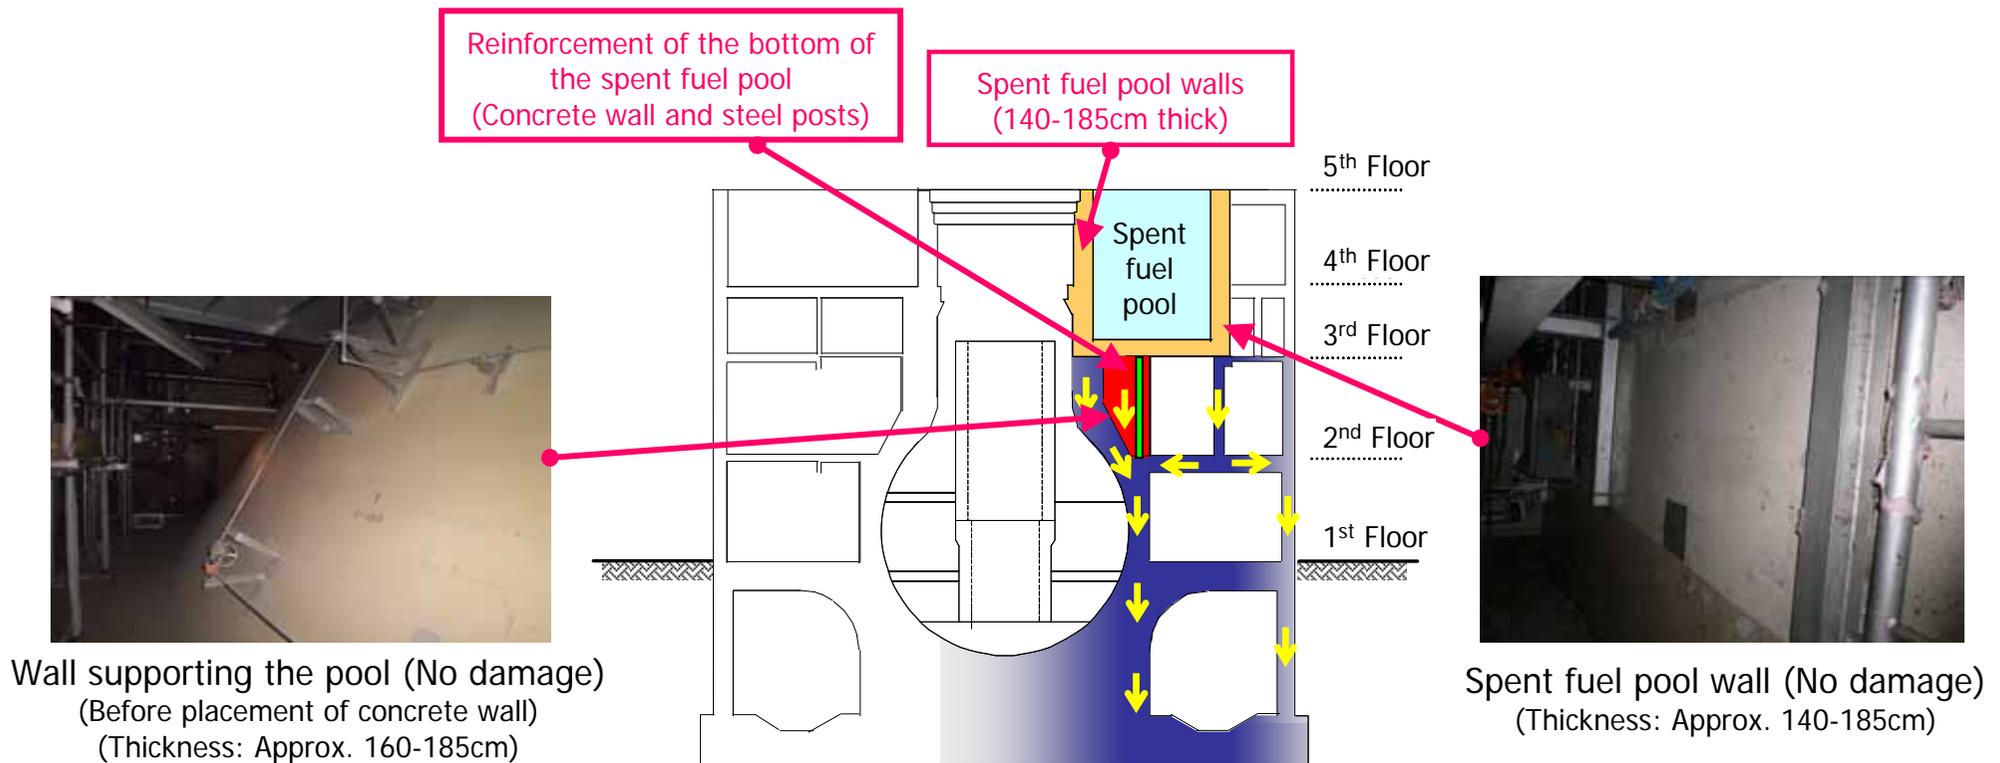
- Since the spent fuel pool walls<sup>\*1</sup> are very thick and the pool is entirely supported by very thick walls<sup>\*2</sup>, the seismic resistance equivalent to that of before the earthquake is maintained even with the exterior walls and the floor slabs of the reactor building being damaged. Therefore it has been confirmed that the spent fuel pool has a sufficient safety margin even in the case of a big earthquake equivalent to the Tohoku-Chihou-Taiheiyou-Oki Earthquake (JMA Seismic Intensity Scale 6+) in the future.

\*1: Spent fuel pool walls: Reinforced concrete (Thickness: 140-185cm)

\*2: Walls supporting the spent fuel pool: Reinforced concrete (Thickness: 160-185 cm)

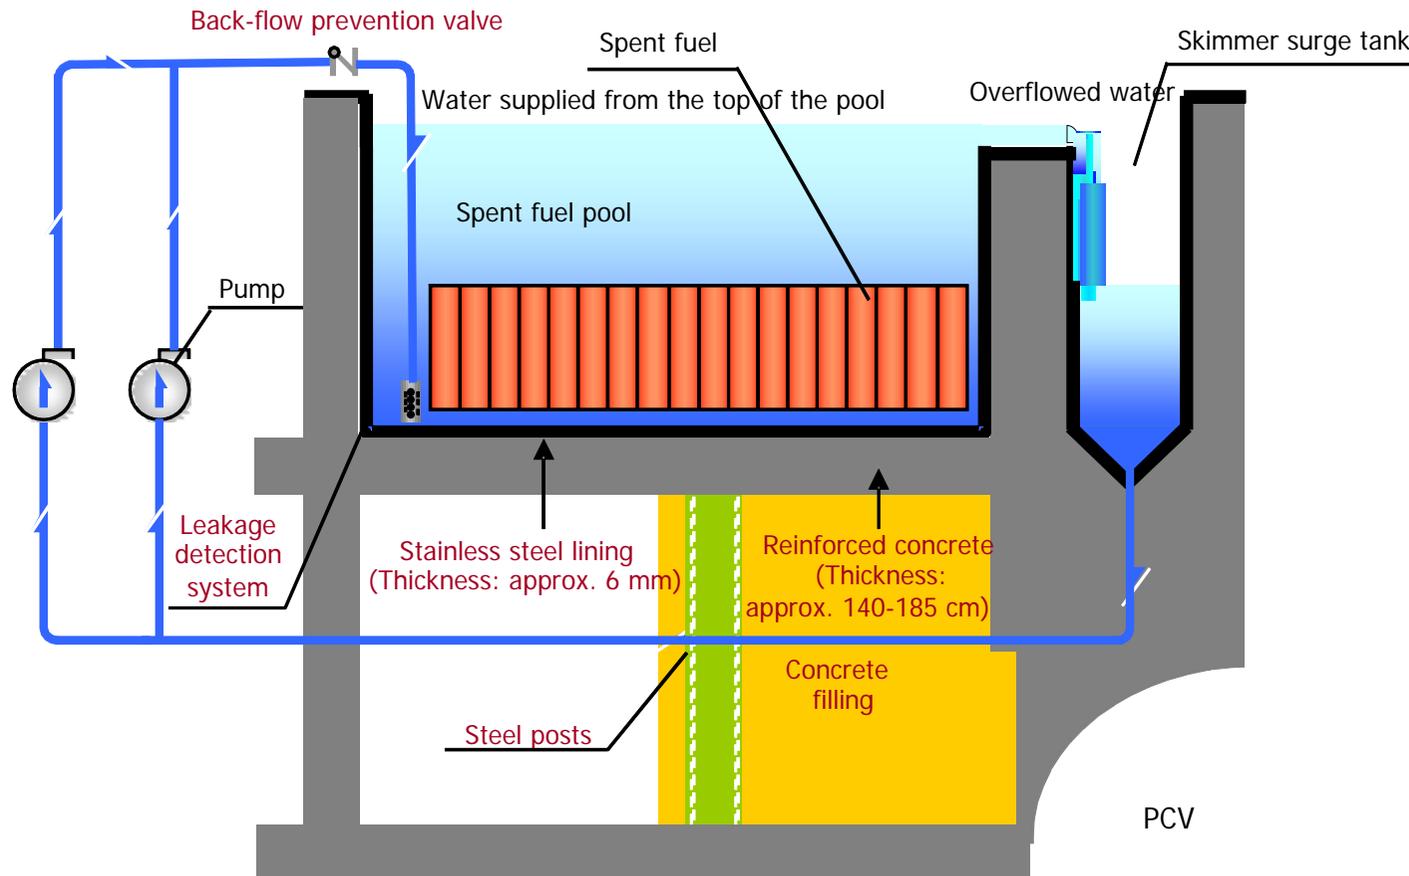
Structure of the spent fuel pool

- The inner surface of the pool is covered with a stainless-steel lining.
  - The spent fuel pool is made of reinforced concrete which is about 140-185cm thick. In addition, the inner surface of the pool is covered with a stainless-steel lining of about 6mm thick.

- There are no pipes or drain holes penetrating through the side walls and the bottom of the spent fuel pool.
  - The water circulating in the pool is injected from the top of the pool, and the overflowed water flows into the skimmer surge tank. There are no pipes or drain holes penetrating through the side walls and the bottom of the spent fuel pool which may be of risk for water leakage.

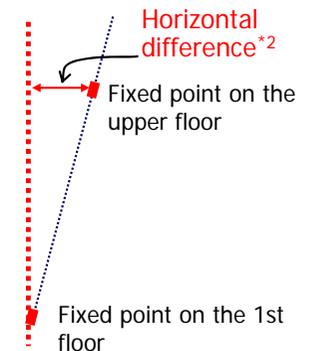
The horizontal difference\*2 measured this time was about the same as those measured in the first regular inspection (May 2012) and the detailed exterior wall inspection (June 2012), and the deformation found at each measurement point has a similar tendency. For the south and west exterior walls of the 2nd floor where partial bulge was found, the analysis was done without taking into considerations the wall rigidity. The results indicate no problem with the seismic safety of the reactor building.\*3

\*2 Horizontal distance between the fixed point on the 1st floor and the fixed point on the upper floor
