Water Leakage from the Desalination System (Reverse Osmosis Membrane) 3

Location: In the temporary warehouse of the desalination system (Reverse osmosis membrane) 3

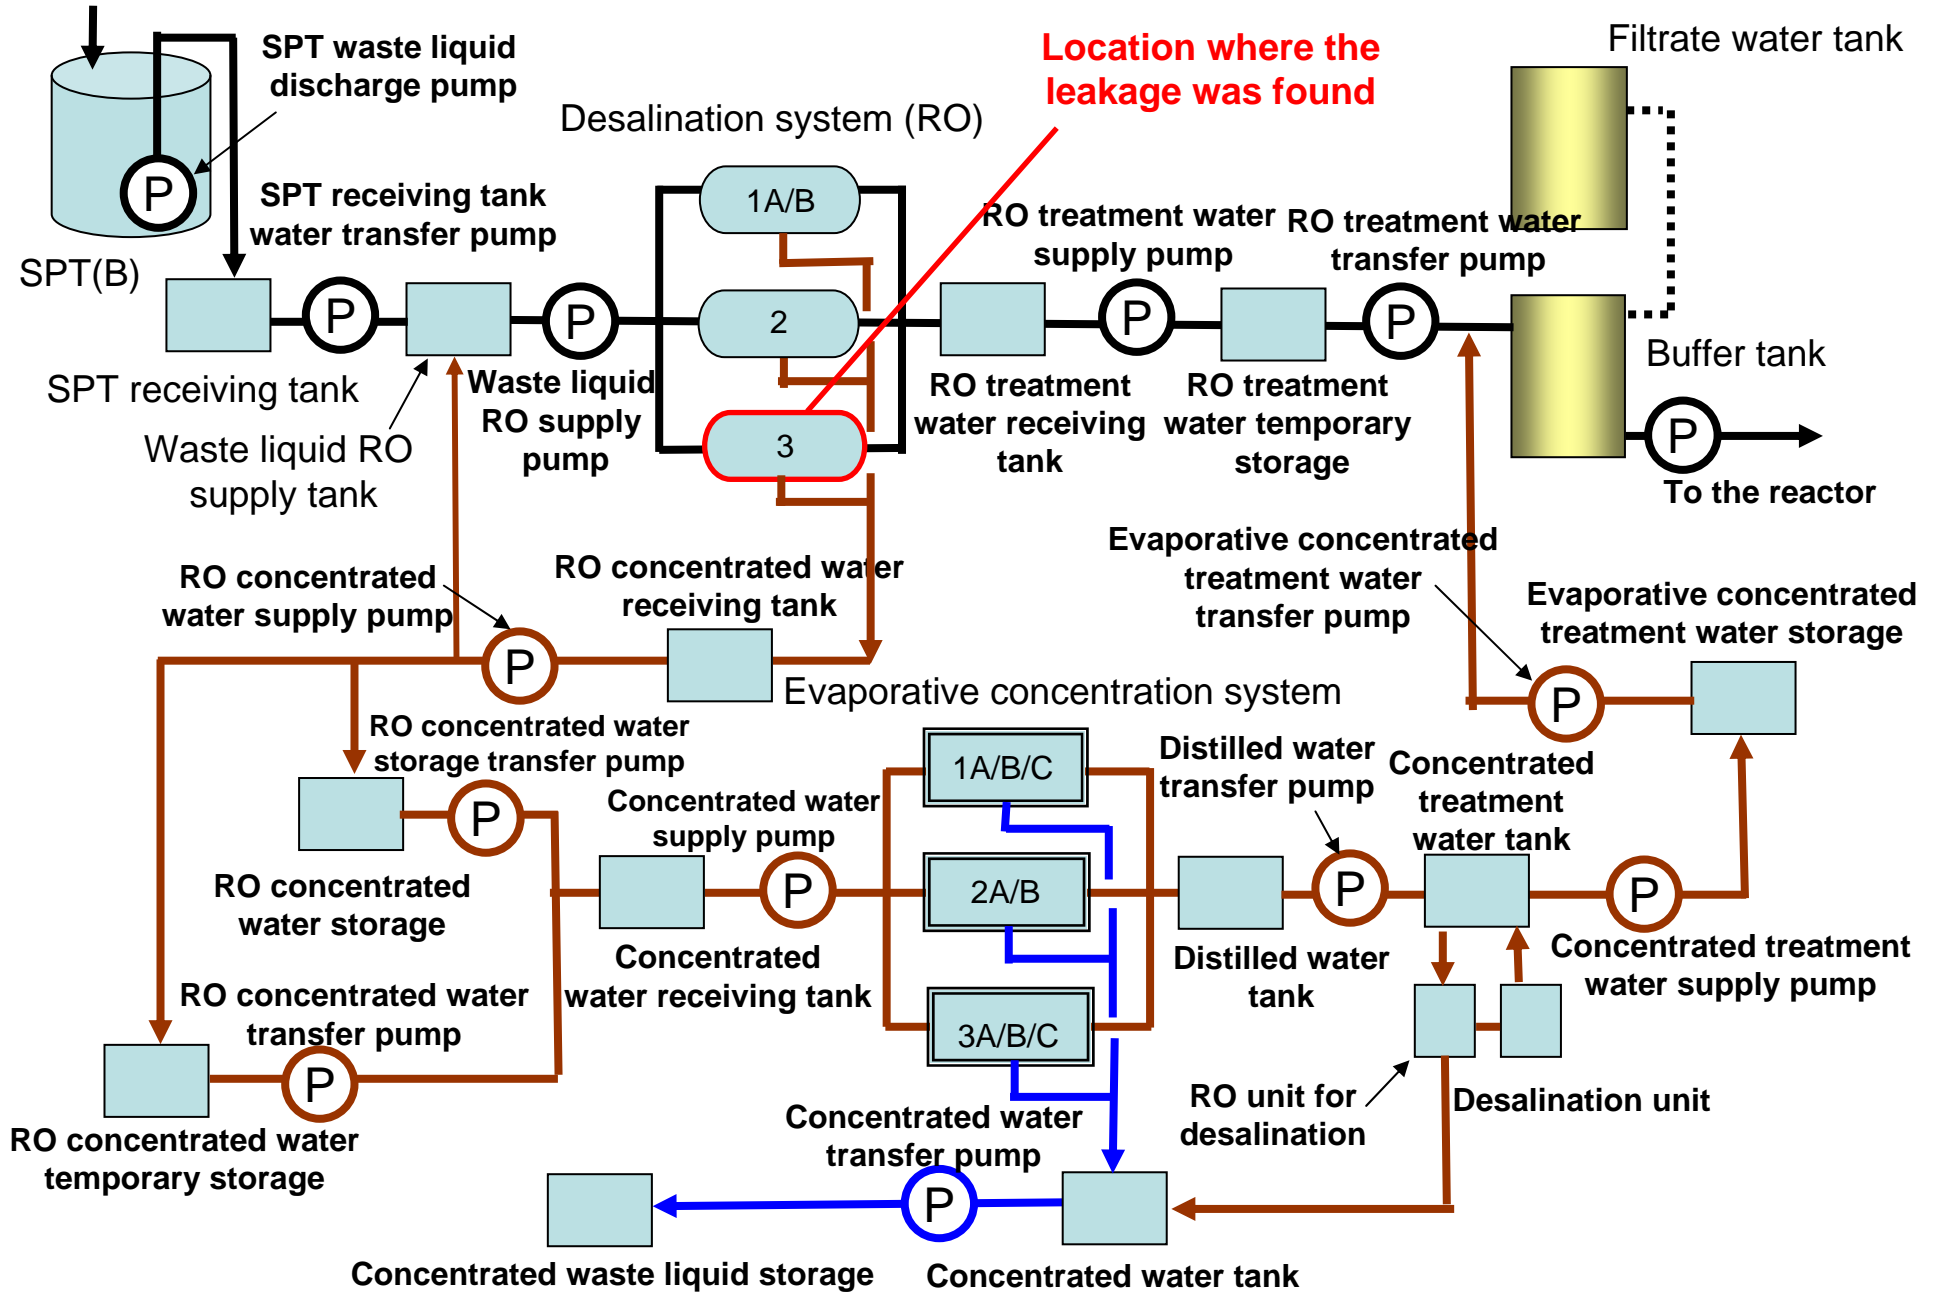
Overview of the Desalination System

Leakage area: Screw on the outlet side of the high pressure pump of Skid 3 of the desalination system (reverse osmosis membrane) 3

Cause: To be investigated (the system will be disassembled for inspection).
